Historic Structures Report:

Jarratt House

Historic Structures Report Jarratt House

Prepared by:
Brandon L. McCuin M.H.P

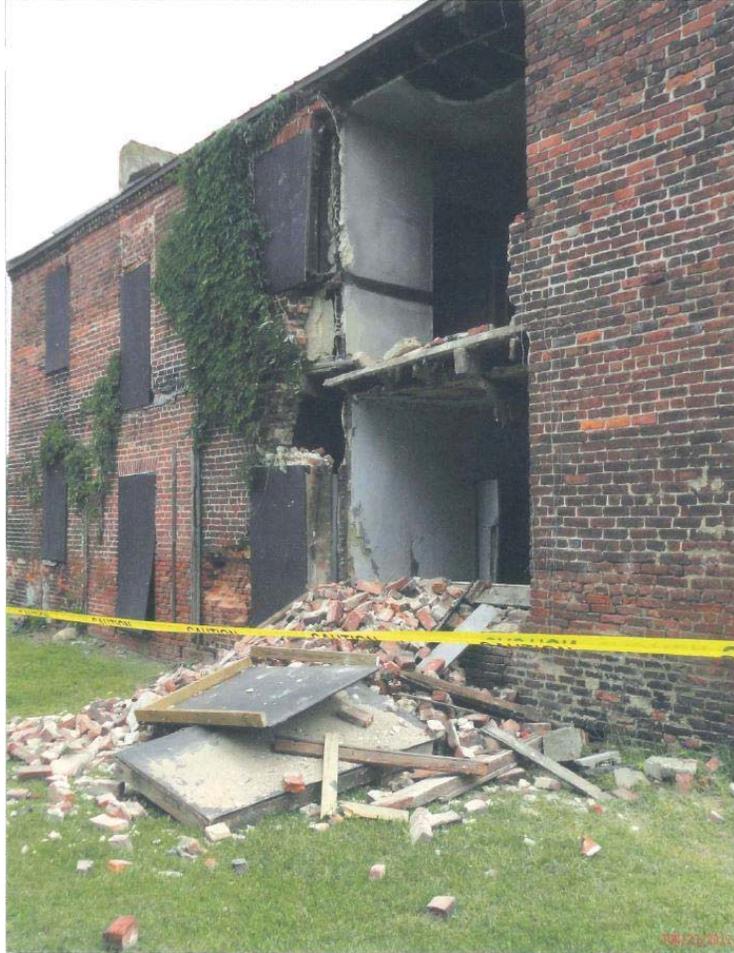
Figure 3-3: Photo of Jarratt House rear (west) wall collapse, 2011.

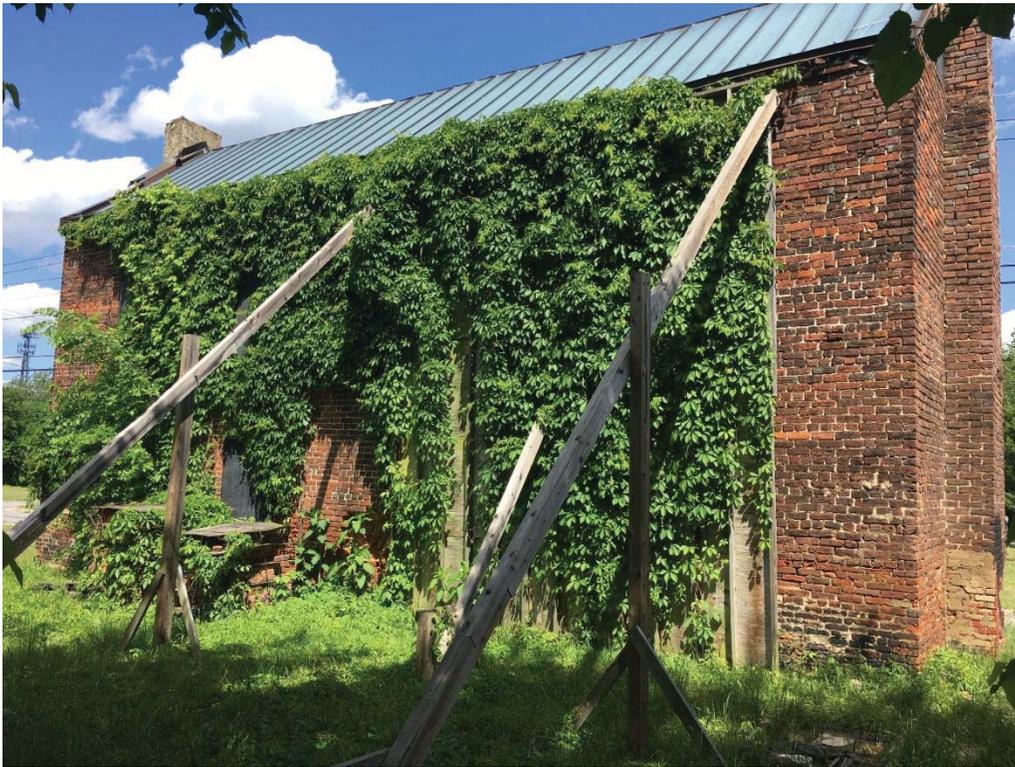
Figure 4-2 Photograph of Jarratt House, rear (west) wall showing shoring and vegetation, 2017.

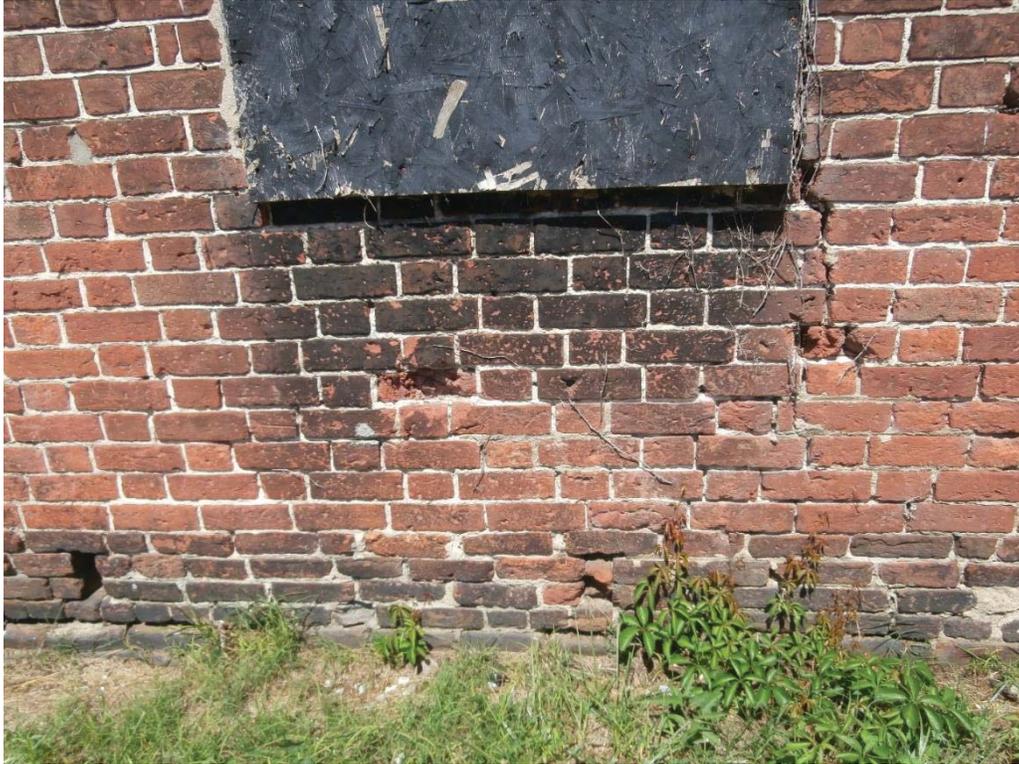
Figure 4-6. Photograph detailing the cracks at the northeast corner of the primary façade, 2017.

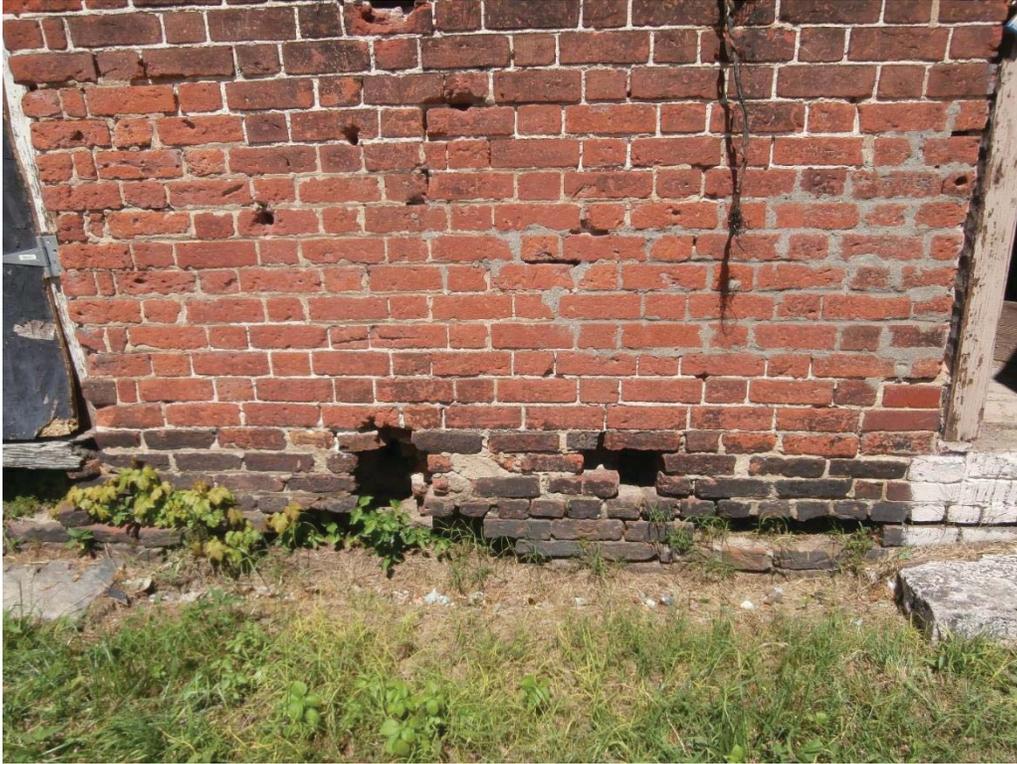
Figure 4-7. Photograph of masonry holes at the foundation on the primary facade, 2017.

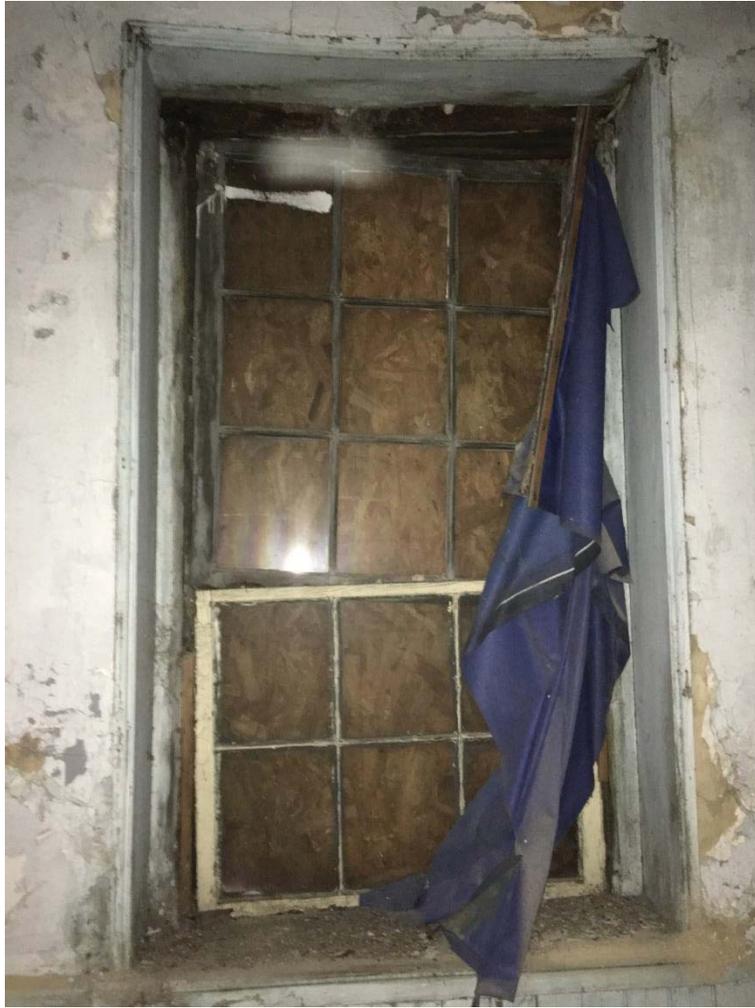
Figure 4-15. Interior photograph of window showing damage, 2017.

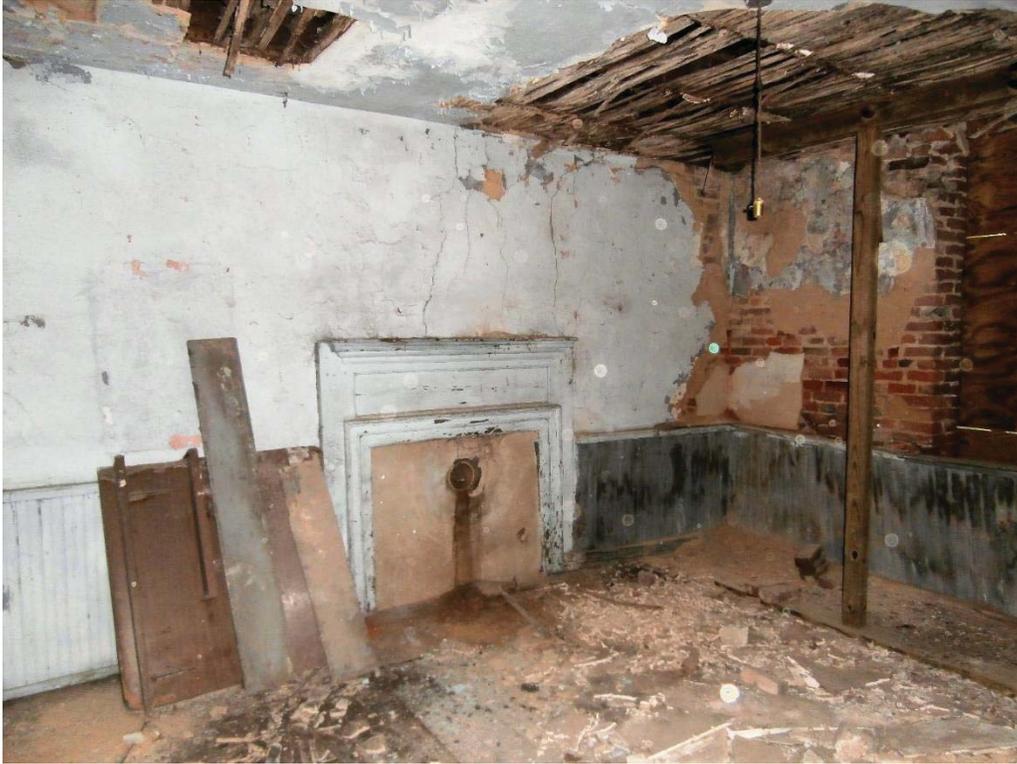
Figure 4-19. Photograph of southernmost room, on first floor, House 1, with historic fireplace and collapsed exterior wall (right), also note the ceiling damage and wainscoting, 2017.

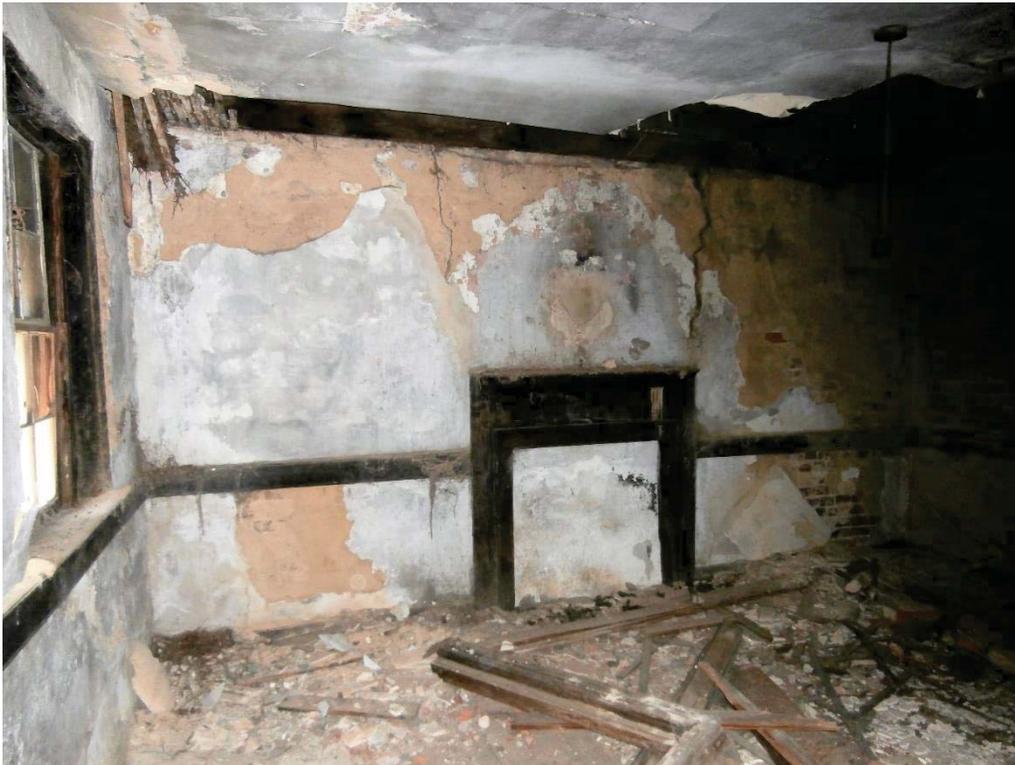
Figure 4-24. Photograph of southernmost room, on second floor, House 1, detailing fireplace mantel, wall cracks, peeling/missing plaster, and exposed exterior brick walls, 2017.

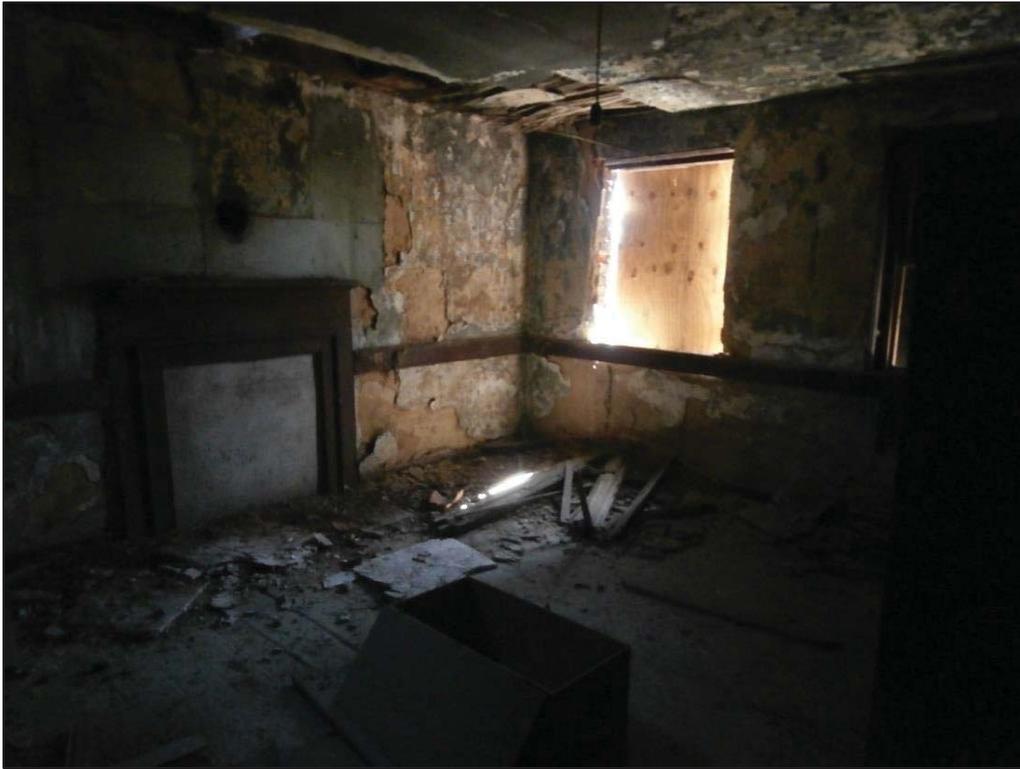
Plate 39: View of northern-most room on the 2nd floor with a missing window covered with plywood on the front façade (House 2), facing northeast.

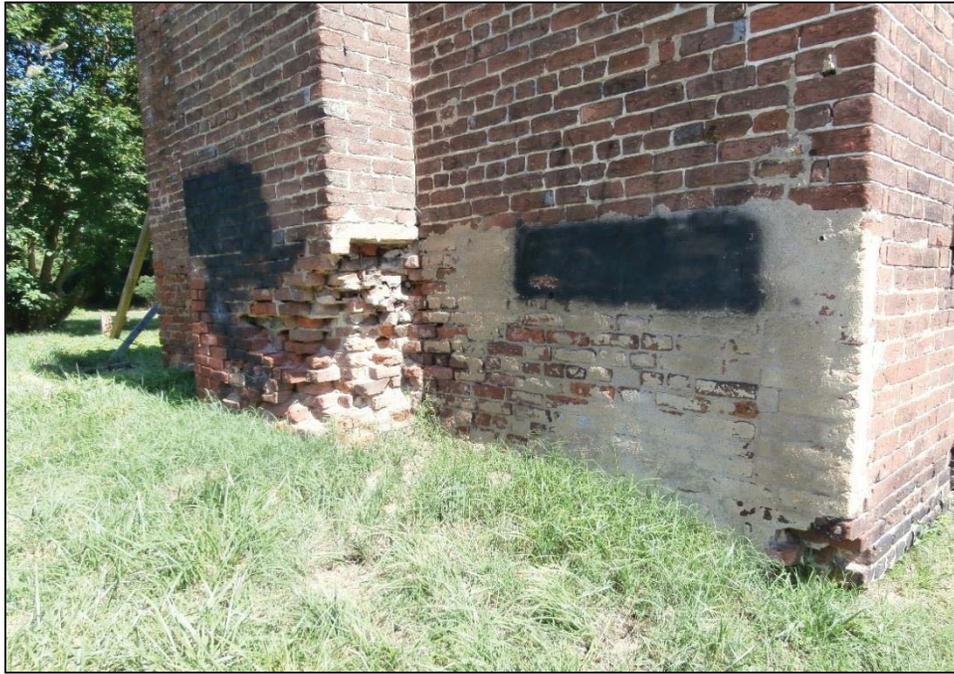
Plate 49: Detail of southeast corner of the building, showing missing bricks on chimney and poor mortar execution on south wall, facing north.

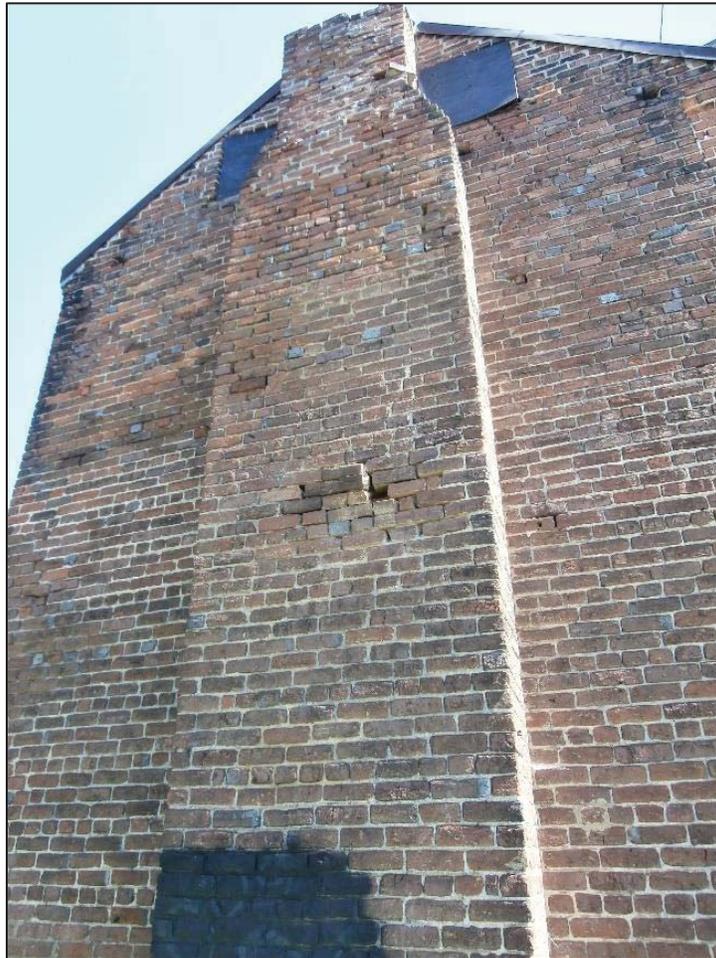
Plate 50: View of south façade, showing deteriorated mortar and two bays of infilled (plywood) attic windows, facing north.

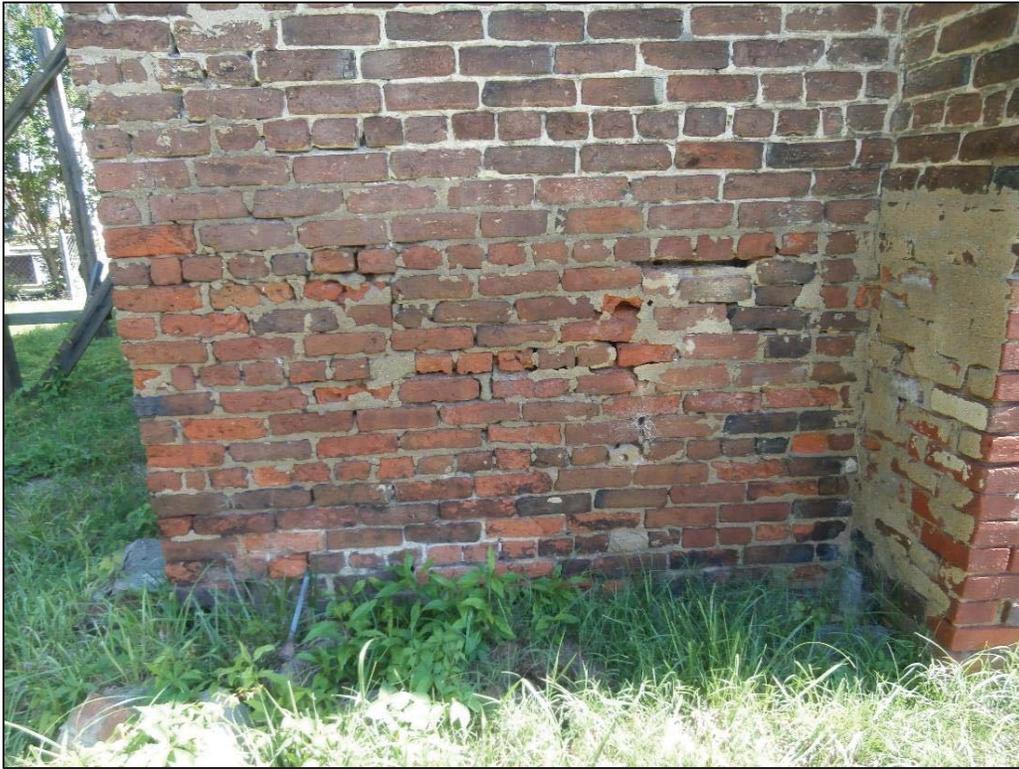
Plate 51 : Detail of southwest corner of building showing poor mortar match and deteriorated mortar, facing north.

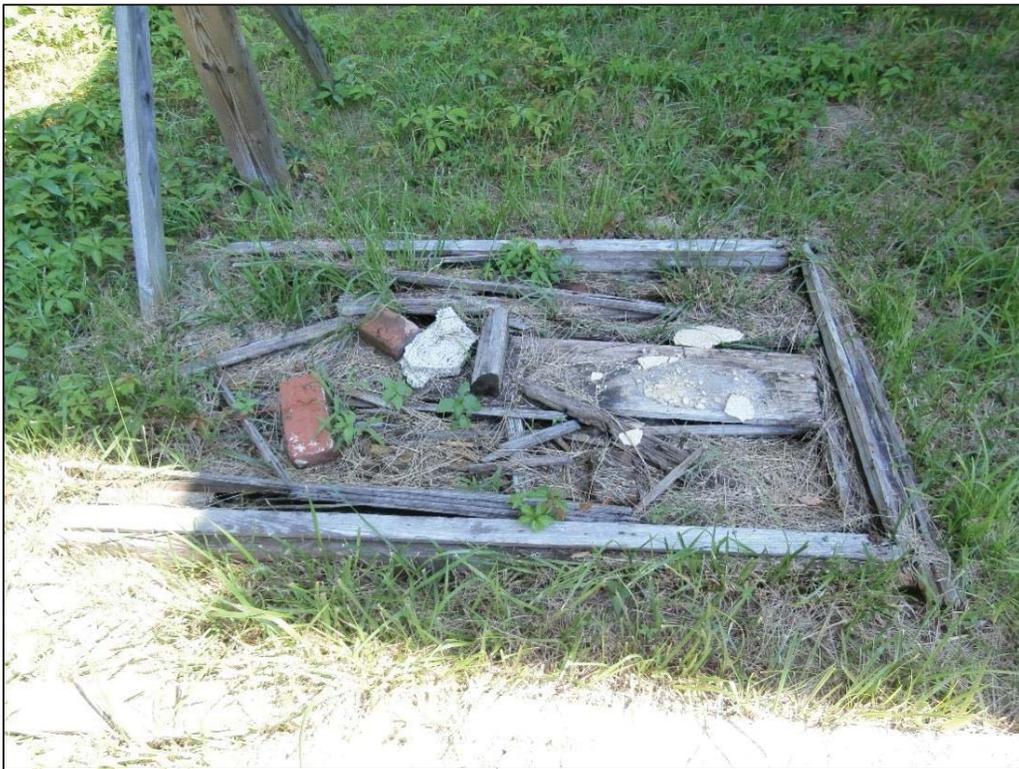
Plate 52: Detail of remnants from rear wall failure.

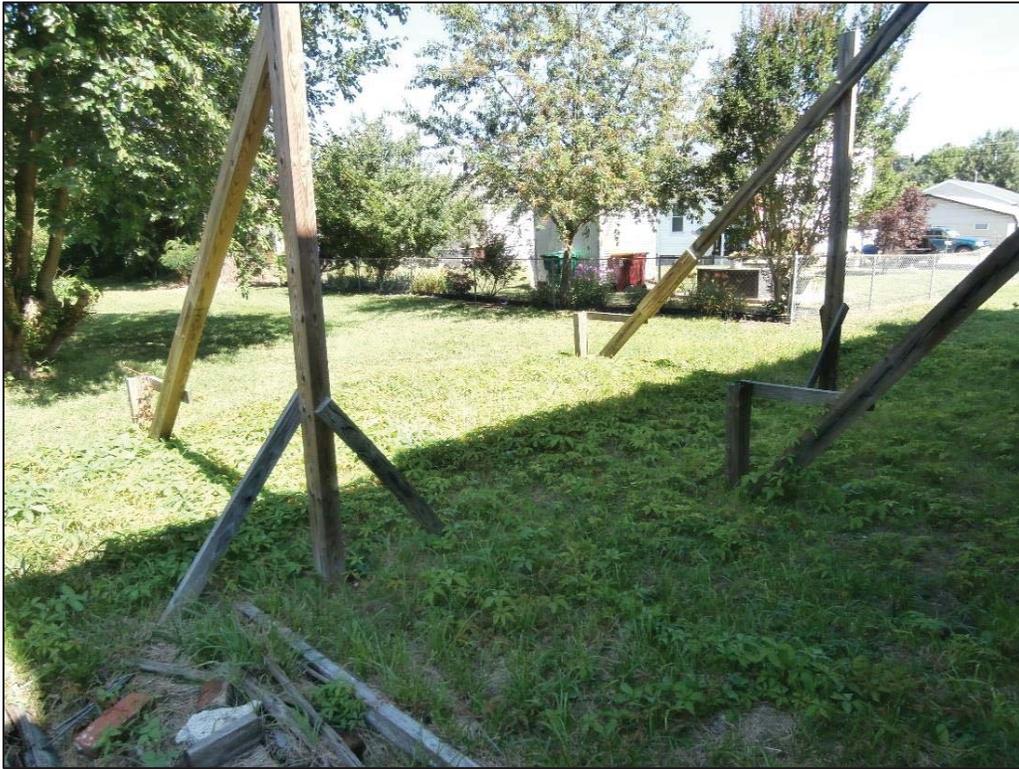
Plate 53: View showing temporary rear wall supporting frames, facing west.

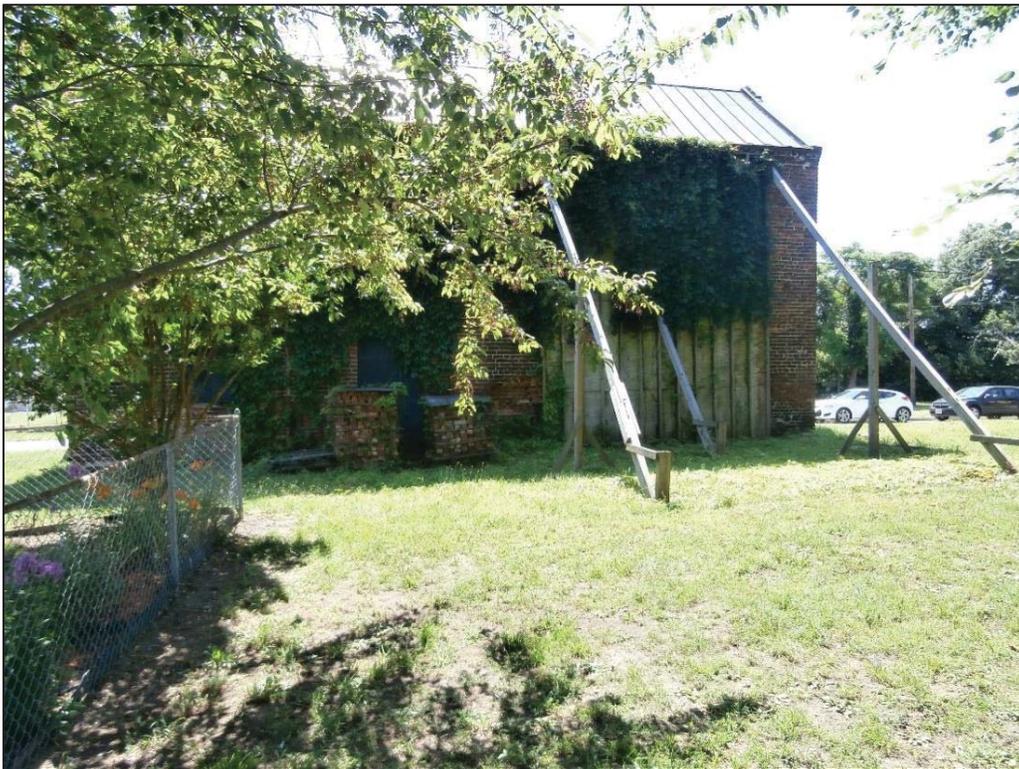
Plate 54: View of rear (west façade), detailing the temporary plywood wall covering damages, caused in 2011, on the right section of the exterior wall on the rear (west façade), facing east.

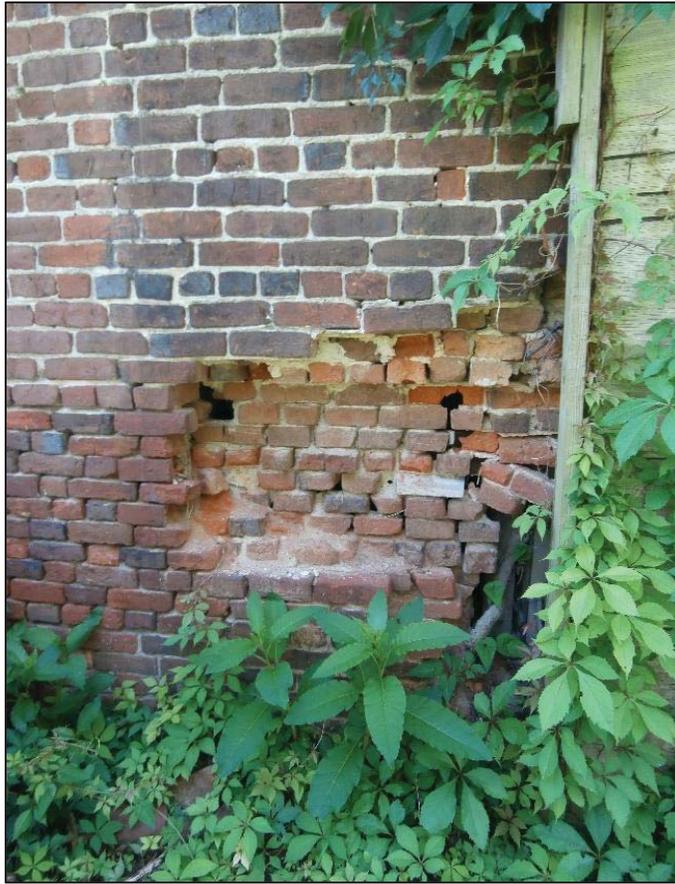
Plate 57: Detail of left side of the rear (west façade) of the building showing missing bricks, facing east.

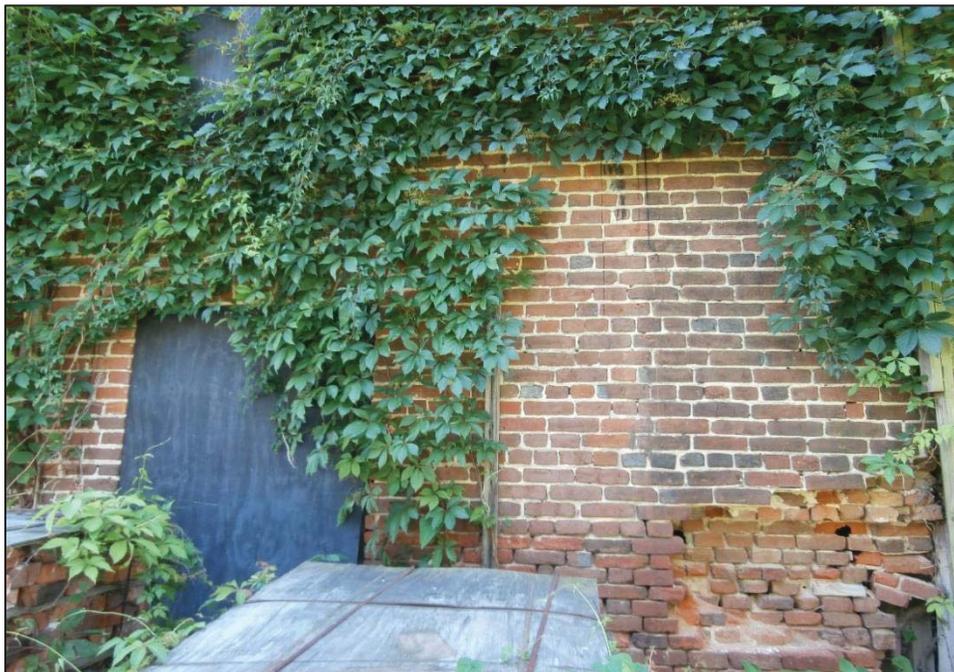
Plate 60: Detail of the rear wall (west facade) showing overgrown vegetation, missing bricks and plywood infilled windows, facing east.

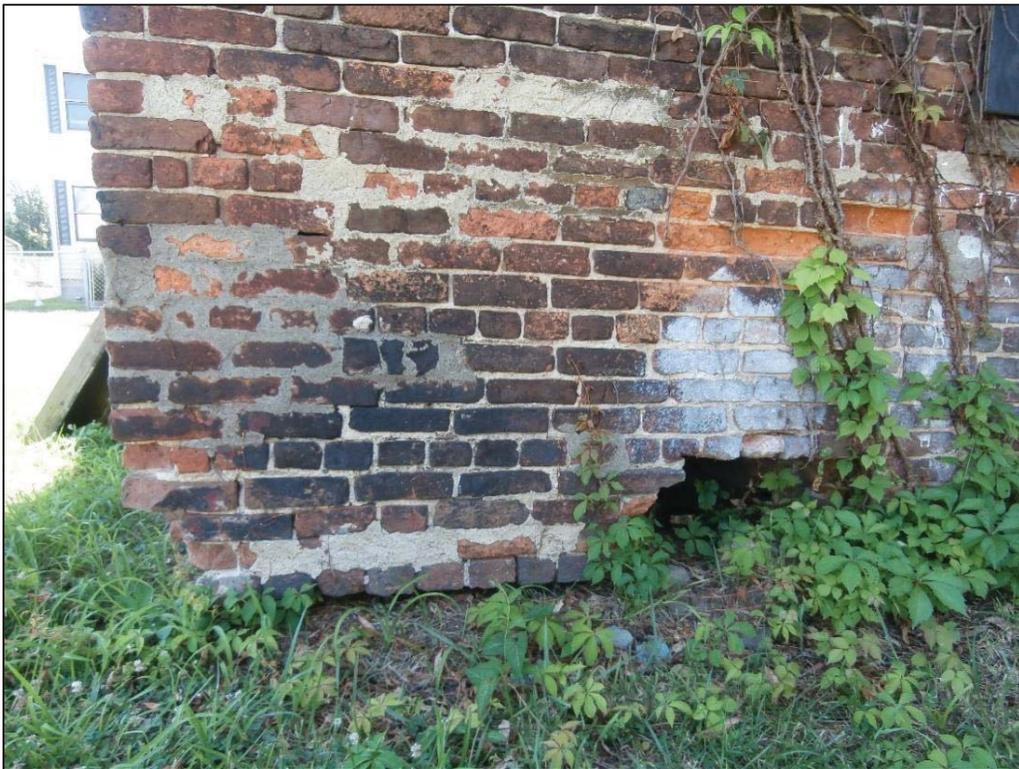
Plate 62: Detail of northwest corner on the rear wall (west facade) showing overgrown vegetation, missing bricks and poor mortar matching, facing east.

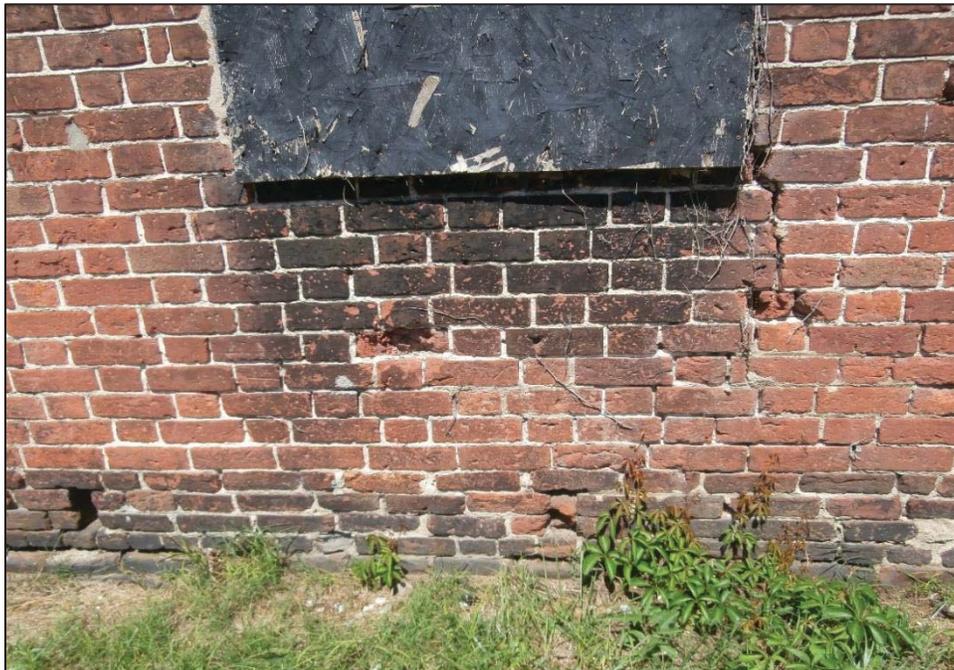
Plate 66: Detail of northeast corner on the front façade (east façade) showing missing brick, cracks in exterior wall and infilled window (window 6) with particle board, facing east.

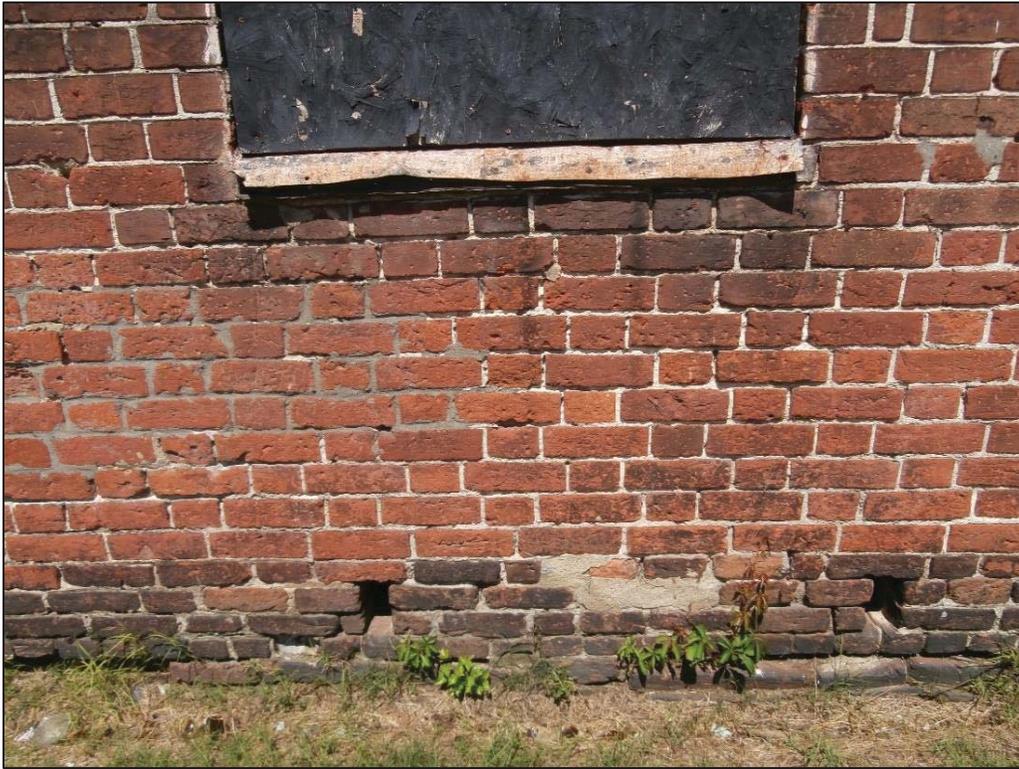
Plate 67: Detail of front façade (east) showing poorly matching mortar and particle board infilled window, facing west.

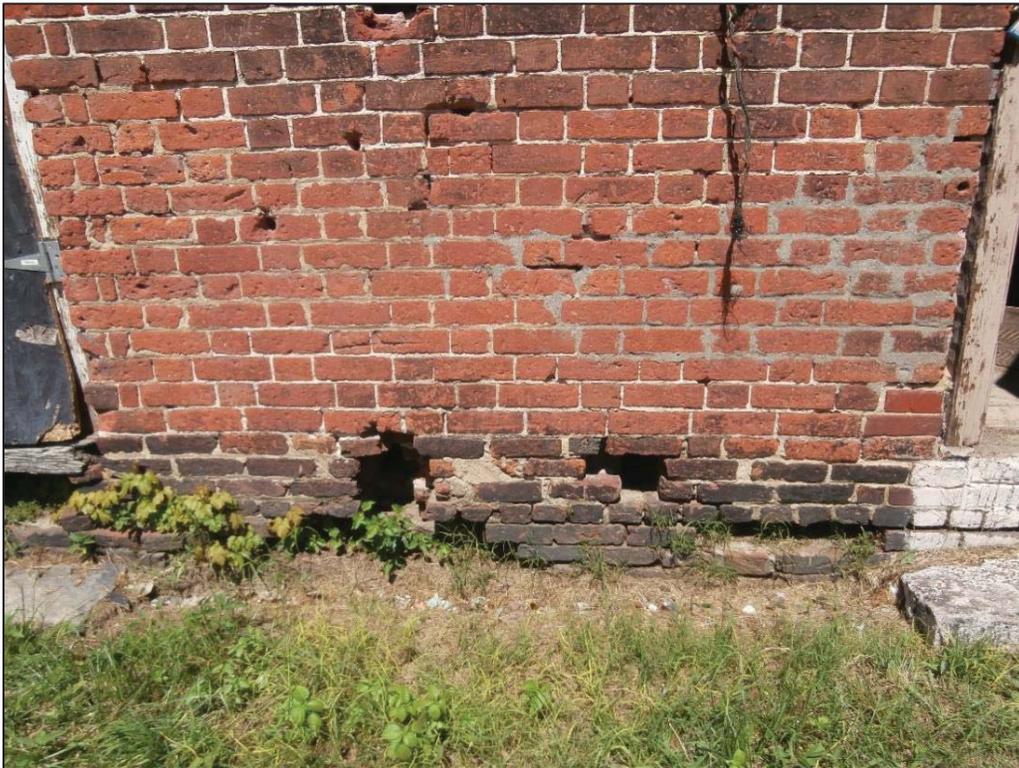
Plate 68: Detail of front façade (east) between both main entrances showing missing brick and poorly matched mortar, facing west.

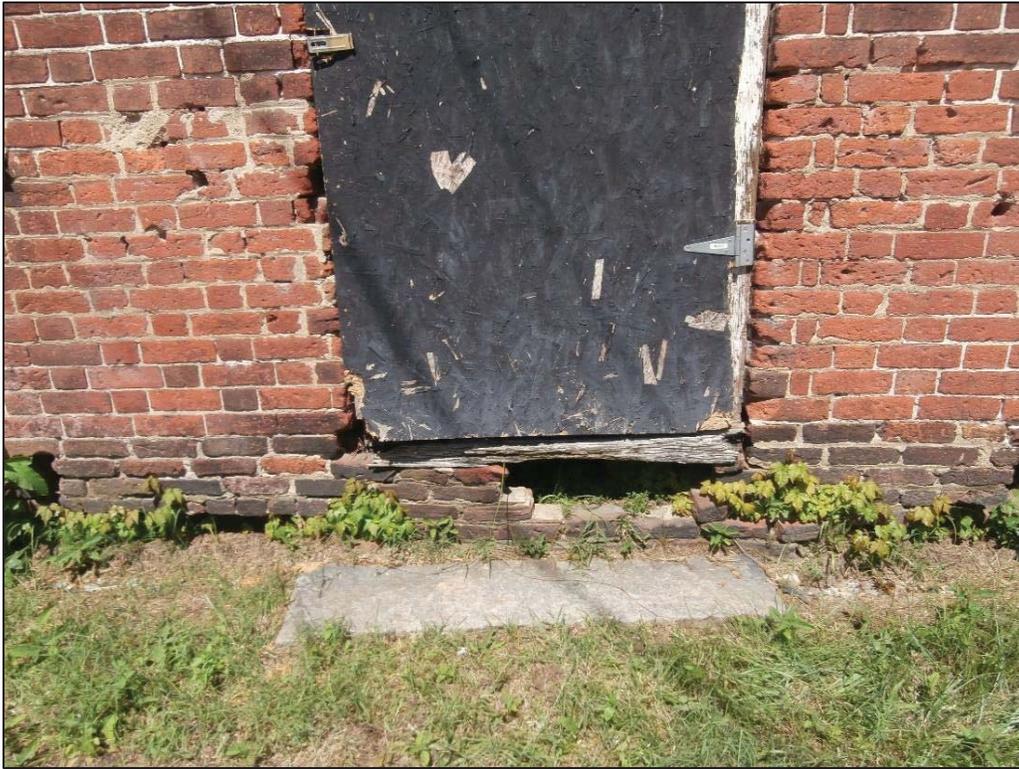
Plate 69: Detail of entrance (House 1) showing overgrown vegetation and missing brick, facing west.

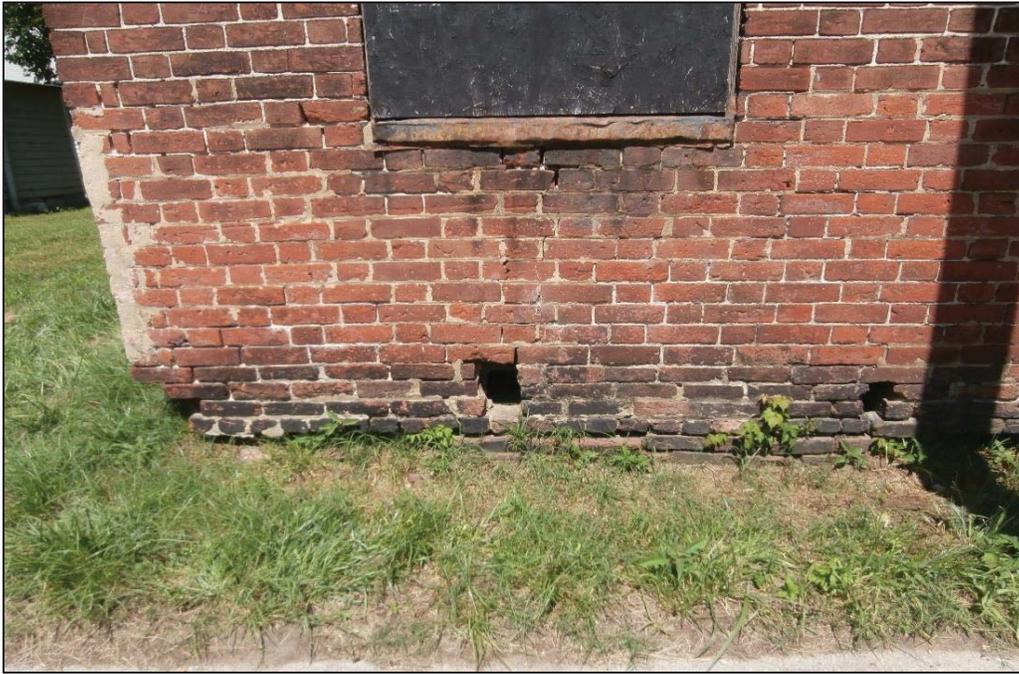
Plate 71: Detail of the southeast corner of the front façade (east) showing particle board infilled window, metal sill, missing brick and deteriorated mortar, facing west.

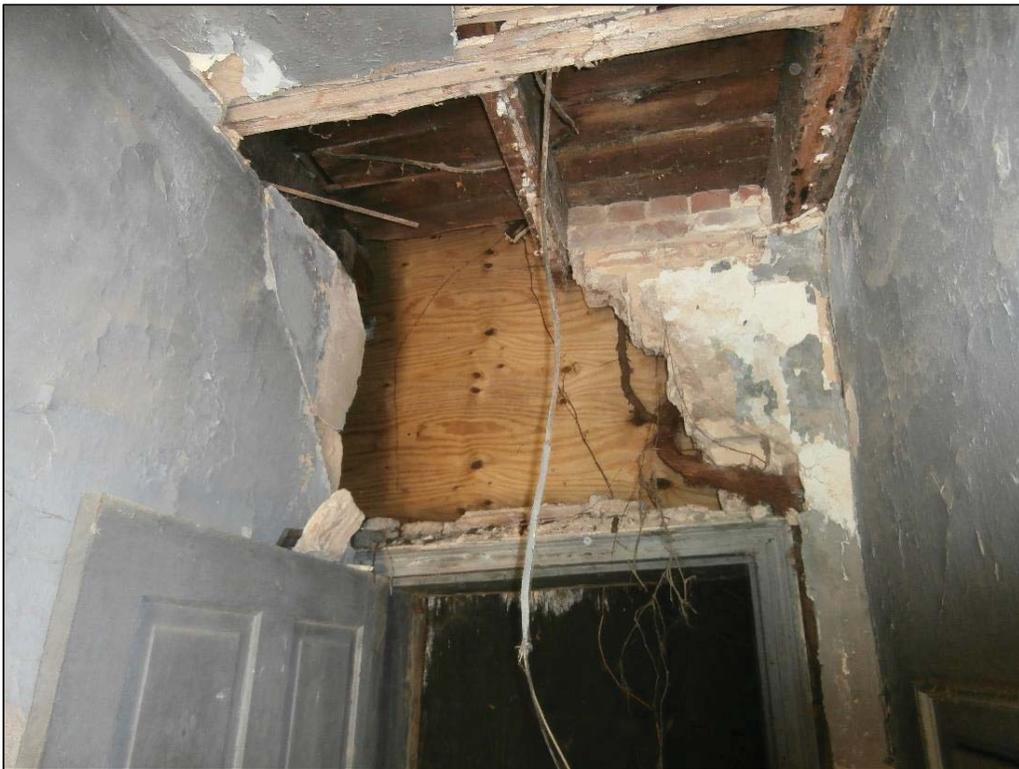
Plate 78: Detail of missing brick, wall and plaster above entrance to the rear of the building, facing west.

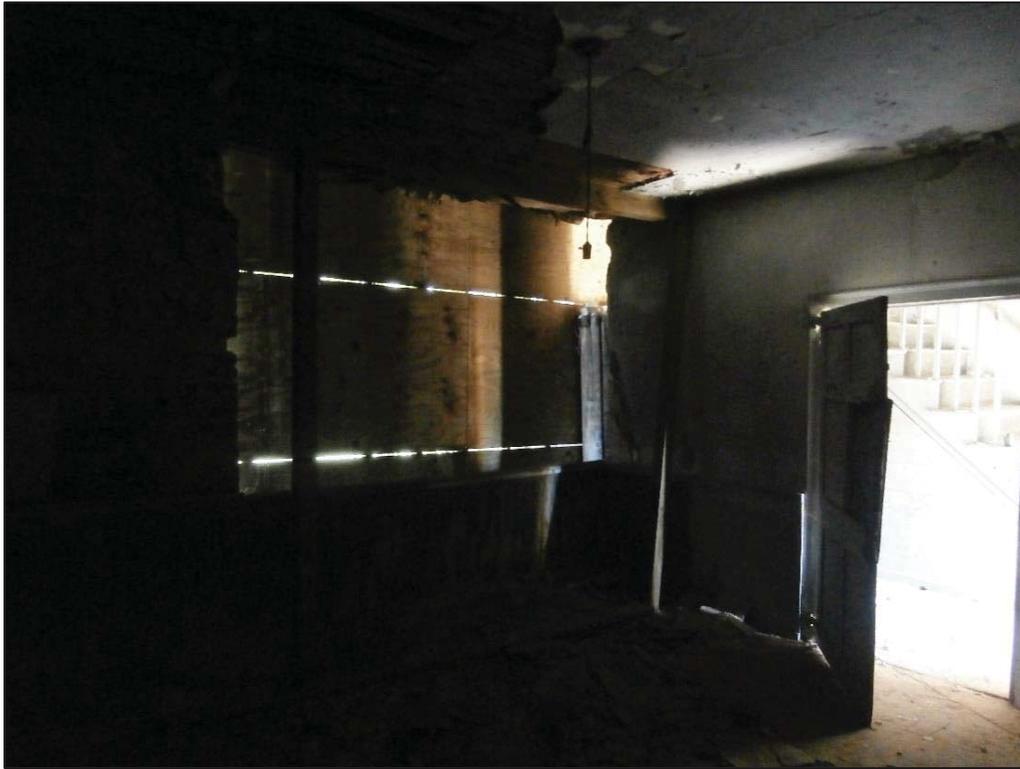
Plate 83: View of southern-most room and collapsed exterior wall to the left, and the door to hallway on the right (House 1), facing northwest.

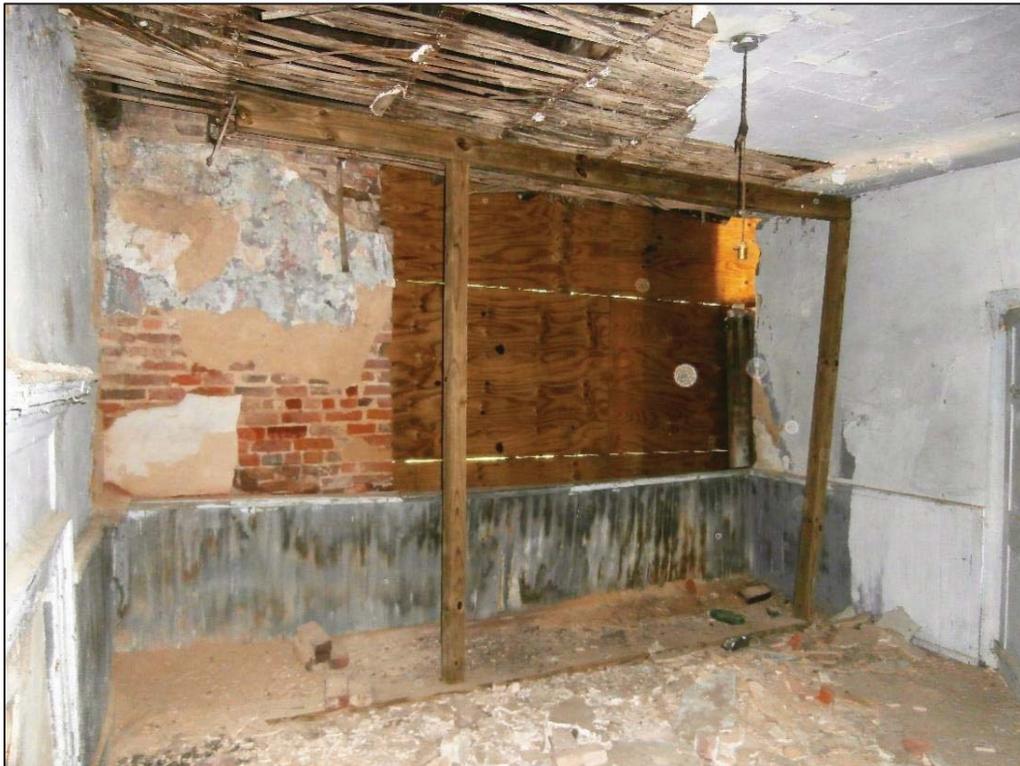
Plate 84: View of collapsed exterior wall and temporary supporting beams in southern-most room (House 1), facing west.

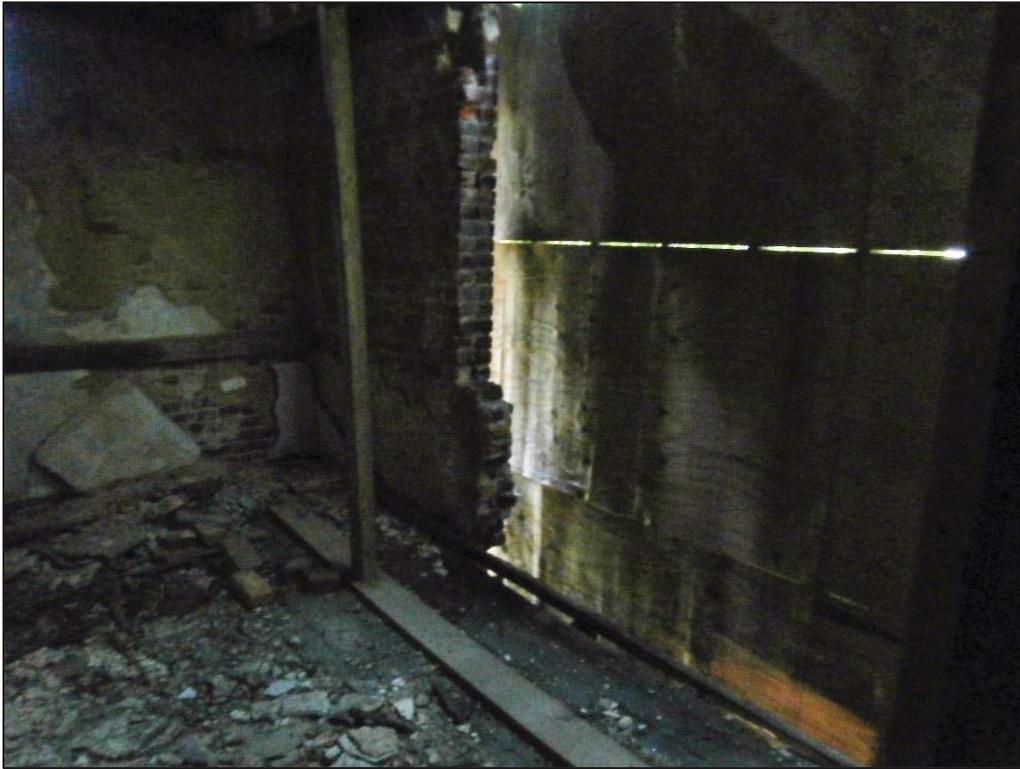
Plate 97: View of collapsed exterior wall in southern-most room on the 2nd floor (House 1), facing southwest.

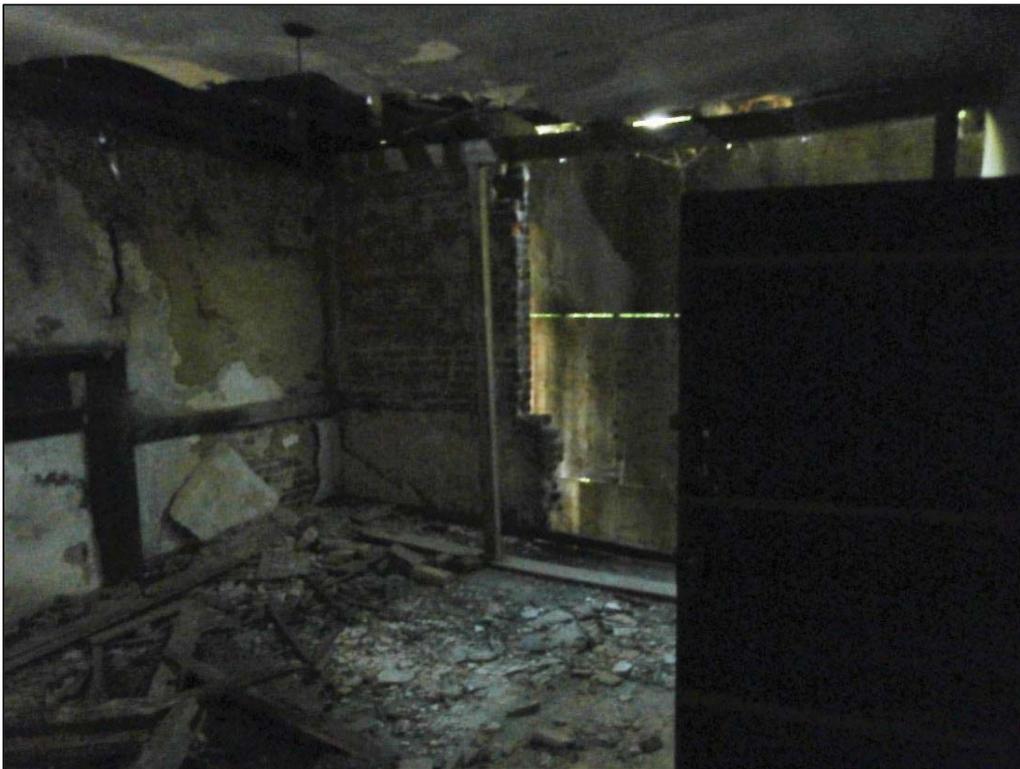
Plate 98: View of collapsed exterior wall in southern-most room on the 2nd floor (House 1), facing southwest.

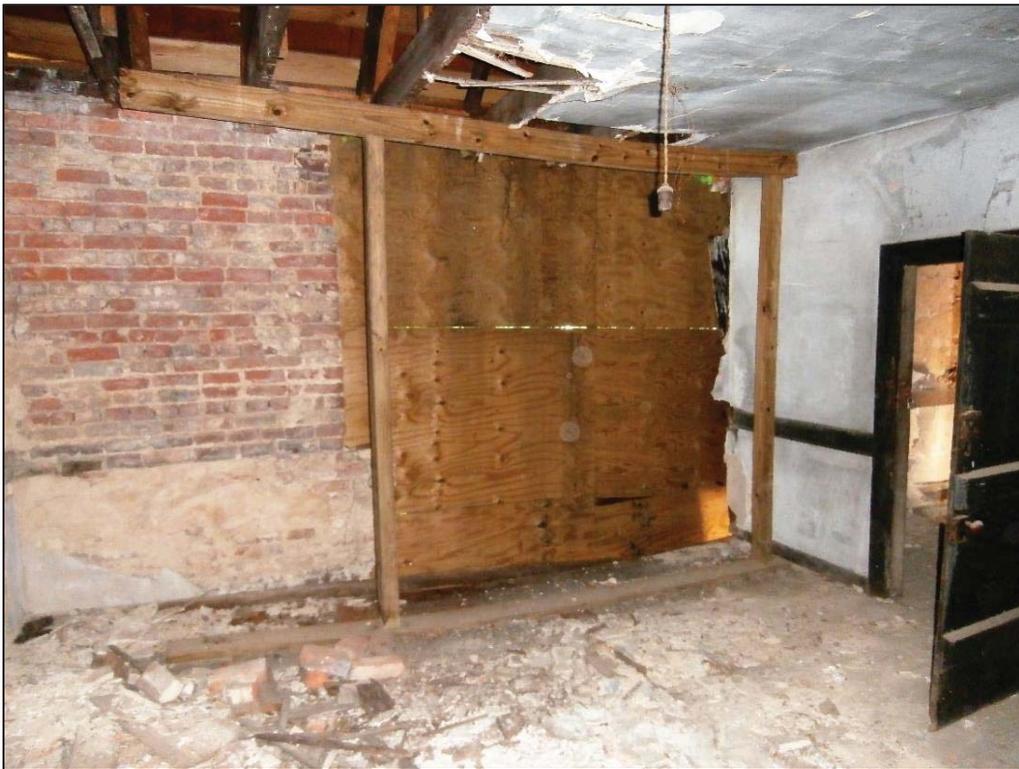
Plate 100: View of exposed brick and collapsed wall in southern-most room on the 2nd floor (House 1), facing west.

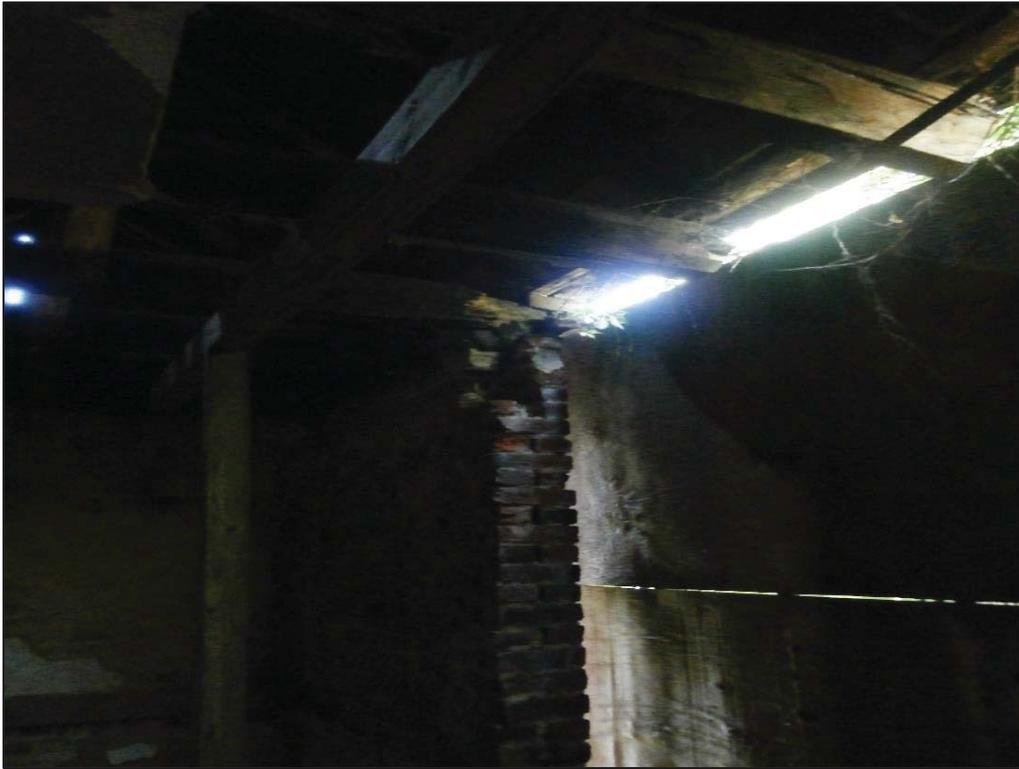
Plate 103: View of collapsed west exterior wall on the 2nd floor (House 1), facing southwest.
