City of Petersburg Virginia

RE: **Public hearing and consideration of an ordinance to declare the property located at 380 E. Washington Street a blighted property and a public nuisance to the community, and authorizing the abatement of such nuisance.**

REPORT OF UNSAFE AND UNSECURED STRUCTURE THAT IS UNFIT FOR HUMAN HABITATION - PURSUANT TO VPMC 106.2

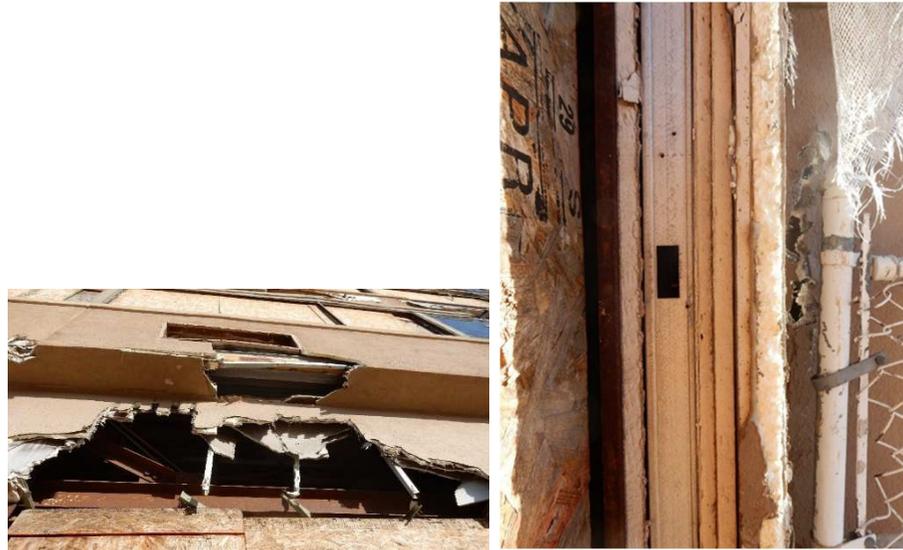
Examples of exposed exterior wall assembly

VMC Section 103.2: Buildings, structures and systems shall be *maintained* and kept in good repair in accordance with the requirements of the VMC.

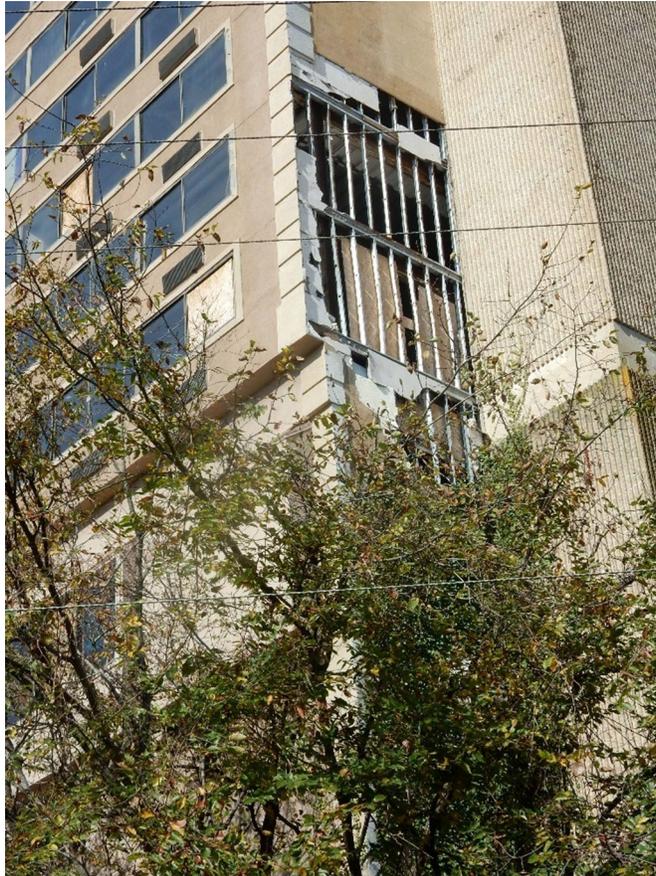
Example of missing exterior veneer

VMC Section 103.2.3: The owner shall maintain all buildings, structures, systems, facilities and associated equipment in compliance with the VMC.

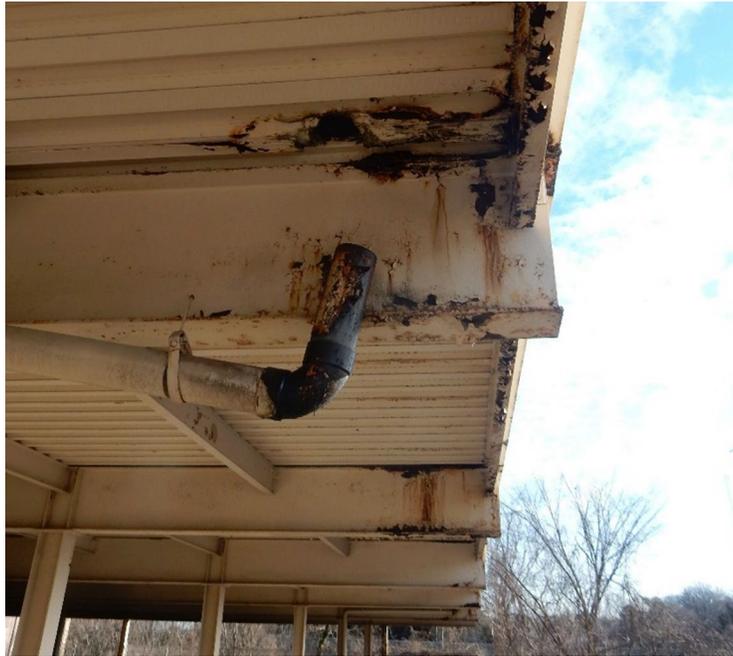
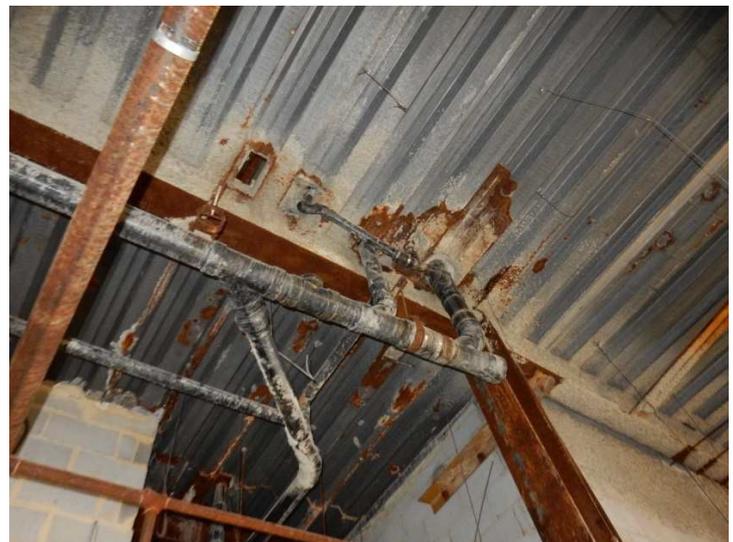
Examples of deterioration

VMC Section 202 - DETERIORATION. To weaken, disintegrate, corrode, rust or decay and lose effectiveness.

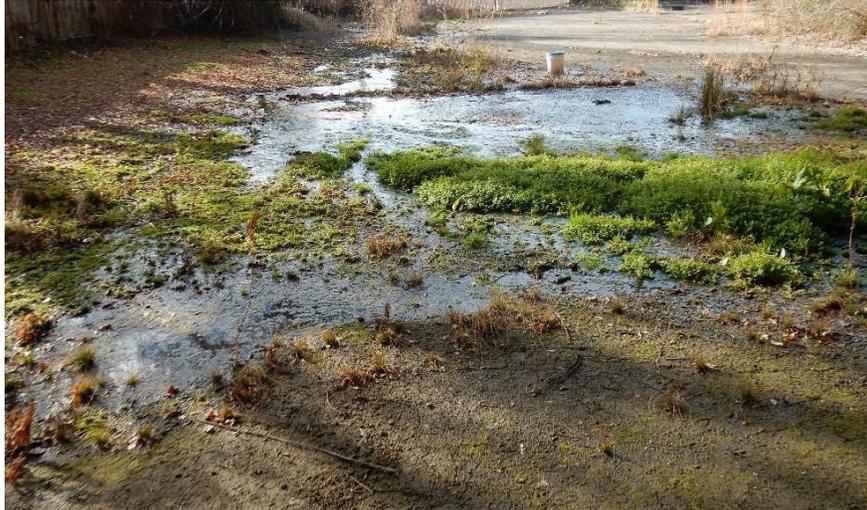
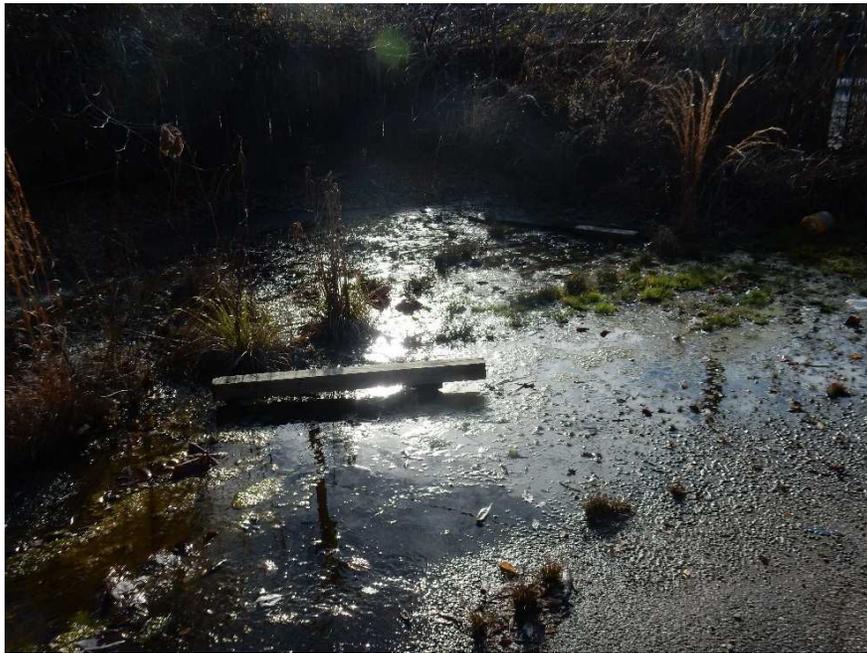
Examples of infestation (or the potential thereof)

VMC Section 202 - INFESTATION. The presence of insects, rodents, vermin or other pests.

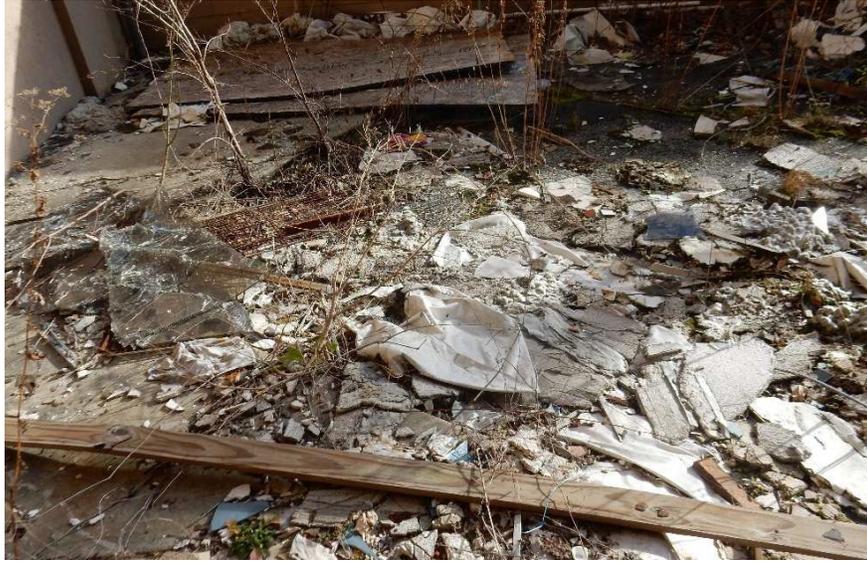
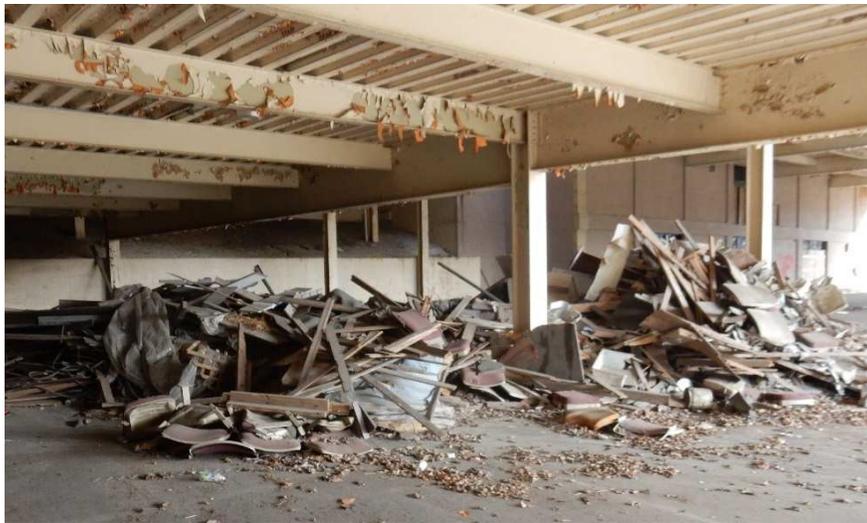
Examples of rubbish

VMC Section 202 - RUBBISH. Combustible and noncombustible waste materials; the term shall include combustible materials, paper, rags, cartons, boxes, wood, excelsior, rubber, leather, tree branches, yard trimmings, tin cans, metals, mineral matter, glass, crockery and dust and other similar materials.

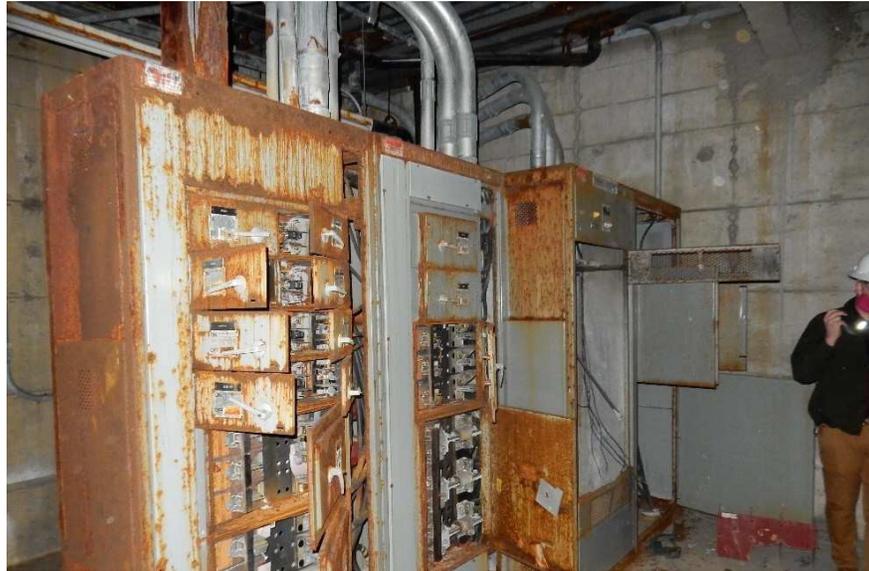
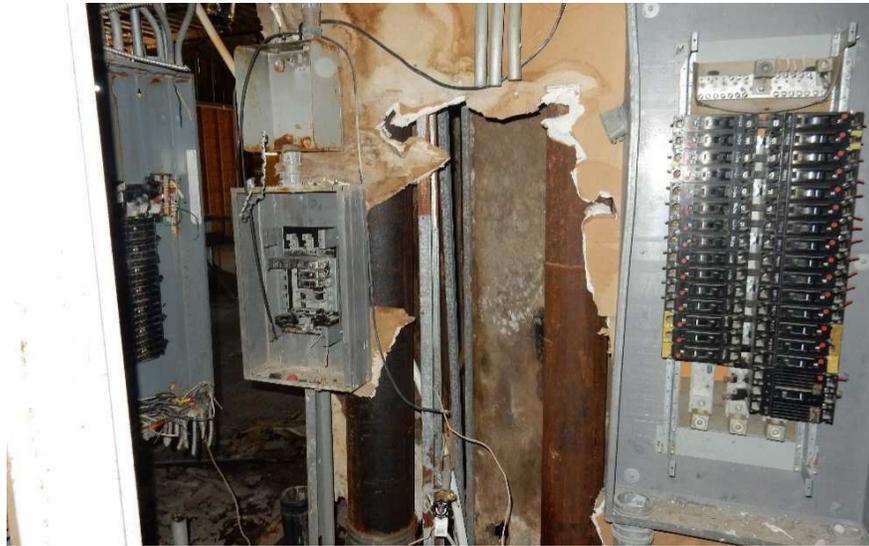
Examples of potentially unsafe equipment

VMC Section 202 - UNSAFE EQUIPMENT. Unsafe equipment includes any boiler, heating equipment, elevator, electrical wiring or device, flammable liquid containers or other equipment that is in such disrepair or condition that such equipment is determined by the code official to be dangerous to the health, safety and welfare of the public.

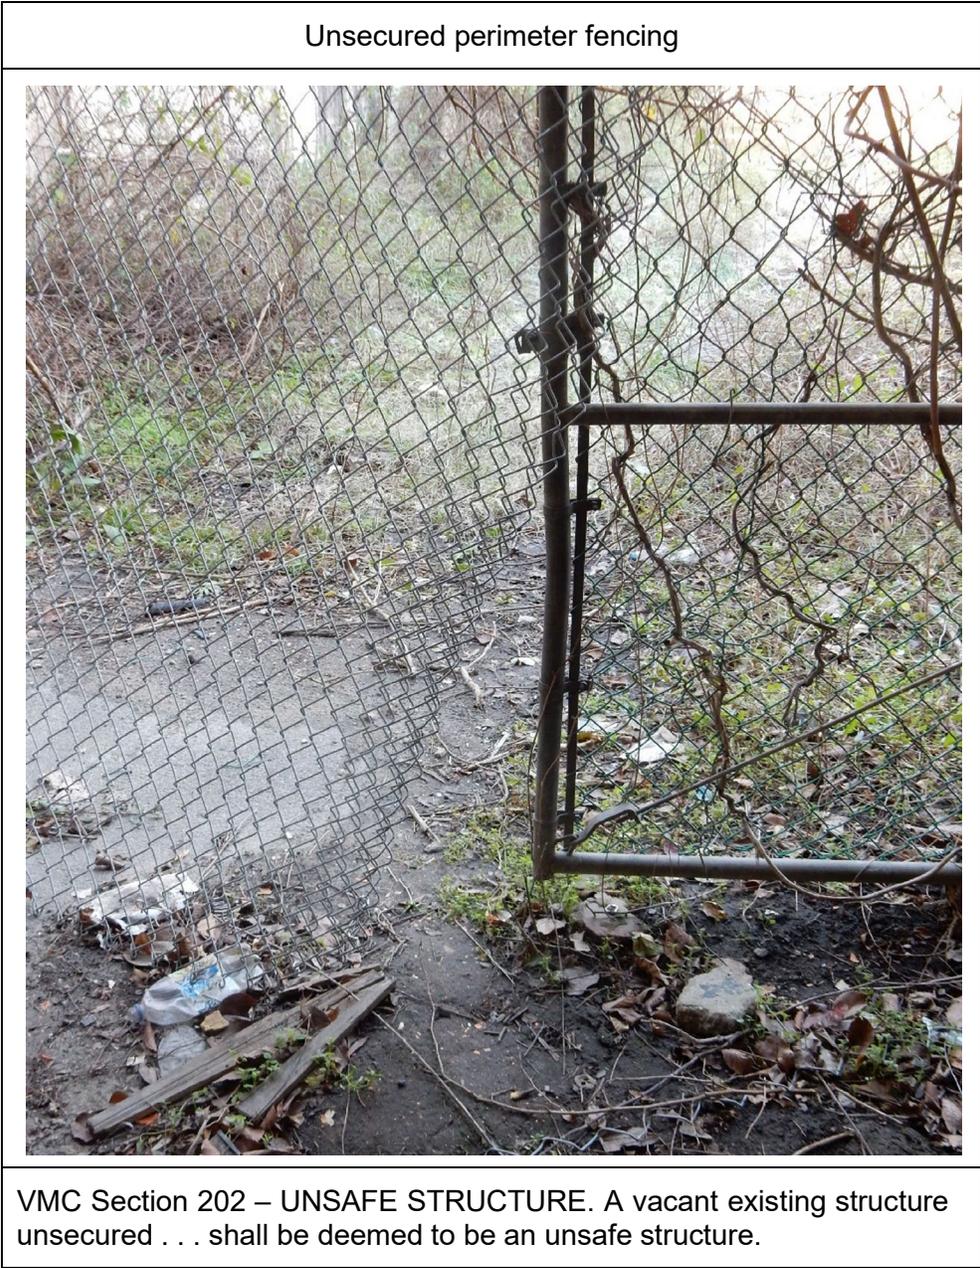
A possible access point in the perimeter fence.

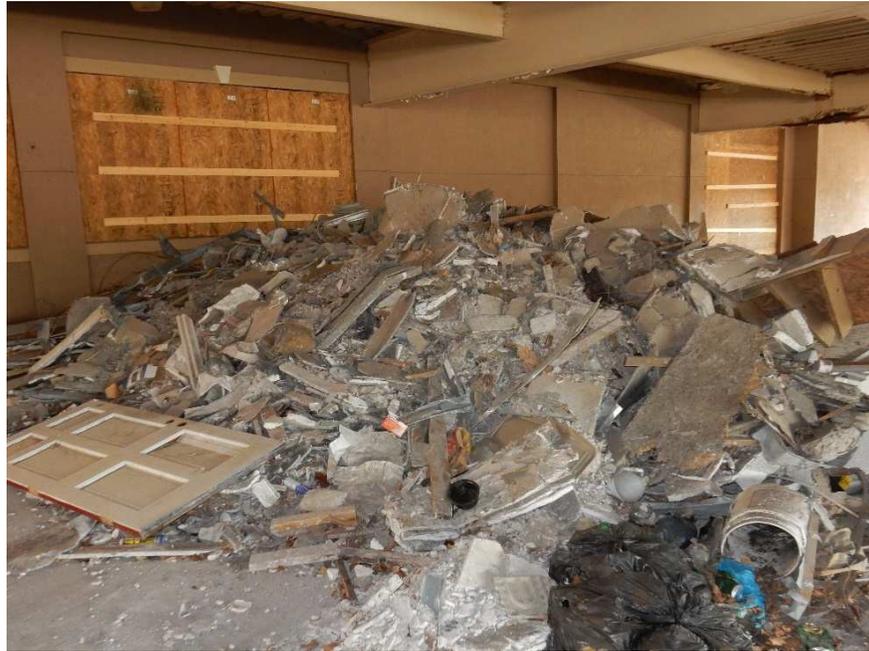
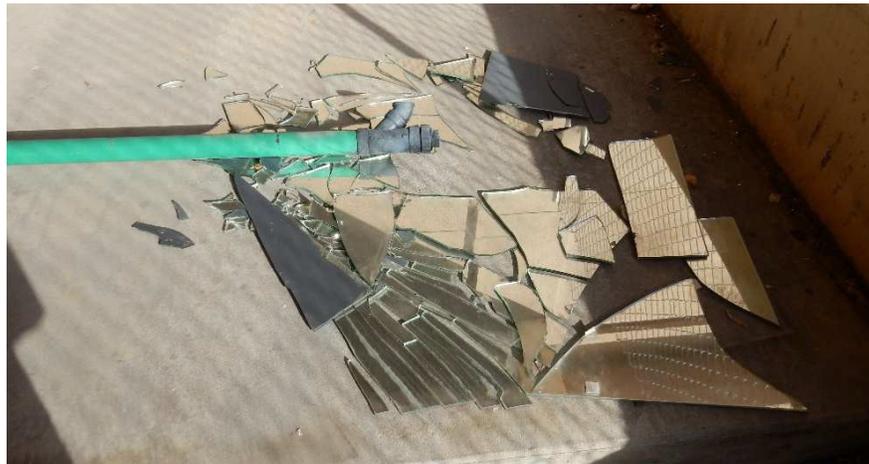
The parking deck is full of debris and potentially hazardous materials (e.g., broken glass), and if determined to be unsecured, poses a potential hazard to those who access these locations..

Examples of debris in the parking deck

VMC Section 302.3: All parking spaces and similar spaces shall be kept in a proper state of repair and maintained free from hazardous conditions.

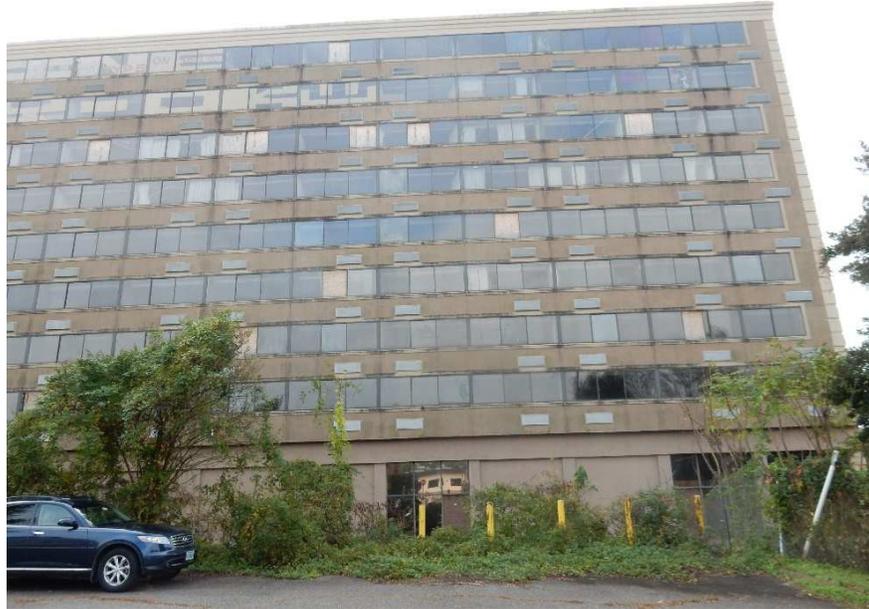
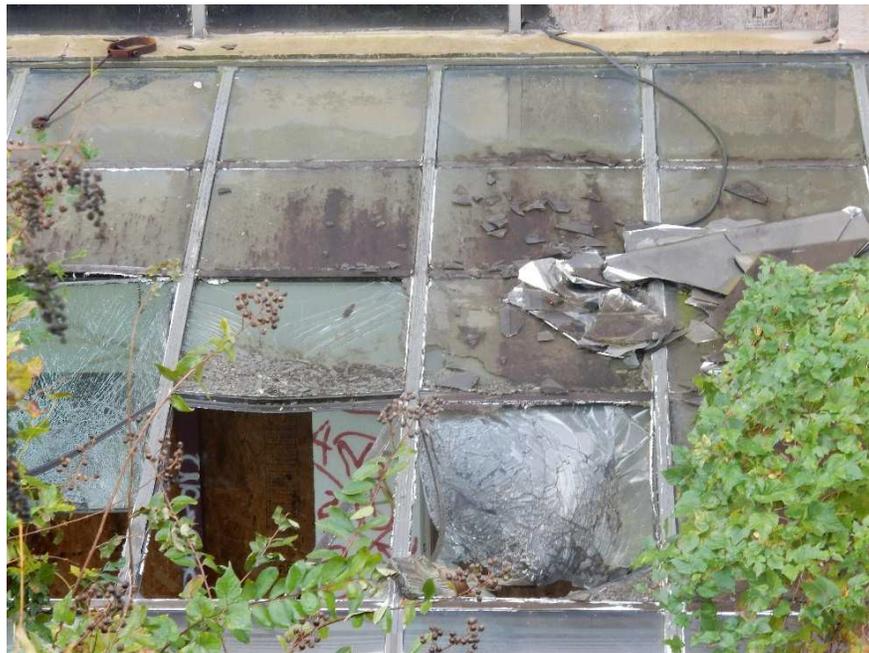
Examples of disrepair on the exterior of the building

VMC Section 304.1: The exterior of a structure shall be maintained in good repair, structurally sound, and sanitary so as not to pose a threat to the health, safety, or welfare.

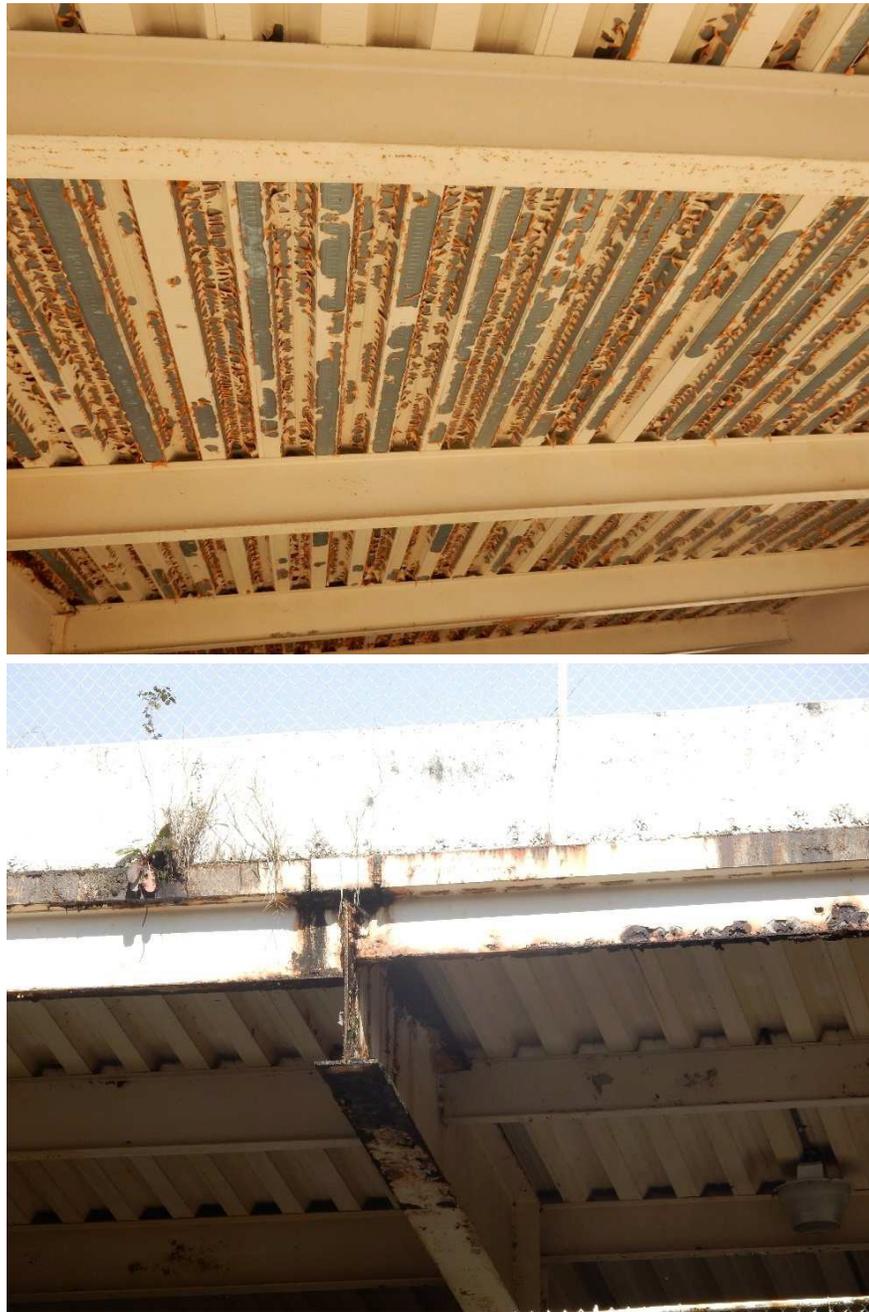
Examples of deteriorating structural members

VMC 304.4: Structural members shall be maintained free from deterioration and shall be capable of safely supporting the imposed dead and live loads.

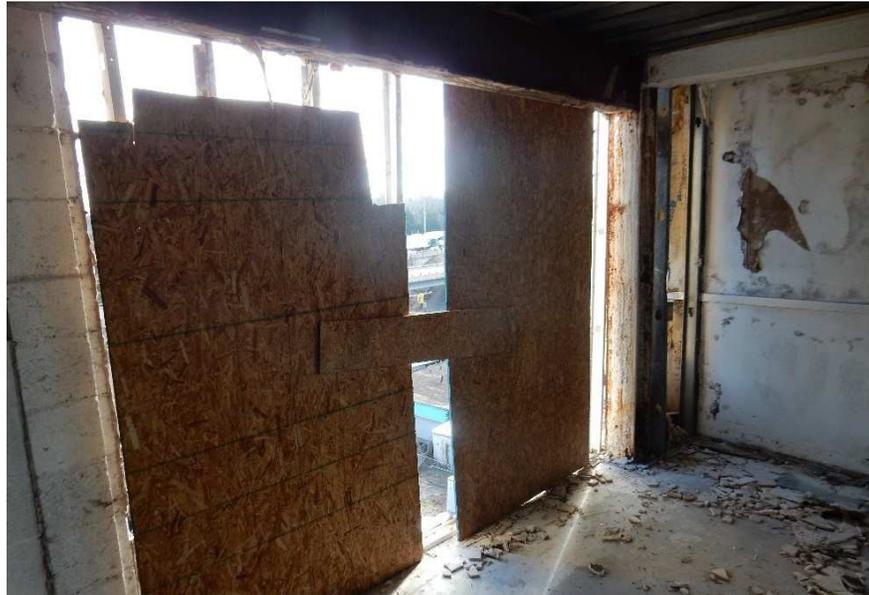
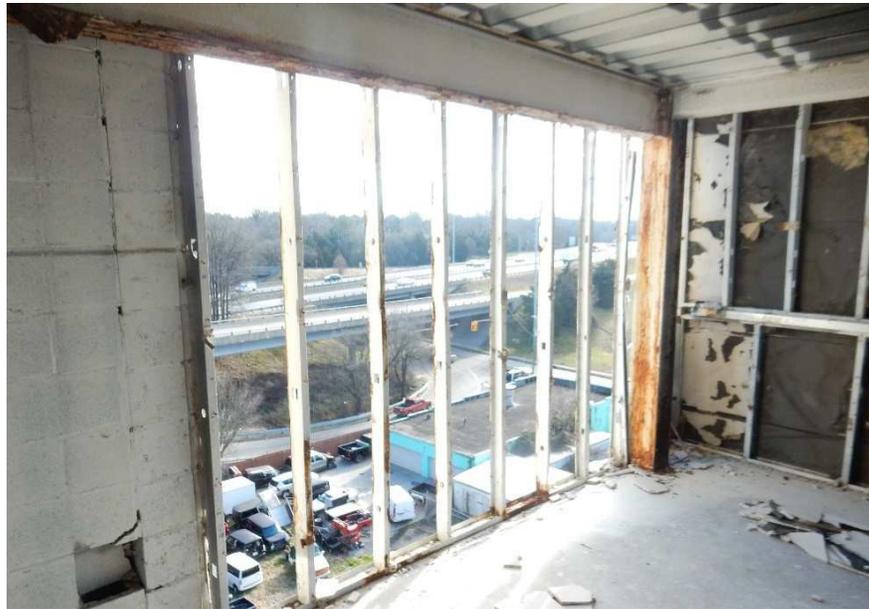
Examples of openings within the exterior walls

VMC Section 304.6: Exterior walls shall be free from holes, breaks, and loose or rotting materials; and maintained weatherproof and properly surface coated where required to prevent deterioration.

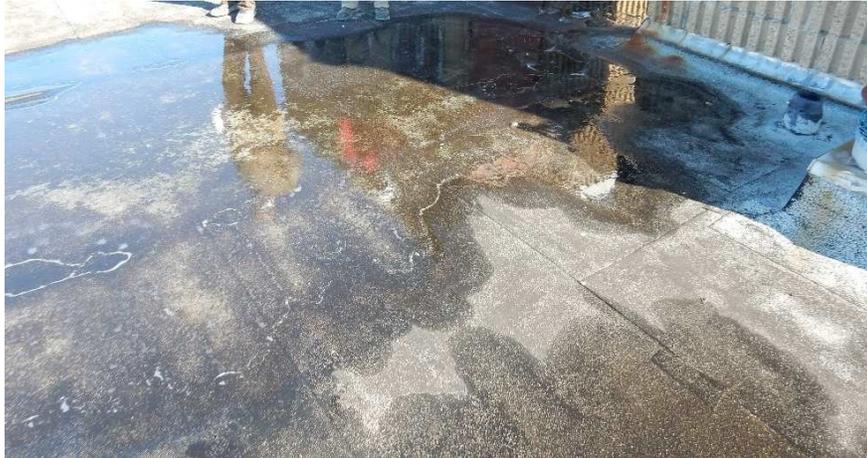
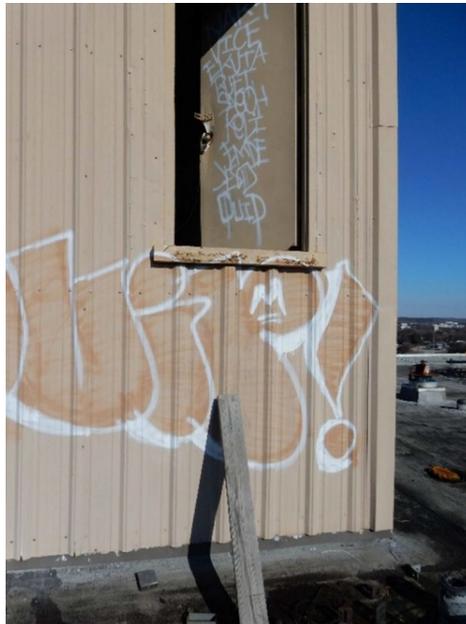
Example of ponding of water on roof and openings that potentially allow water into interior

VMC Section 304.7: The roof and flashing shall be sound, tight, and not have defects that admit rain. Roof drainage shall be adequate to prevent dampness or deterioration in the walls or interior portion of the structure.

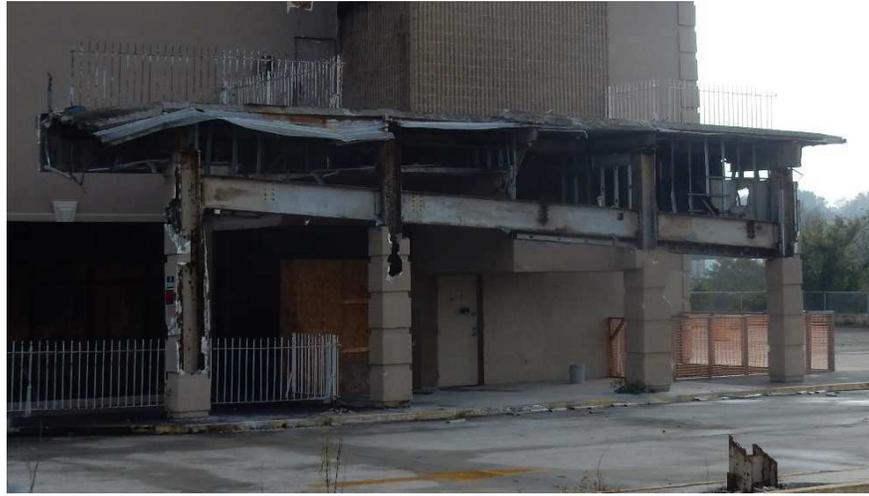
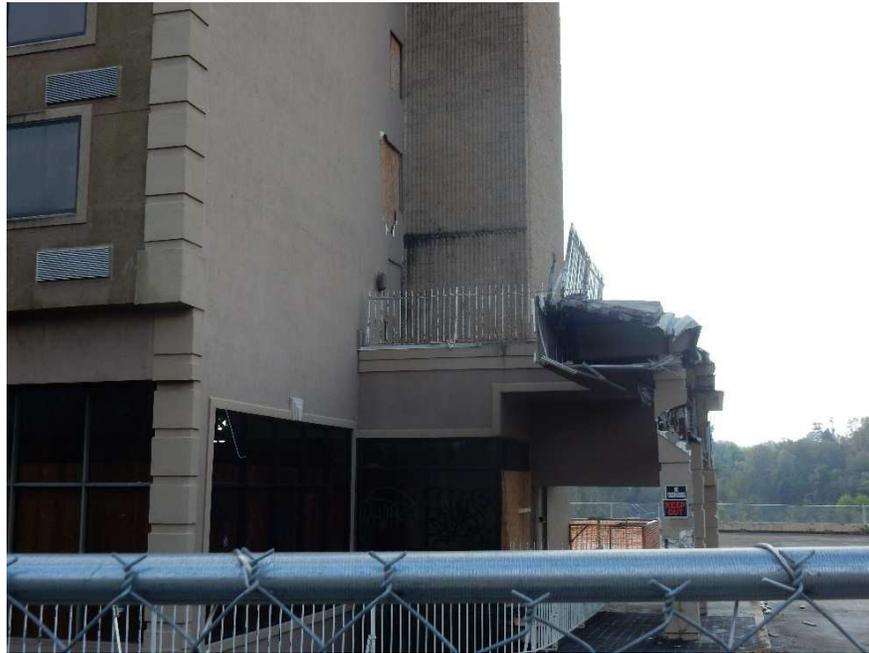
Deteriorating canopy

VMC Section 304.9: Overhang extensions including, but not limited to, canopies . . . shall be maintained in good repair and be properly anchored so as to be kept in a sound condition. Where required, all exposed surfaces of metal . . . shall be protected from the elements and against decay or rust by periodic application of weather-coating materials, such as paint or similar surface treatment.

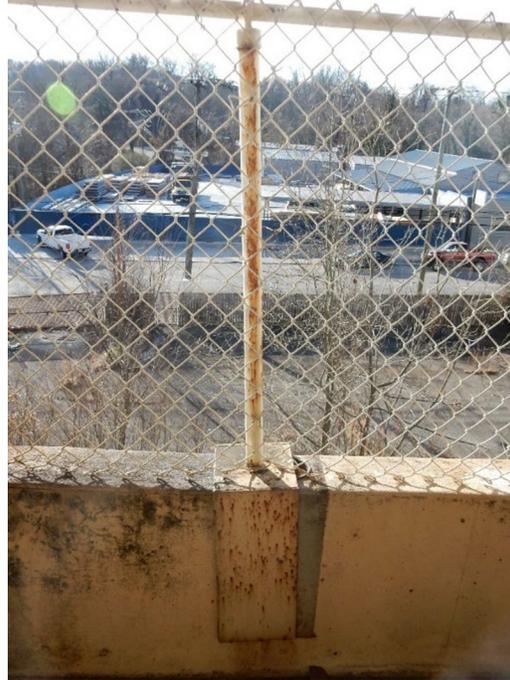
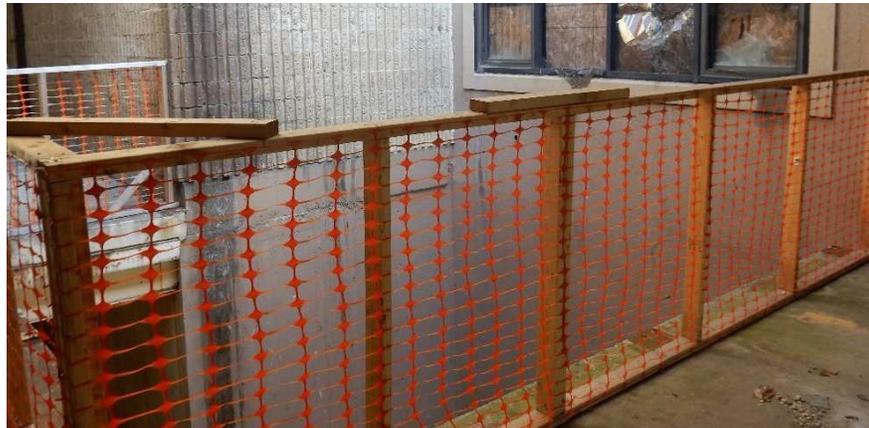
Examples of loose (easily push against them) and/or inadequate guards

VMC Section 304.12: Every . . . guard shall be firmly fastened and capable of supporting normally imposed loads . . .

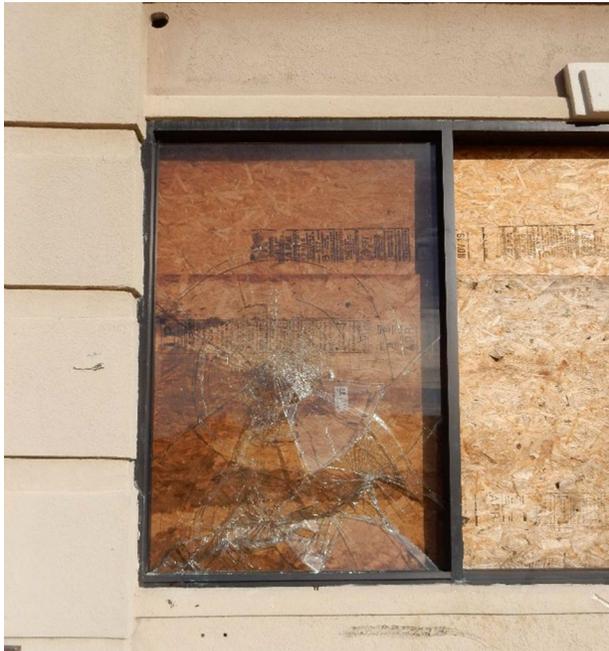
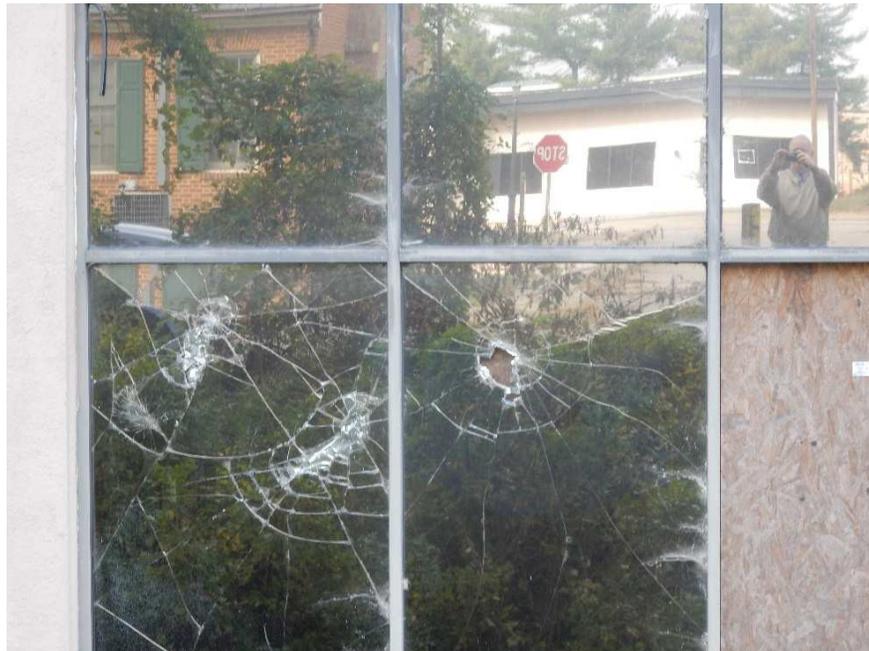
Examples of window disrepair

VMC Section 304.13: Every window and frame shall be kept in sound condition, good repair and weather tight.

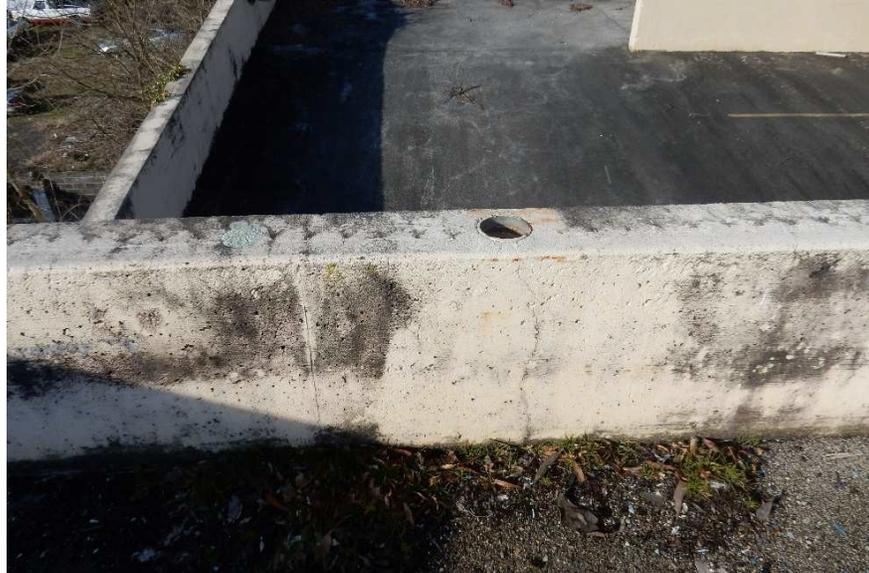
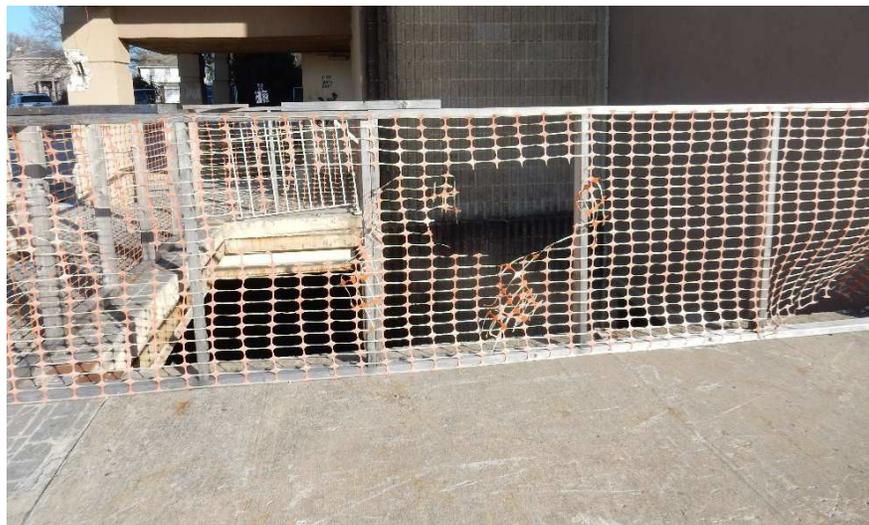
Examples of improper and/or missing guards

VMC Section 307.1: [G]uards required by the applicable building code or which were provided when a building was constructed shall be maintained.

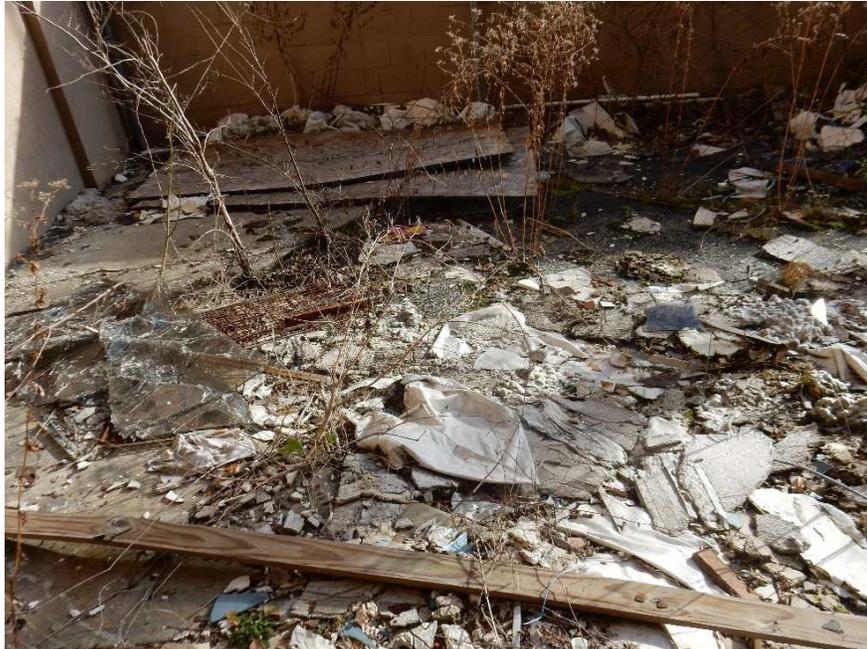
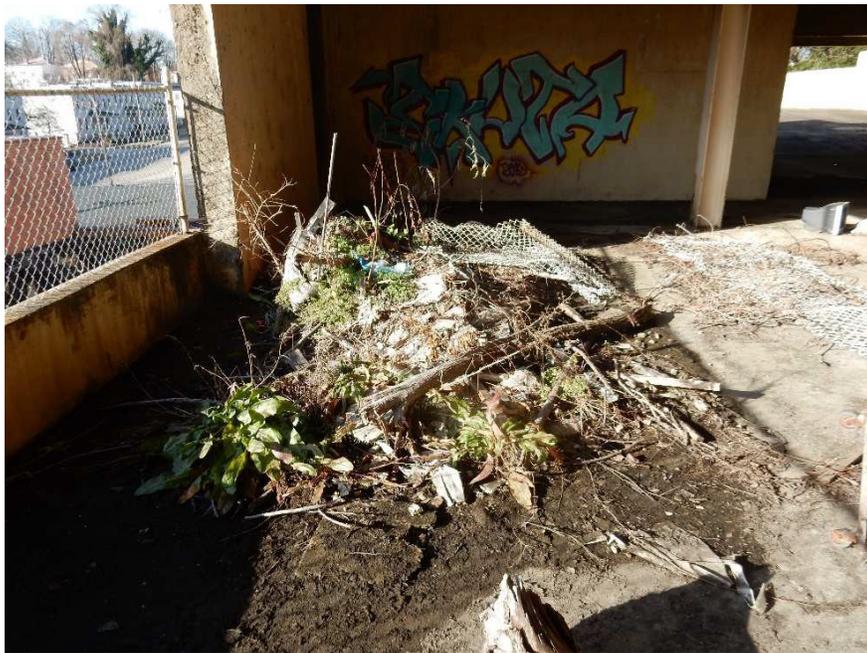
Examples of debris

PCC Section 50-62: Any condition of any premises which is offensive, unwholesome, unsanitary is hereby declared a nuisance. This includes the keeping or the depositing on, or the scattering over the land or premises of any lumber, trash, junk, and debris.

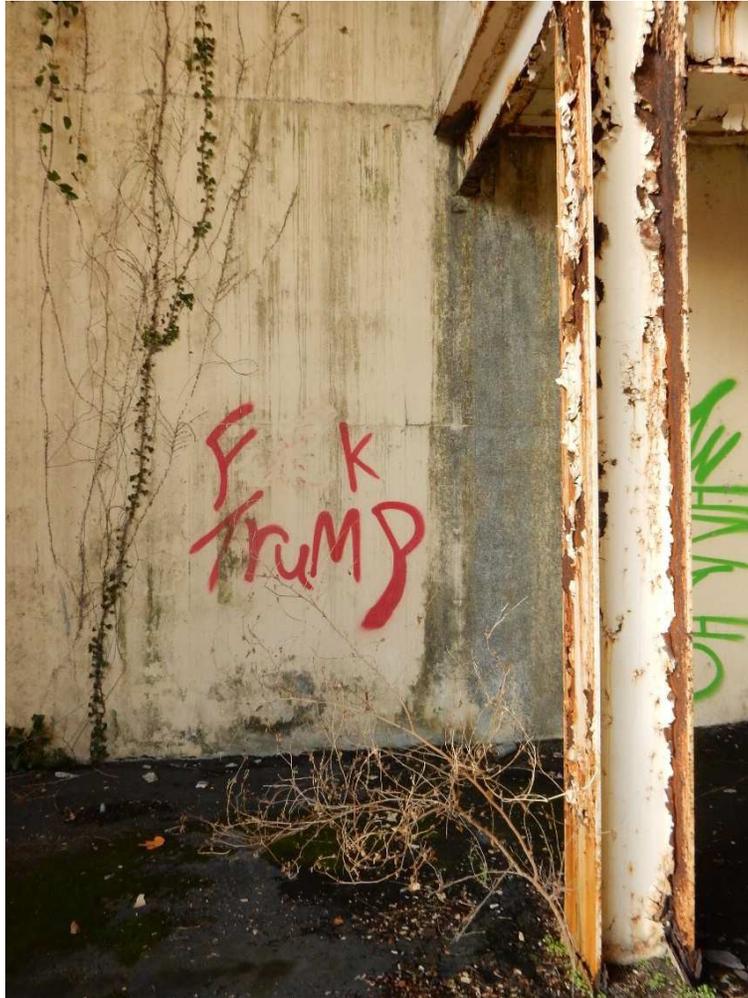
Example of offensive condition
suggesting possible access between 2016-2021
(photo has been edited to delete two letters)

PCC Section 50-62: Any condition of any premises which is offensive, unwholesome, unsanitary is hereby declared a nuisance.

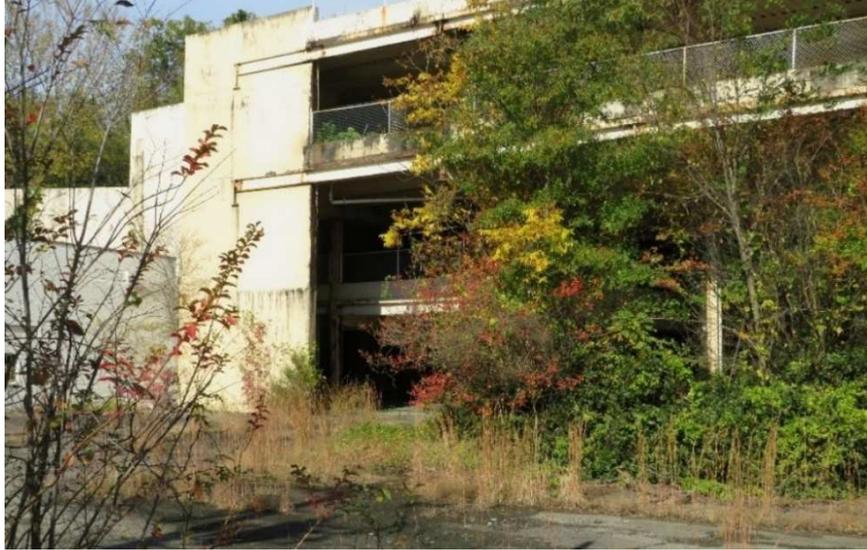
Example of overgrowth

PCC Section 50-63: The existence of any weeds, bushes, grass or other vegetable matter upon any premises which exceeds a height of 12 inches is hereby declared a nuisance.

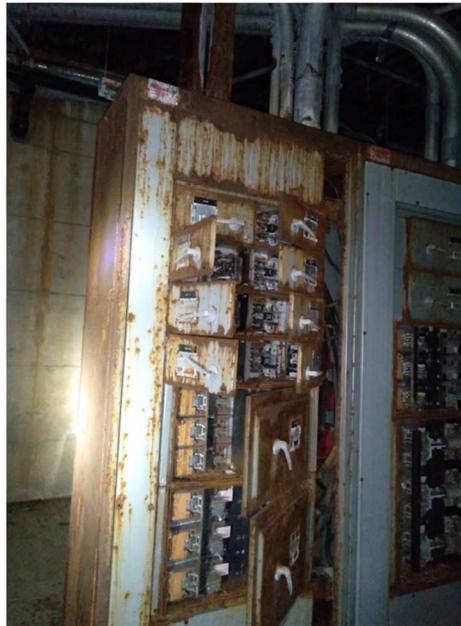
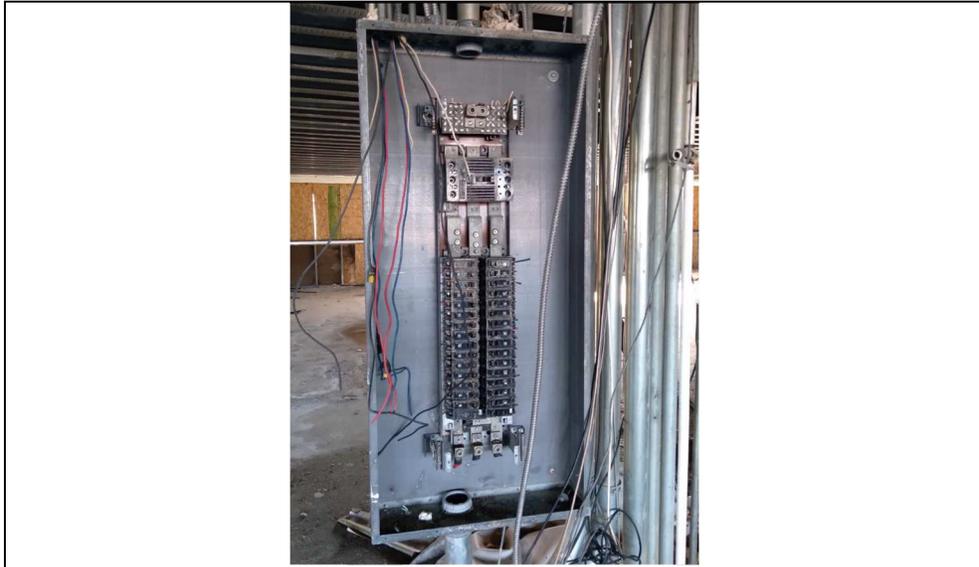
Examples of electrical system deterioration

VMC Section 604.3: Where it is found that the electrical system in a structure constitutes a hazard to the occupants or the structure by reason of deterioration or damage or for similar reasons, the code official shall require the defects to be corrected to eliminate the hazard.

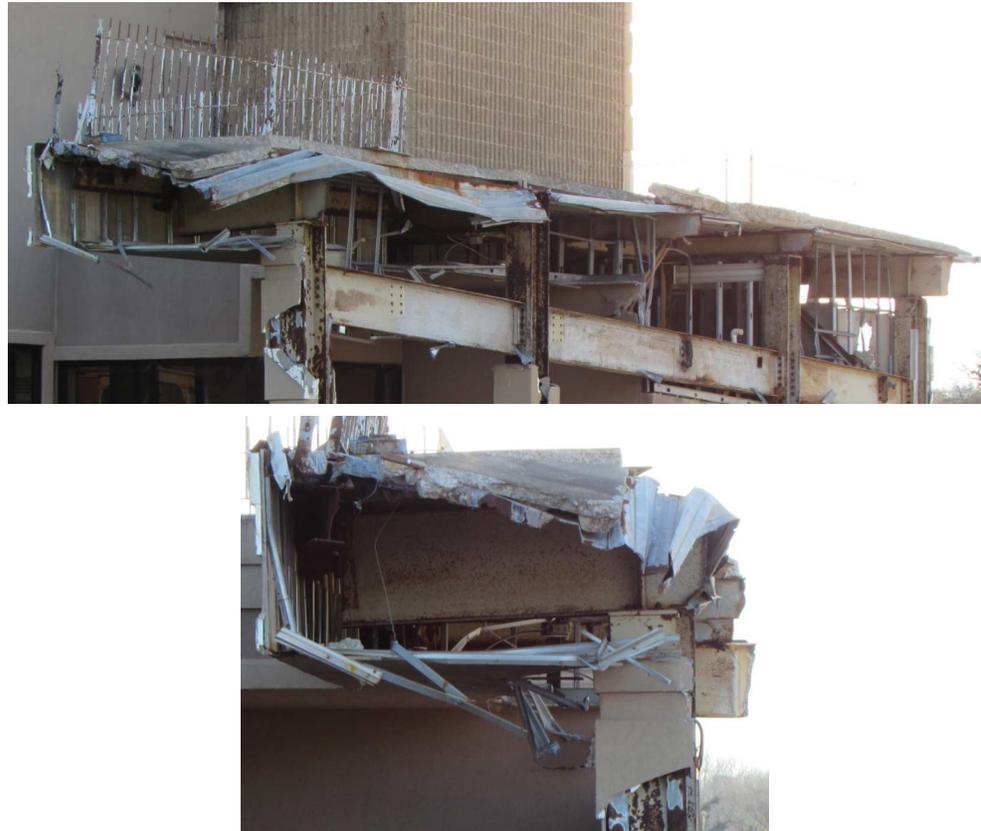
Partially demolished canopy structure

At the West end of the building, part of a partially demolished canopy remains standing. This framing was likely not intended to be exposed and does not appear to have an exterior-rated coating. The original framing was likely a series of cantilevered beams, each supported by two columns. Four beams remain which have each been cut off at the column nearest the building, such that the cantilevered part of the beams remain supported by only one column each. The beam nearest the front of the building appears to have rotated from level. Portions of concrete deck appear to be unsupported and display significant amounts of deflection. The remaining construction is partially over an entry walkway, and also serves as the support structure for the floor and roof of the Chlorine room. This construction may not be at imminent risk of collapse but could be considered an unstable condition.

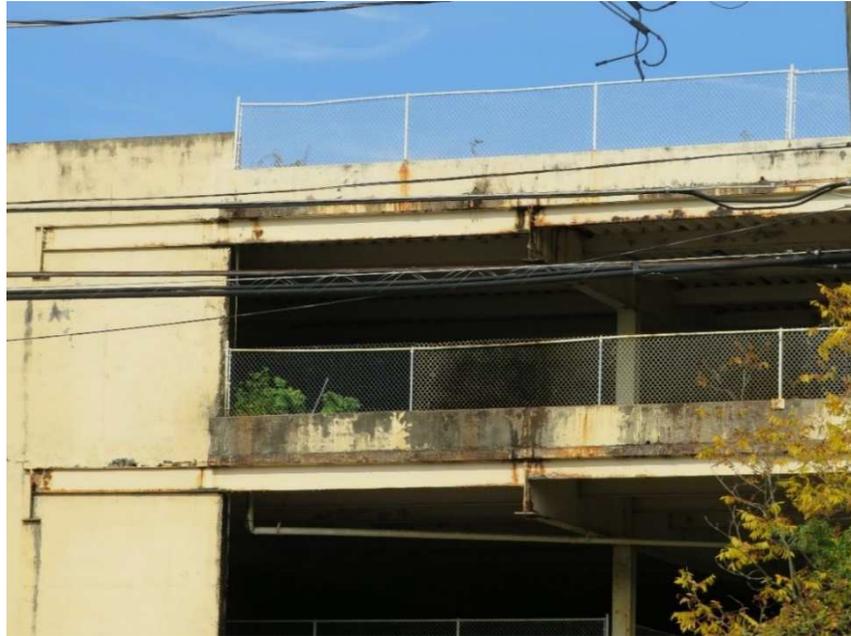
Examples of deterioration of the Parking Deck – perimeter structure

Significant corrosion is visible on the structural steel beams and ends of supporting girders along the perimeter, including the beam-to-girder connections. Beams and girders at the west end are partially encased in the cast-in-place concrete wall. The corrosion of this steel due to exposure to the elements and associated rust expansion has caused damage to the concrete wall. Concrete has spalled above the 2nd level beam and cracking has developed adjacent to the top of the girder.

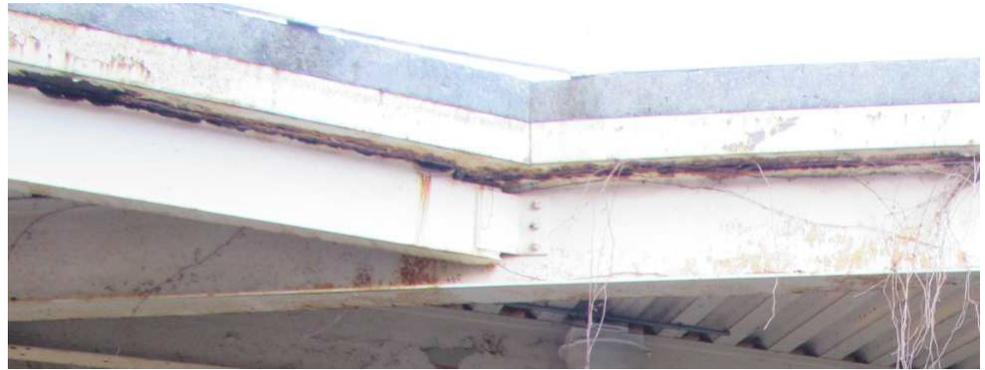
Corrosion is visible at the edge of the parking deck slab along much of the perimeter, where the slab edge angle meets the top flange. In several areas, vegetation is growing along the slab edge and on the beams. Closer observations of these elements was limited without a lift or tall ladder, thus the extent of the damage to these structural elements could not be determined.

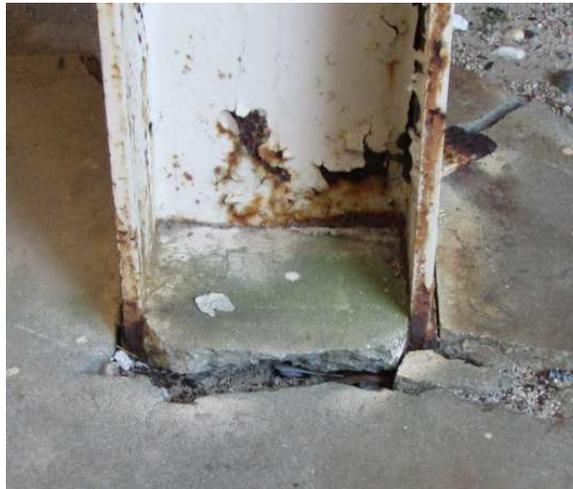
Concrete at the base of column has cracked and spalled, exposing the base plate and anchor bolts to water infiltration and potentially ponding. Discoloration indicates corrosion may be occurring beneath the remaining concrete; however, the level of corrosion was not observable.

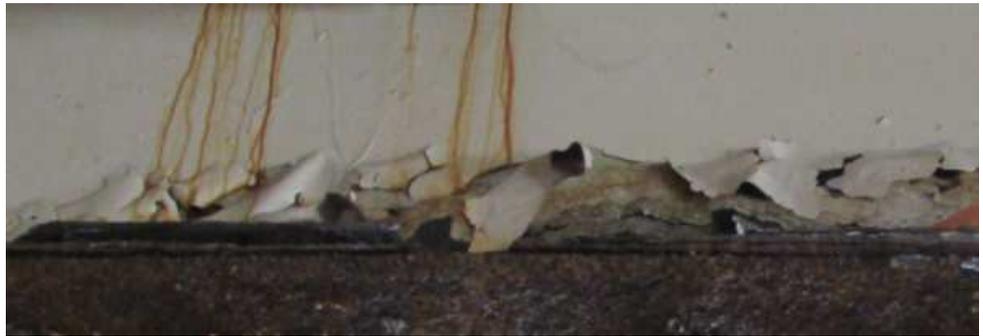
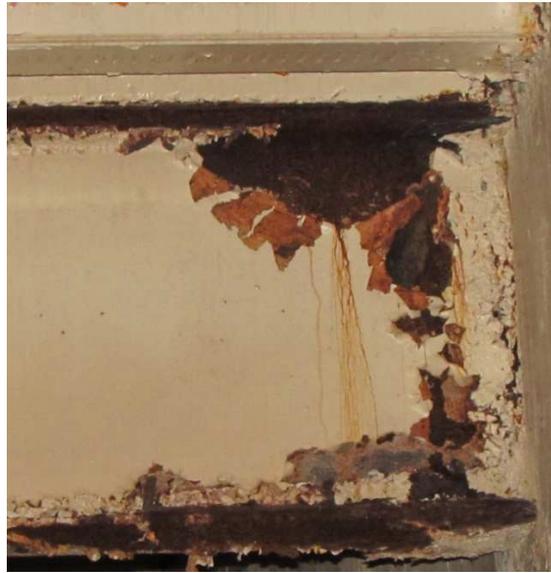
In several locations, significant corrosion including delamination of the top and/or bottom flanges of steel beams was observed. Deterioration of this nature and extent can significantly impact the structural load carrying capacity of the beam.
