City of Petersburg Virginia

RE: **Public hearing and consideration of an ordinance to declare the property located at 380 E. Washington Street a blighted property and a public nuisance to the community, and authorizing the abatement of such nuisance.**

REPORT OF UNSAFE AND UNSECURED STRUCTURE THAT IS UNFIT FOR HUMAN HABITATION - PURSUANT TO VPMC 106.2

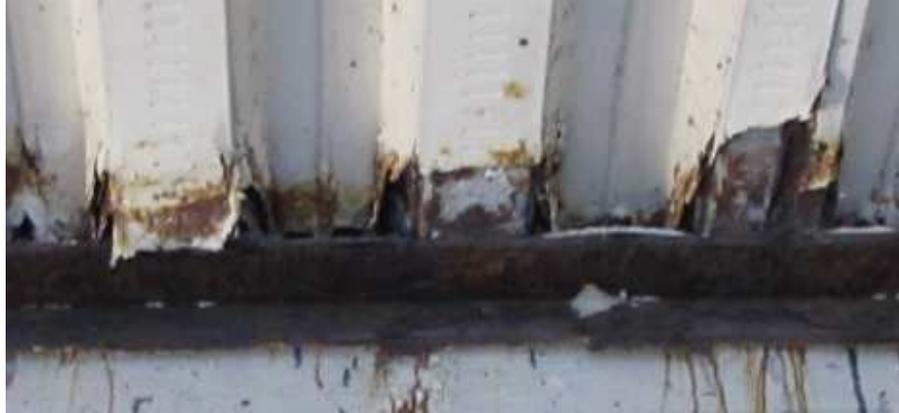
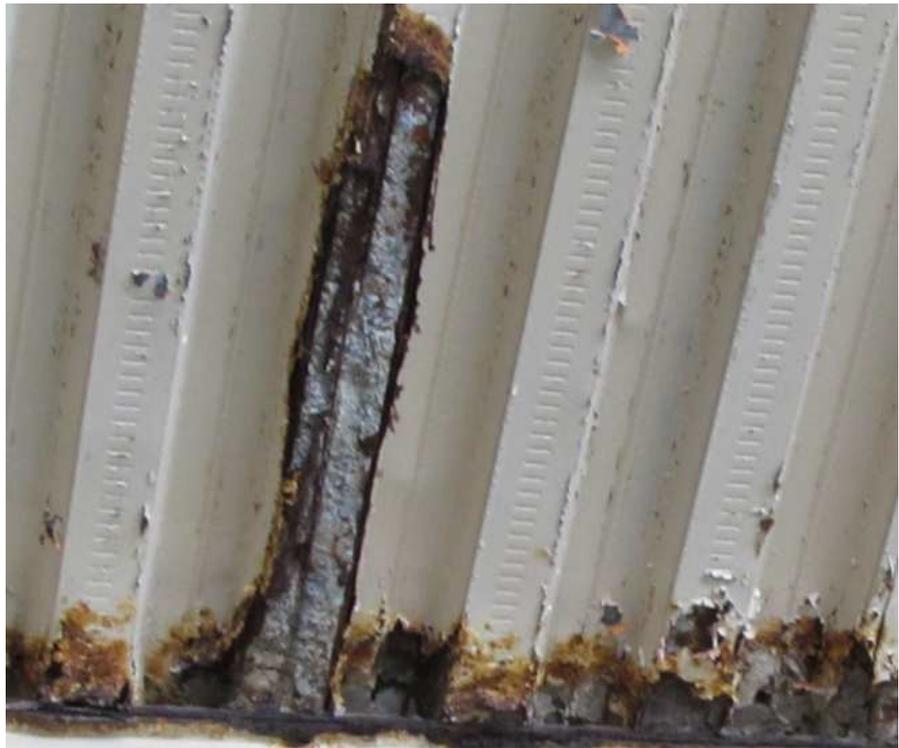
Significant corrosion and loss of section of steel floor deck was observed in multiple locations. In several of these instances, the deck had deteriorated such that the concrete was visible from below. The existing steel floor deck appears to be composite-type. This type of deck acts as steel reinforcement to resist the tensile stresses at the bottom of the slab. Where the steel floor deck has deteriorated, significant loss of load carrying capacity can be expected.

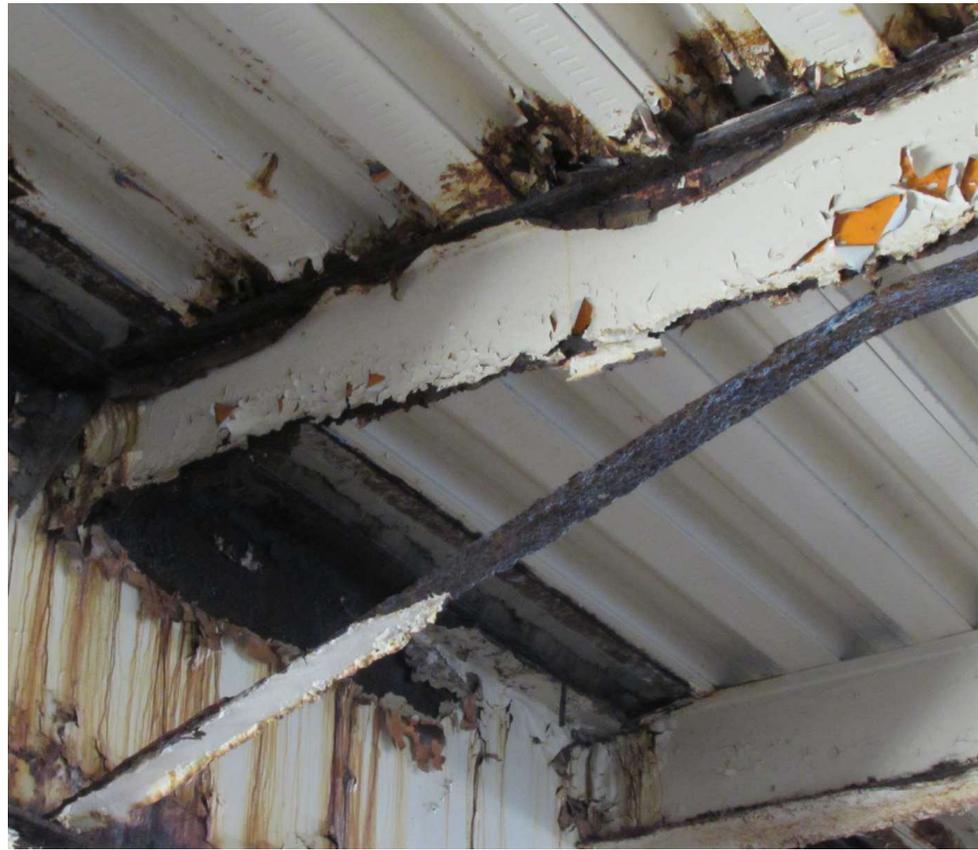
Bottom flange has separated from beam for approximately 1/3 of the span. Significant corrosion was observed at the top flange of this beam and in the adjacent steel floor deck and girder. The load carrying capacity of the structure in this area is significantly diminished from its original condition.

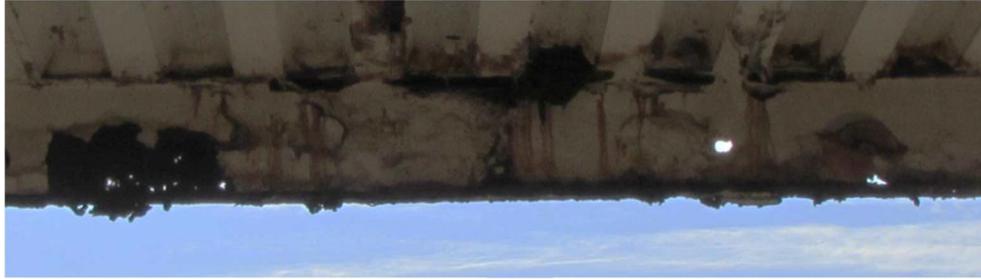
Corrosion has resulted in full-thickness loss of section in several locations along the beam. Significant corrosion was observed at the top flange of this beam and adjacent steel floor deck. The load carrying capacity of the structure in this area is significantly diminished from its original condition.

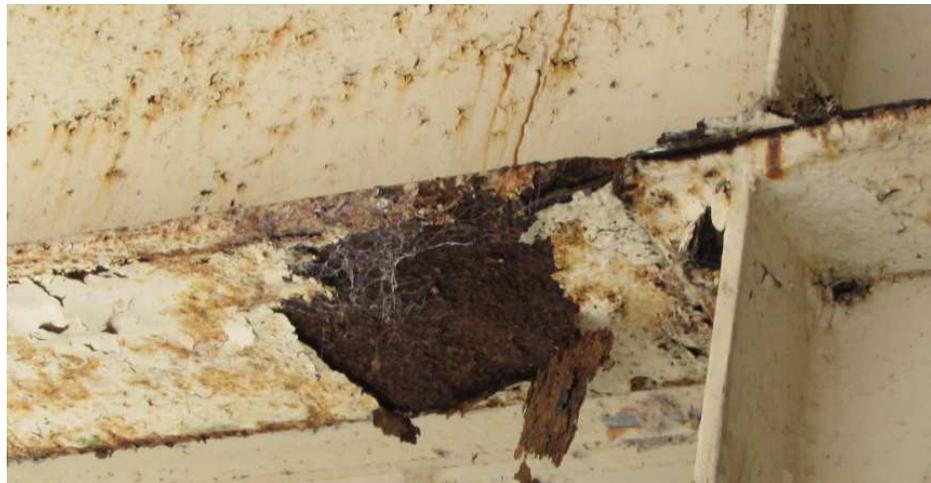
Corrosion has resulted in loss of section of bottom flange at a cantilevered beam connection to the top of the column. Peeling of paint and discoloration from corrosion below the paint was observed. Reduction of load carrying capacity is likely at this location.

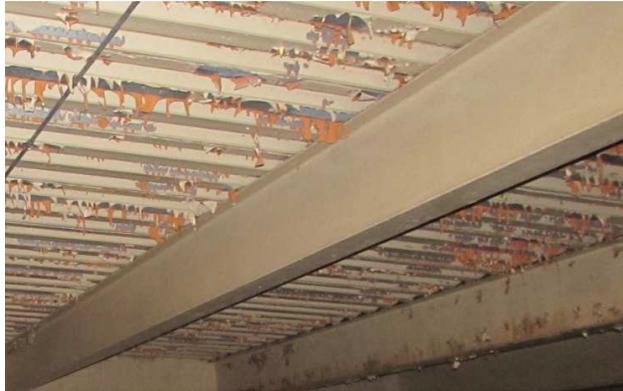
Peeling of paint and primer on steel floor deck, beams, and columns observed in several locations. While no corrosion was noted in these areas at the time of observation, continued exposure to the elements could result in future corrosion.

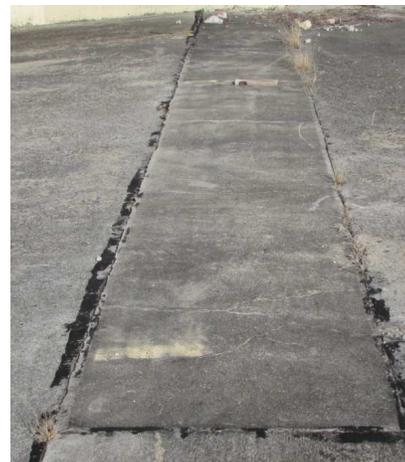
Corrosion of the steel floor deck has resulted in loss of a complete deck flute across two spans. The adjacent deck flute at each span has broken away from the beam support. Concrete above appears to have been removed and replaced. The steel deck at the apparent repair does not appear to have been repaired nor replaced, and the concrete appears to have been poured on top of a white tarp-like material. This material does not appear to be structural in nature, and it is not apparent if reinforcing was added in the concrete patch. Thus, the structural capacity of this condition is unlikely to be adequate for the required loading.

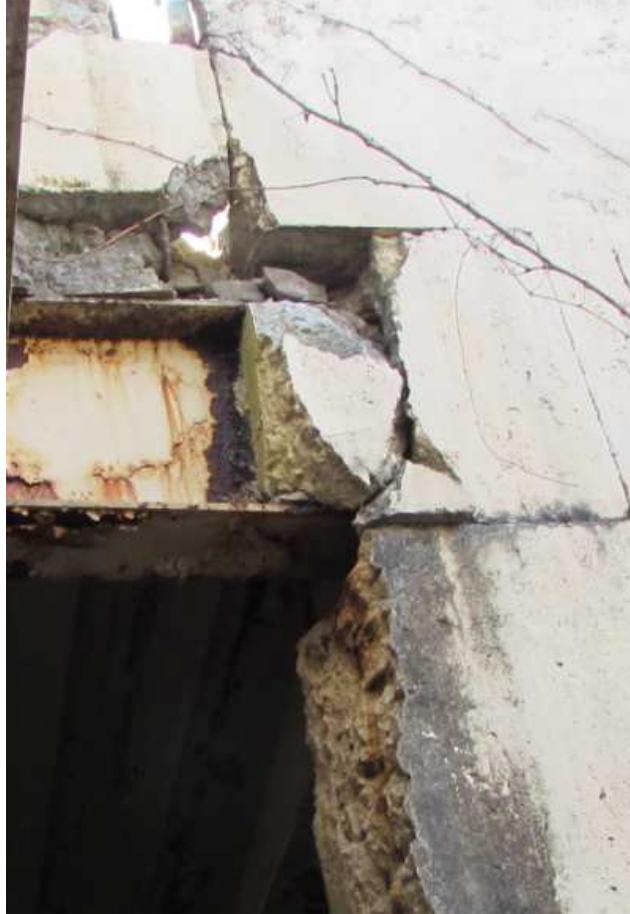
In several locations, significant concrete spalling was observed at steel beam bearing locations, exposing part of the beam bearing plate and anchor studs. The load carrying capacity of this condition is significantly reduced. In some of these locations, significant concrete spalling above the beam in the concrete barrier was observed. The capacity of the concrete barrier is likely significantly reduced.

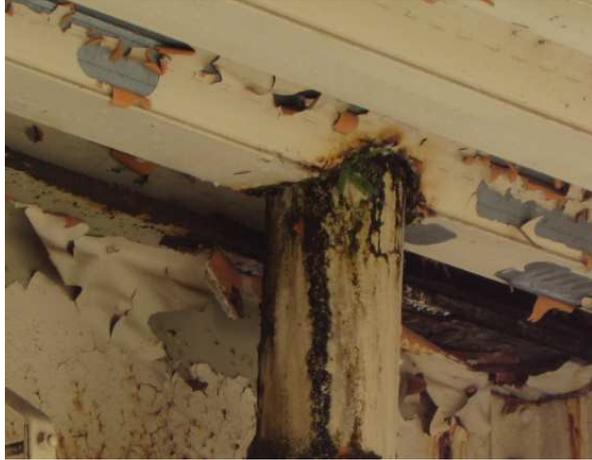
Corrosion was observed in steel deck at a vertical drainpipe penetration. Deterioration was noted around the cut opening, and no supplemental framing to support the interrupted steel deck was observed.

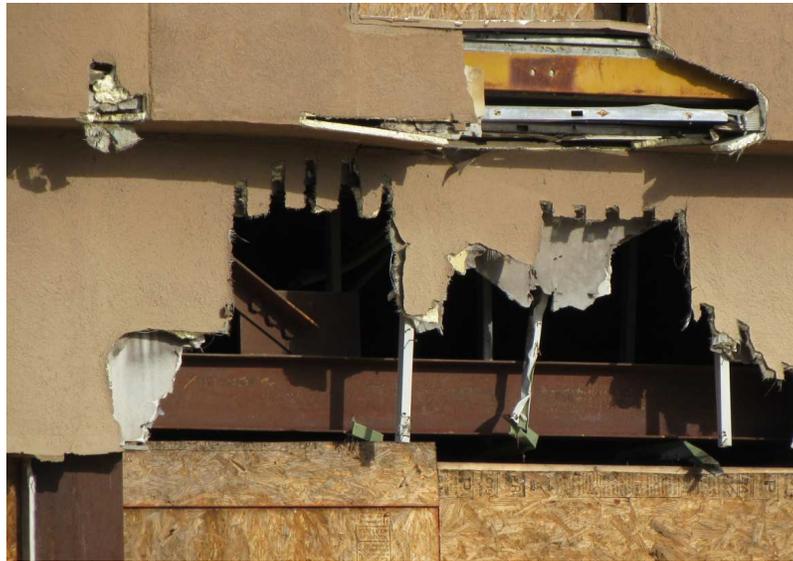
In several locations, openings of various sizes were observed in the building façade. Although this presents a direct path for water to enter the building, little to no corrosion was observed in the observable steel framing at the time of observations.

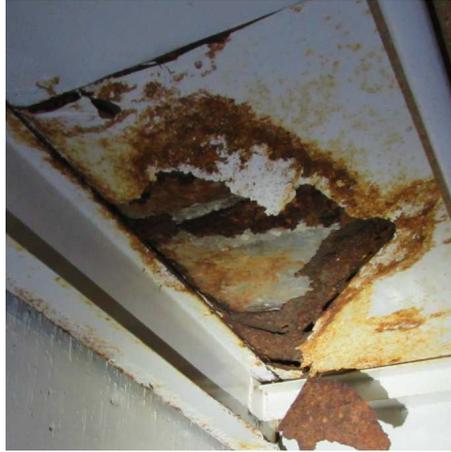
At the West stair landing leading to the lower floors, corrosion in the steel stair pan appears to have resulted in significant loss of section. Load carrying capacity of this landing may be reduced.

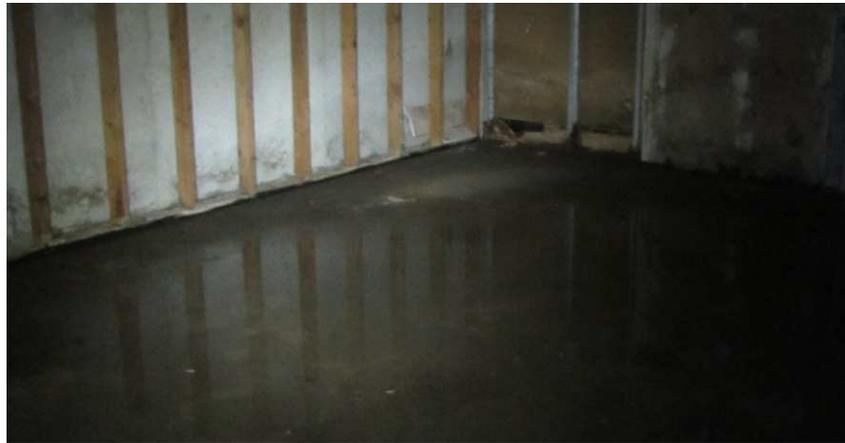
At the lower basement level, standing water was observed on the floor in several locations. Standing water may lead to corrosion of steel column base plates and other structural components.

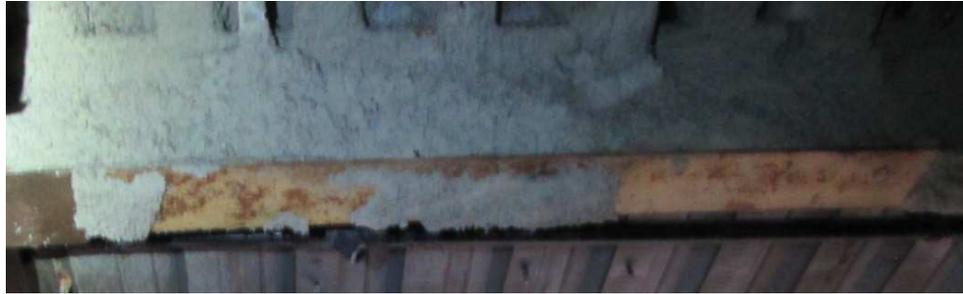
At the lower basement level, fireproofing has detached from steel beams in several locations. Fire rating of structure may be impacted.

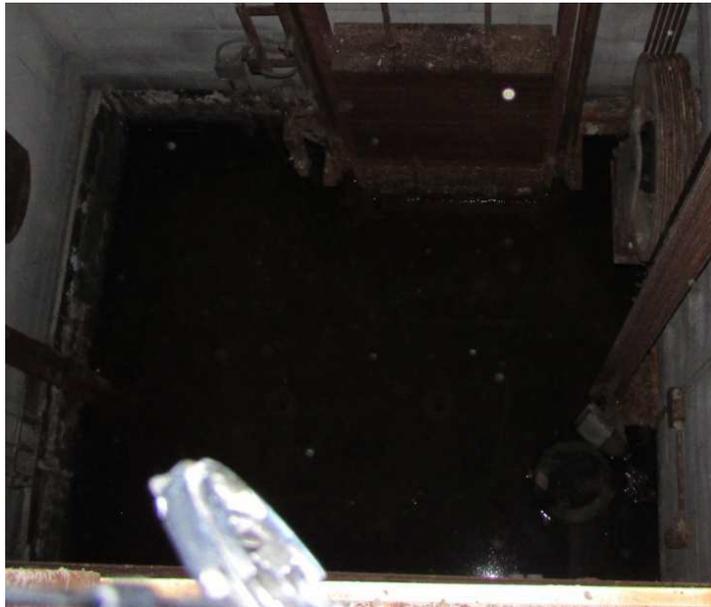
At the East elevator, an indeterminate amount of standing water was observed at the base of the service elevator. Standing water may cause corrosion to elevator and other components in the pit area.

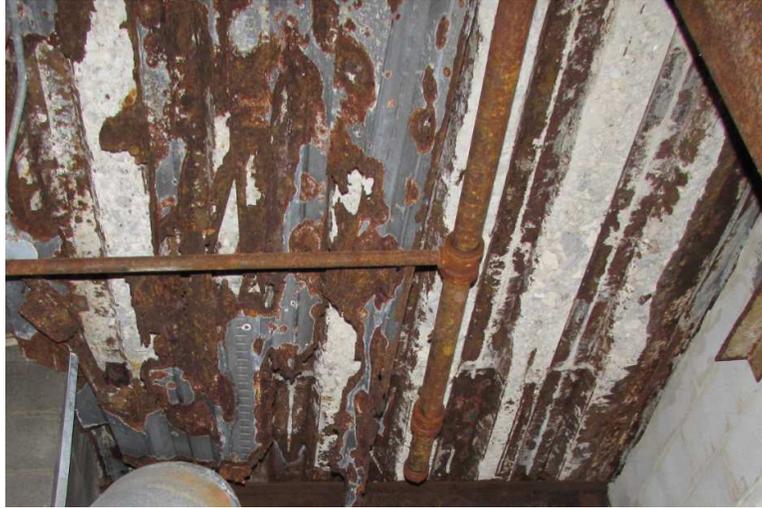
Significant corrosion was observed in the steel floor deck near the East elevator. Similar corrosion was observed at all floors where the deck was observable and exposed to view. In these instances, the deck has deteriorated such that the concrete is visible from below. The existing steel floor deck appears to be composite-type. This type of deck acts as steel reinforcement to resist the tensile stresses at the bottom of the slab. Where the steel floor deck has deteriorated, significant loss of load carrying capacity can be expected.

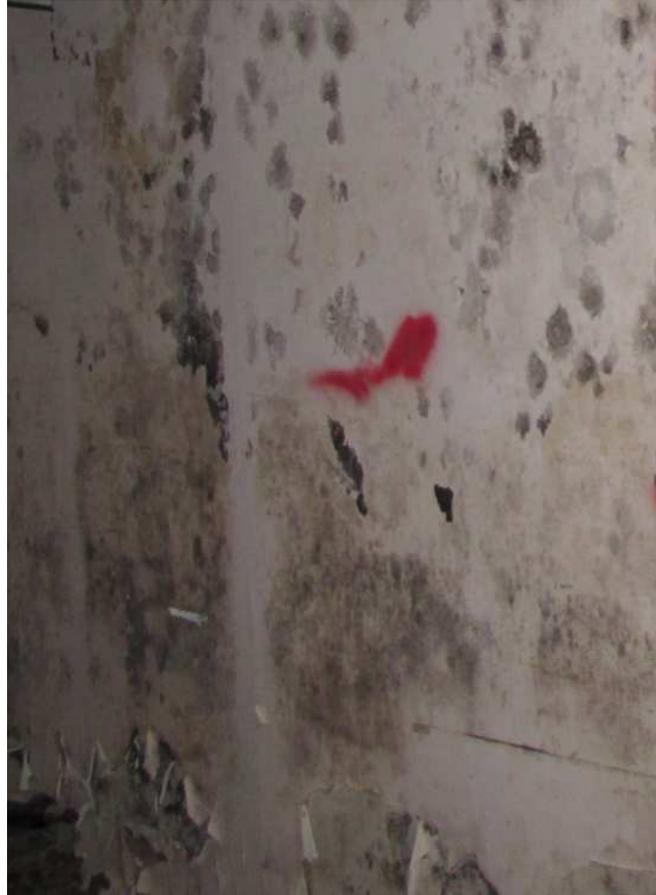
At the lower basement level, several extensive areas of apparent water damage and mold were observed at the interior gyp board furring against the basement foundation wall. It is unclear whether the water may be migrating through the concrete foundation wall, coming up from the floor, and/or making its way down from an upper level.

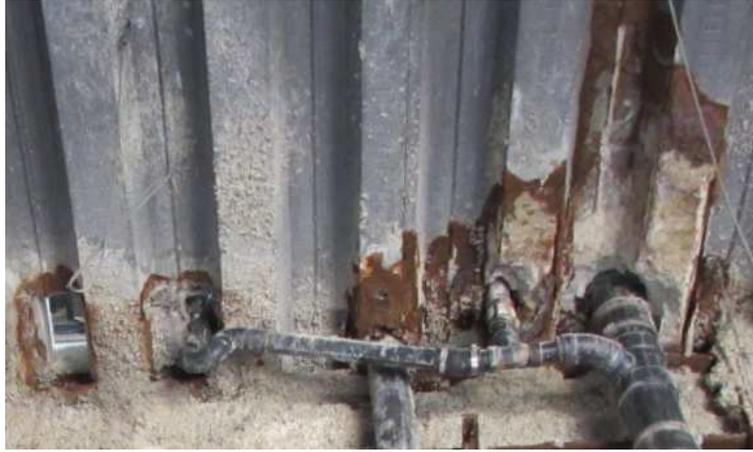
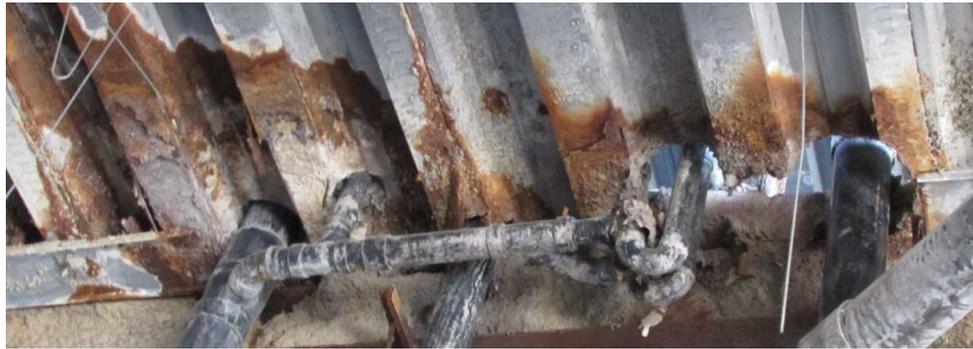
In several locations on each floor where the steel deck was observable, multiple pipe penetrations within close proximity to one another were observed to penetrate the floor. At these locations, multiple adjacent flutes of steel deck were penetrated, and no supplemental framing was observed to support the interrupted deck. Also, at these locations, significant corrosion of the steel floor deck was observed. In several instances, the deck has deteriorated such that the concrete is exposed to view. The load carrying capacity of the floor deck at these locations may be significantly reduced.

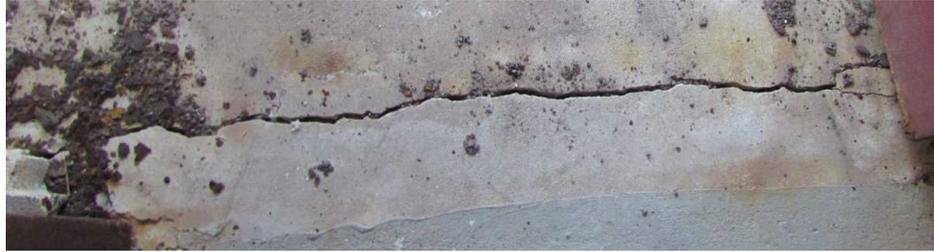
At the Chlorine Room, off of the West stair, the floor appears to have moved away from the building. This may be due to movement caused by the partial demolition of the canopy described earlier in this document.

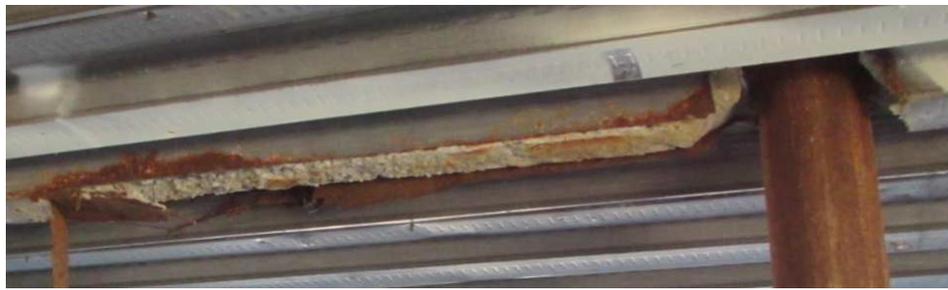
At several locations on several floors, corrosion and deterioration of steel floor deck was observed near single pipe penetrations. This deterioration may result in loss of structural load carrying capacity of the floor.

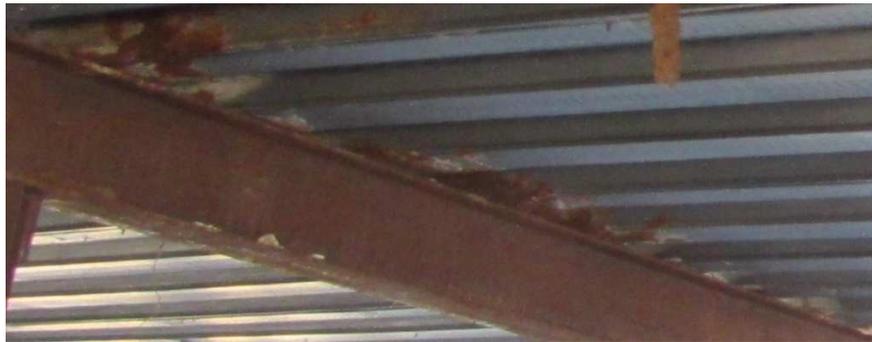
At several locations on several floors, corrosion of steel floor deck was observed at the top of floor beams and trusses. Continued corrosion may lead to deterioration of the floor and beams, which in turn may lead to loss of load carrying capacity.

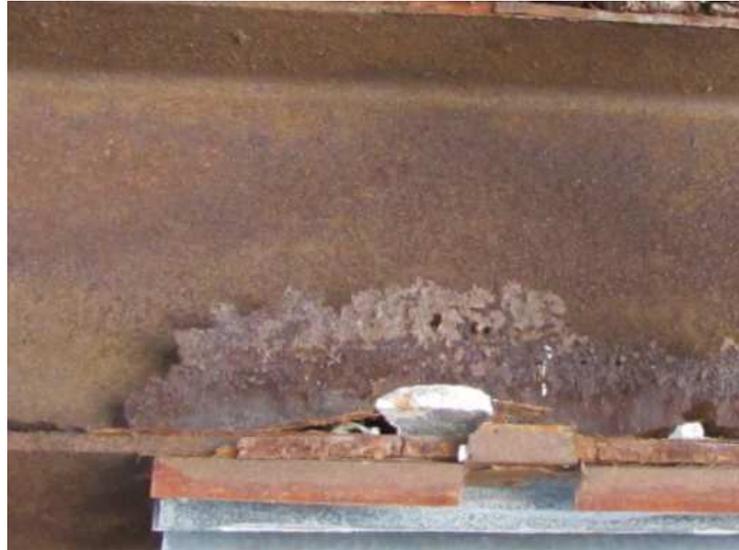
At several locations on several floors, corrosion of steel beams and columns was observed. This corrosion appears to have caused surface deterioration of the beam and column webs and flanges.

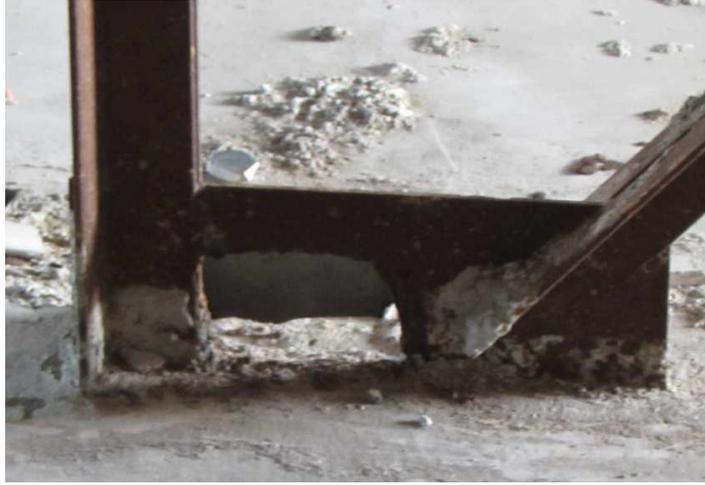
Gusset plate of floor truss has been damaged. This may result in reduced load carrying capacity at this location.

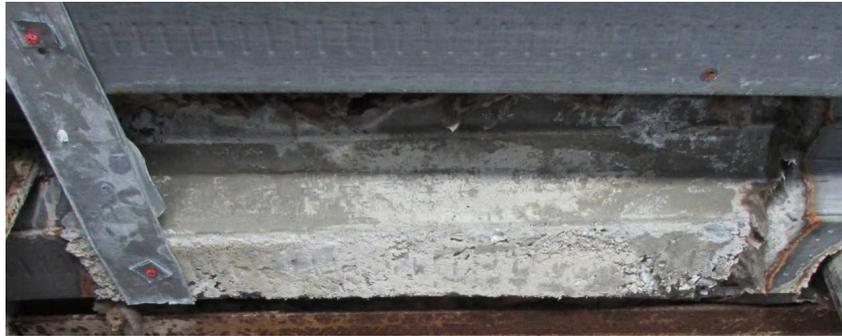
Section of steel floor deck is missing, and a portion of the concrete floor appears to be separated from the rest of the concrete. Load carrying capacity of this section of floor is likely significantly reduced.

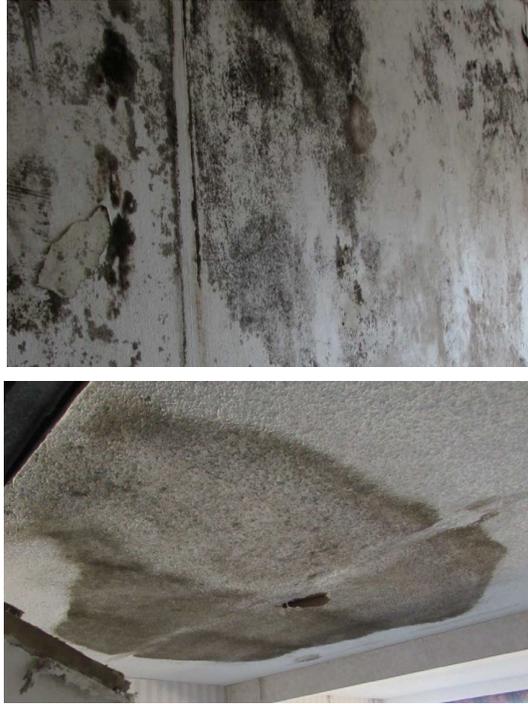
At the upper floor levels, where internal demolition was not completed, several extensive areas of apparent water damage and mold were observed at the interior demising walls and ceilings. Exposure of the floor trusses inside the walls and above the ceilings to moisture may lead to corrosion and deterioration.

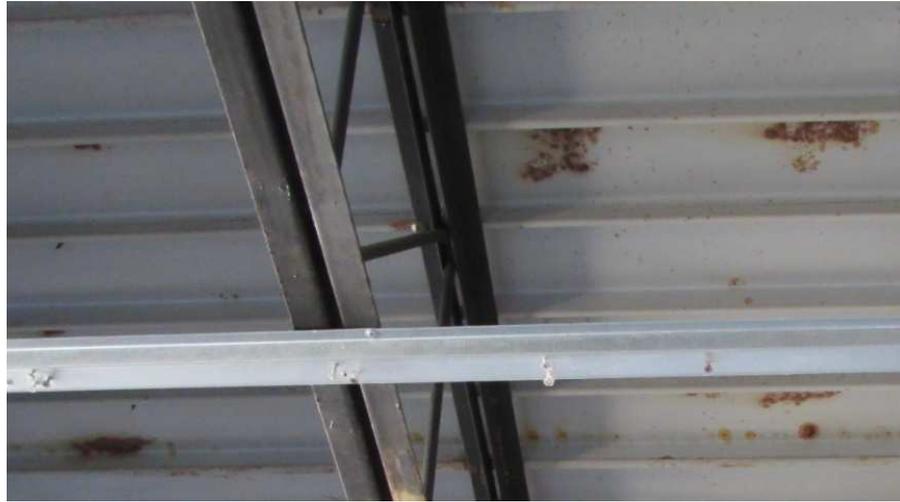
Corrosion was observed on the underside of the steel roof deck in several areas, indicating potential water infiltration of the roofing materials above. Continued corrosion may lead to deterioration and loss of material in the deck.
