**Condition Survey Report  
General Structural Assessment  
Main Sewage Pump Station  
City of Petersburg, VA**

October 24, 2016

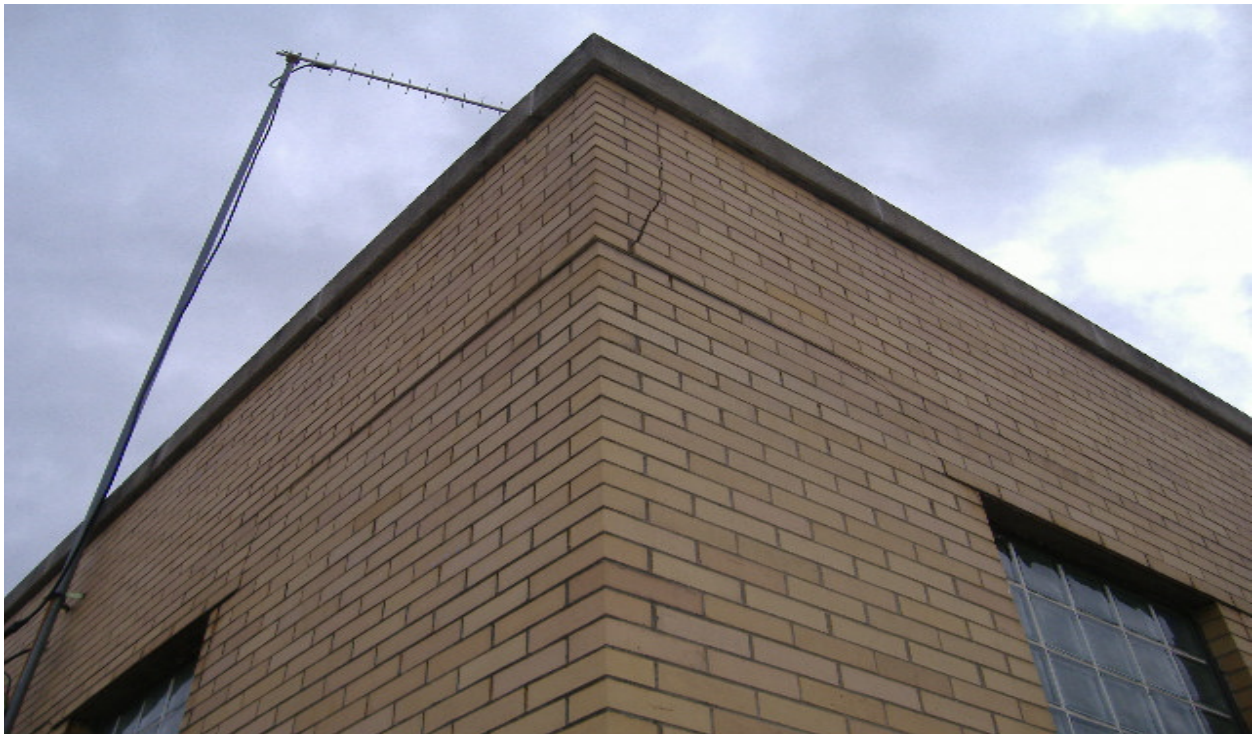
1. At (2) corners, at the approximate elevation of the parapet/roof slab intersection, the brick wall has pushed out along a bed joint plane approximately  $\frac{1}{2}$ ". See photo #2 at the end of this report.

The cause is almost certainly the consequence of thermal expansion.

2. At most or perhaps even all of the brick wall openings at doors and windows there are significant cracks in the masonry in the general vicinity of the lintel bearings. See photos #2, 3 and 4.

It looks as though all of those lintels are steel and are showing signs of corrosion. I would speculate that the cracks are the consequence of the swelling that occurs as the steel rusts.

One of two corners where brick has pushed out along a bed joint. Also, cracking can be seen at the lintel bearing areas at the openings.

The lintel corrosion could become critical at some point. It may be advisable to clean the steel as best as possible and provide some sort of moisture seal.

The brick expansion problem can probably only be corrected by removal of the upper courses and a reinstallation with expansion joints.

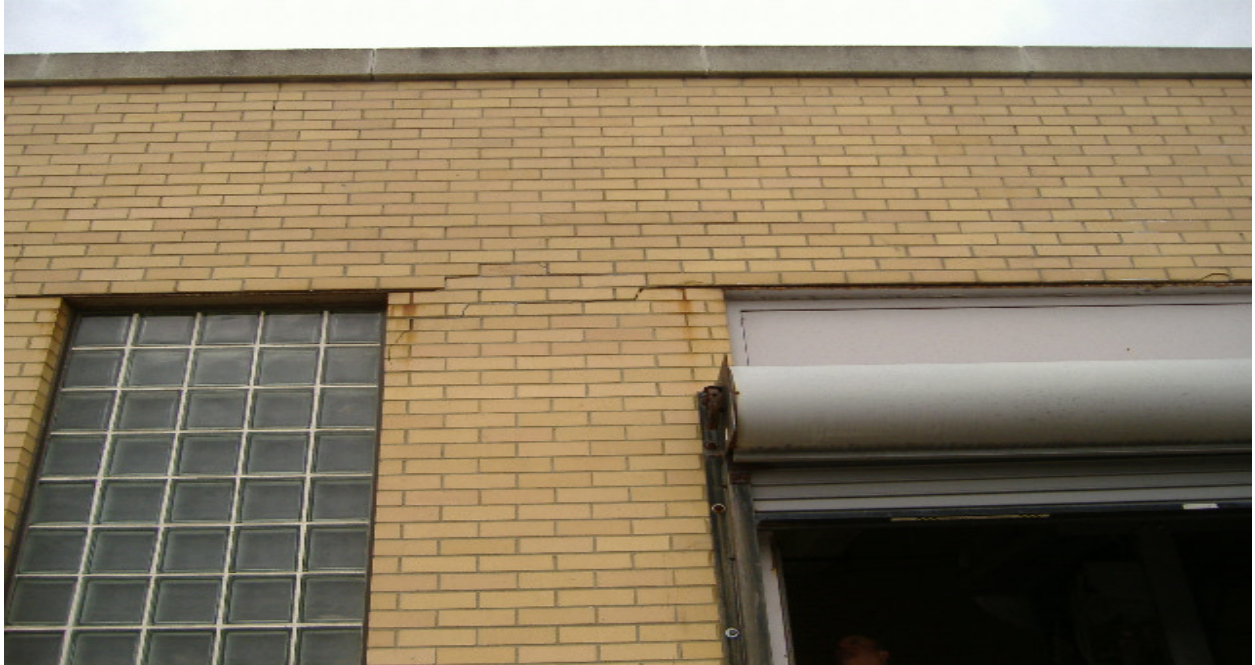
Cracking of brick at lintel bearing areas.

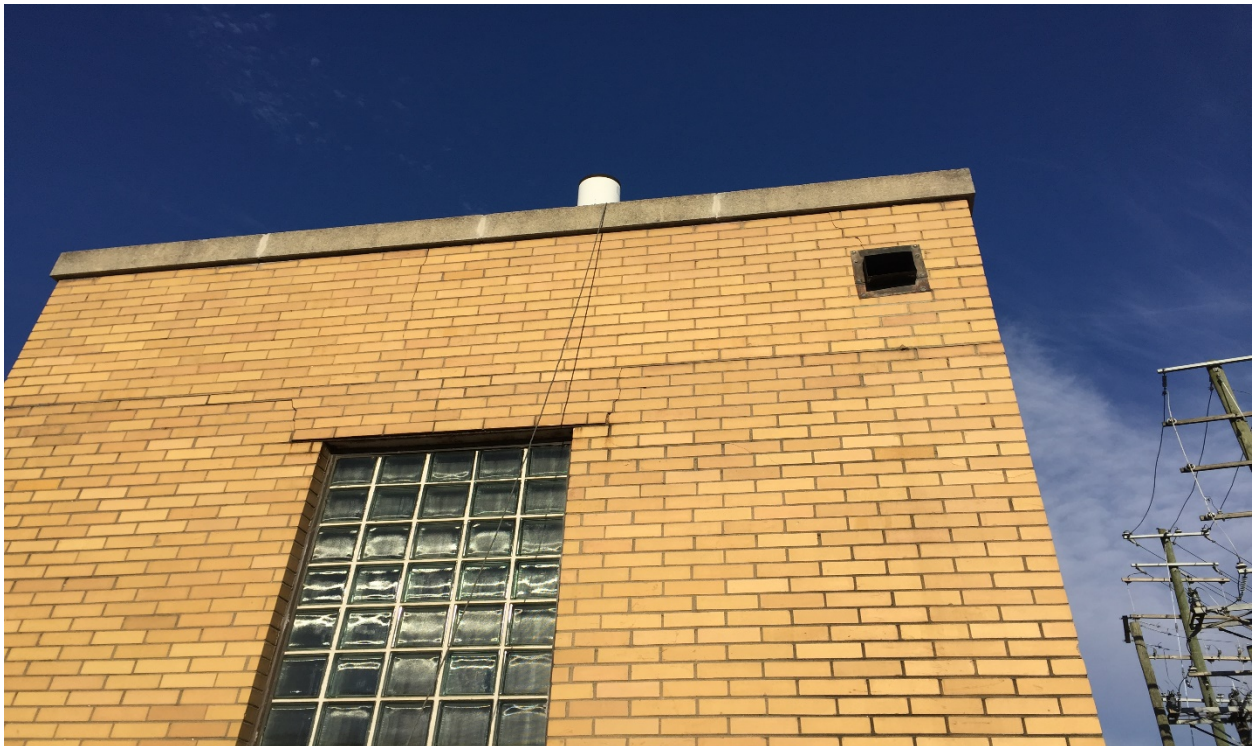
Cracking of brick at lintel bearing areas.

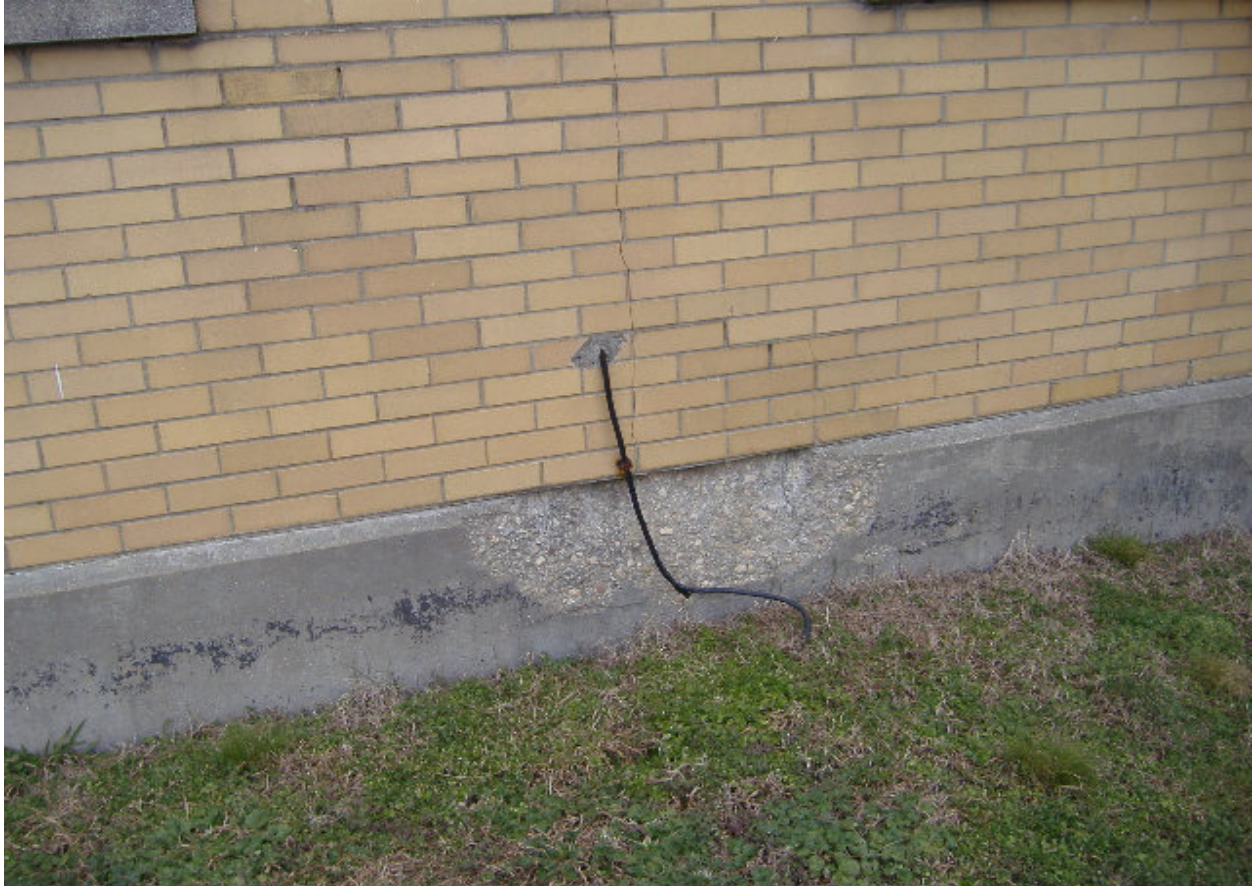
3. There is a concrete spall at the edge of the ground floor slab. See photo #5. The cause was not obvious. There is not an appearance of delamination or deterioration. It seems more likely that it is the consequence of a deliberate or accidental impact.

Floor slab spall.
