City of Petersburg Virginia

RE: **Public hearing and consideration of an ordinance to declare the property located at 380 E. Washington Street a blighted property and a public nuisance to the community, and authorizing the abatement of such nuisance.**

REPORT OF UNSAFE AND UNSECURED STRUCTURE THAT IS UNFIT FOR HUMAN HABITATION - PURSUANT TO VPMC 106.2

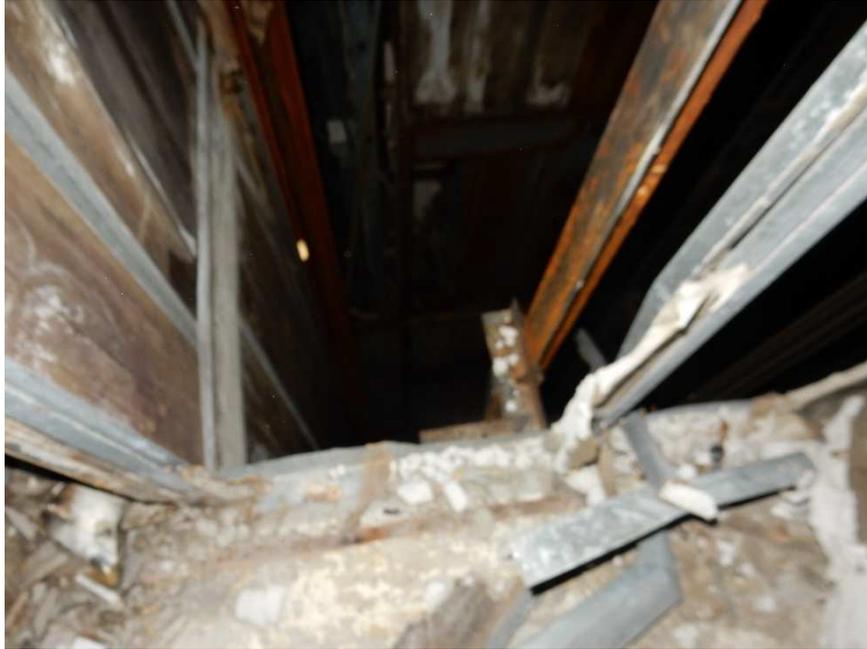
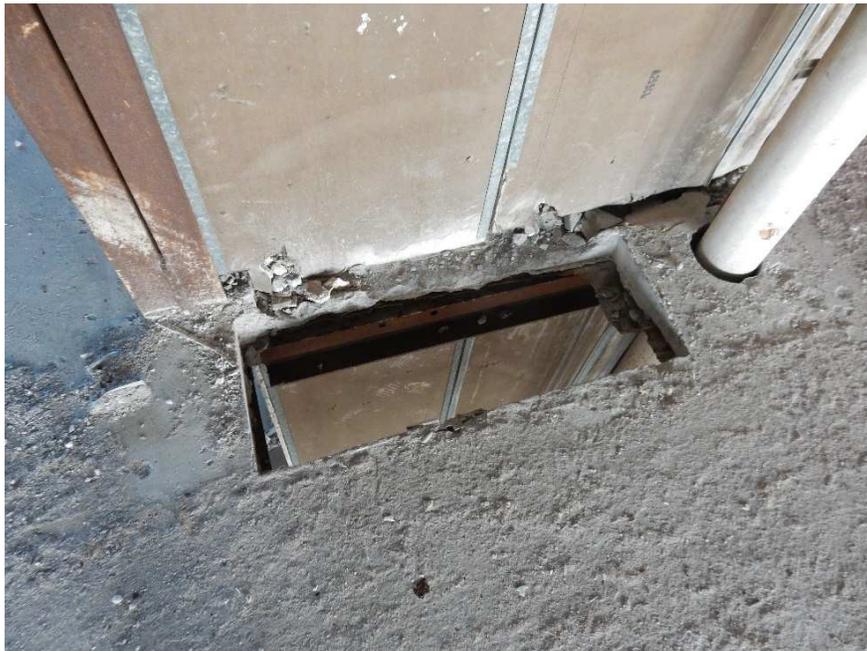
Examples of unprotected floor openings

If the interior premises are determined to be unsecured, there are numerous locations where materials have been removed but the floor openings have not been protected against the potential of falling through, including the main elevator shaft.

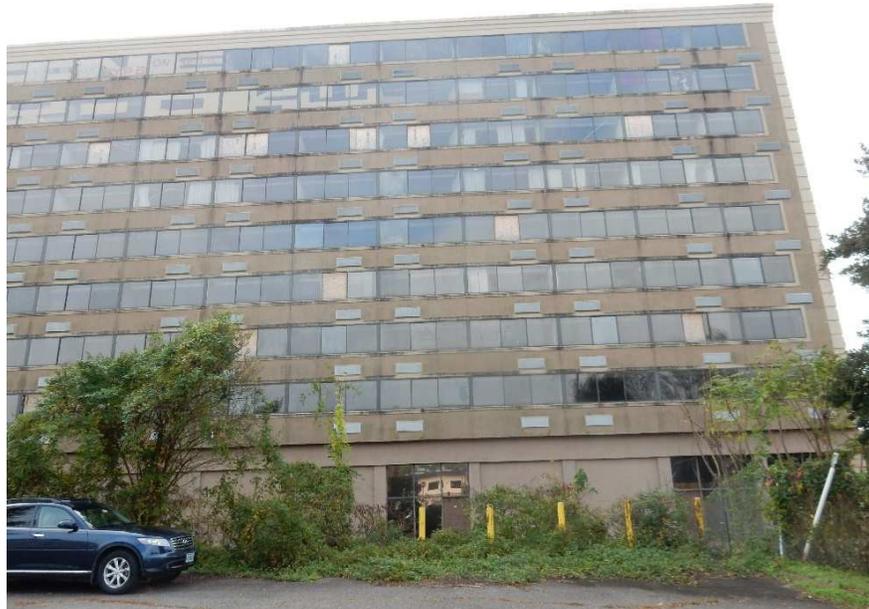
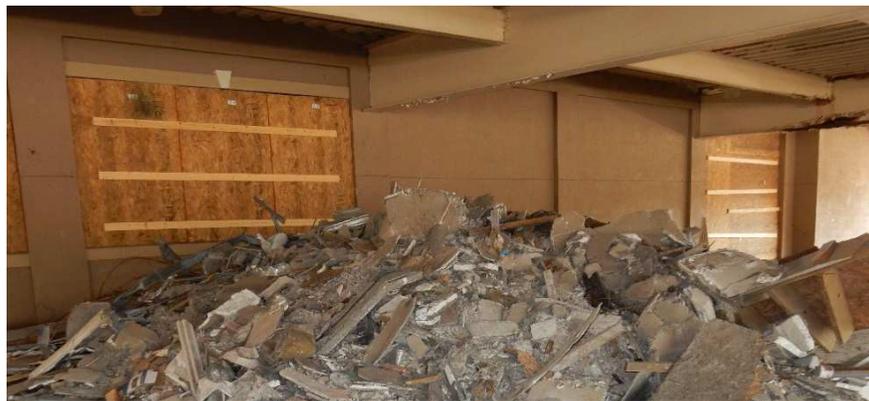
Examples of "boarding up" of windows/openings

The next grouping of photos potentially demonstrates noncompliance with the cited Petersburg City Code (PCC) section.

PCC Section 2-196: "Derelict building" shall mean a building or structure that might endanger the public's health, safety, or welfare and for a continuous period in excess of six months, has been (i) vacant, (ii) boarded up in accordance with the building code, and (iii) not lawfully connected to electric service from a utility service provider or not lawfully connected to any required water or sewer service from a utility service provider.

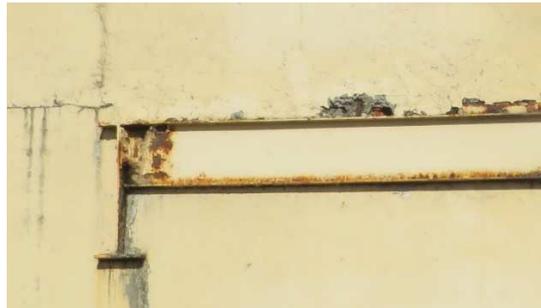
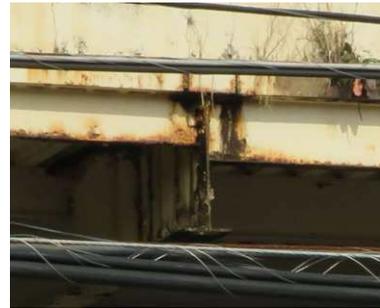
Examples of deterioration of the Parking Deck – perimeter structure

Significant corrosion is visible on the structural steel beams and ends of supporting girders along the perimeter, including the beam-to-girder connections. Beams and girders at the west end are partially encased in the cast-in-place concrete wall. The corrosion of this steel due to exposure to the elements and associated rust expansion has caused damage to the concrete wall. Concrete has spalled above the 2nd level beam and cracking has developed adjacent to the top of the girder.

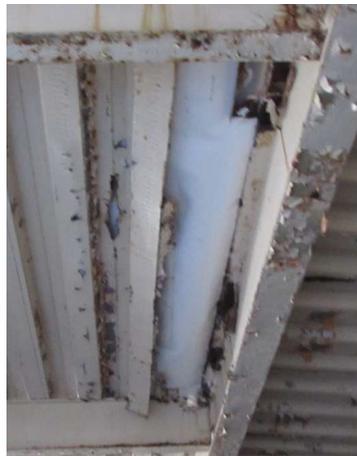
Examples of deterioration of the Parking Deck – deck repair

Corrosion of the steel floor deck has resulted in loss of a complete deck flute across two spans. The adjacent deck flute at each span has broken away from the beam support. Concrete above appears to have been removed and replaced. The steel deck at the apparent repair does not appear to have been repaired nor replaced, and the concrete appears to have been poured on top of a white tarp-like material. This material does not appear to be structural in nature, and it is not apparent if reinforcing was added in the concrete patch. Thus, the structural capacity of this condition is unlikely to be adequate for the required loading.

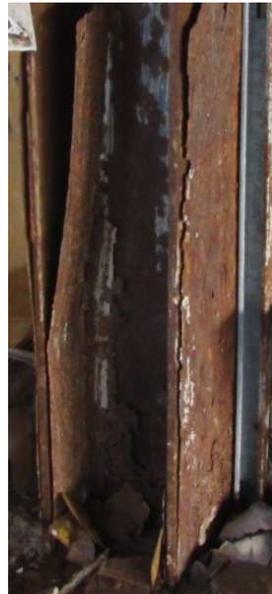
Examples of deterioration of the Building –
steel beam and column corrosion

At several locations on several floors, corrosion of steel beams and columns was observed. This corrosion appears to have caused surface deterioration of the beam and column webs and flanges.
