Historic Structures Report:

Jarratt House

Historic Structures Report Jarratt House

Prepared by:
Brandon L. McCuin M.H.P

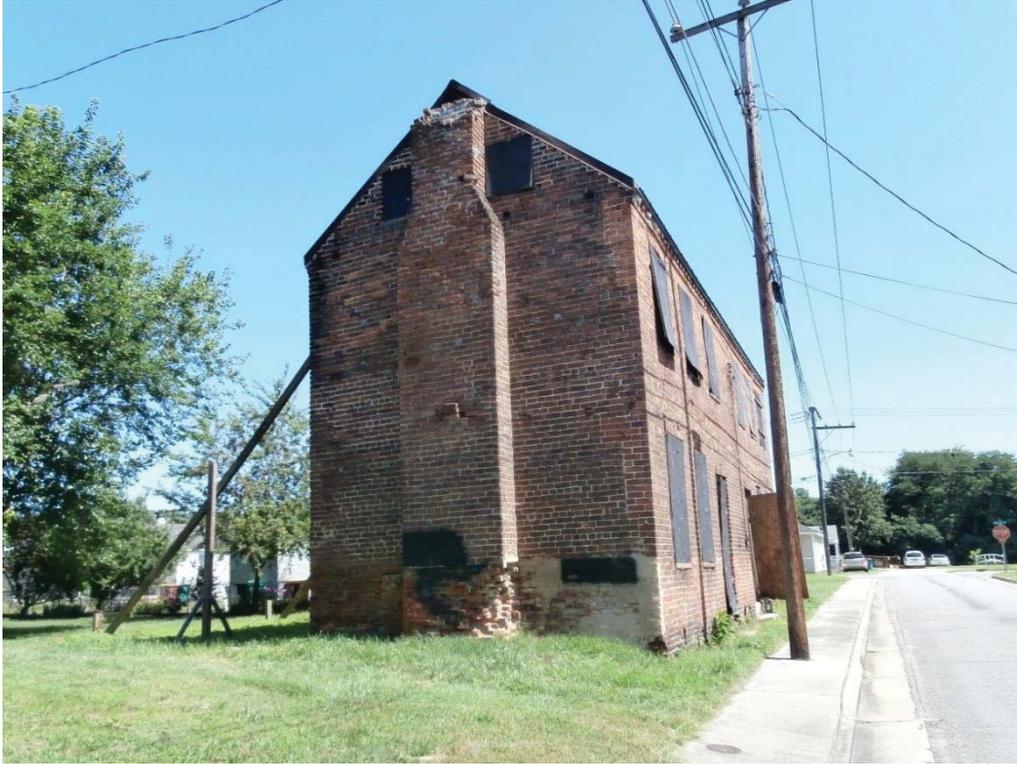
Figure 3-1. South wall and primary (east) facade of Jarratt House, facing north, 2017.

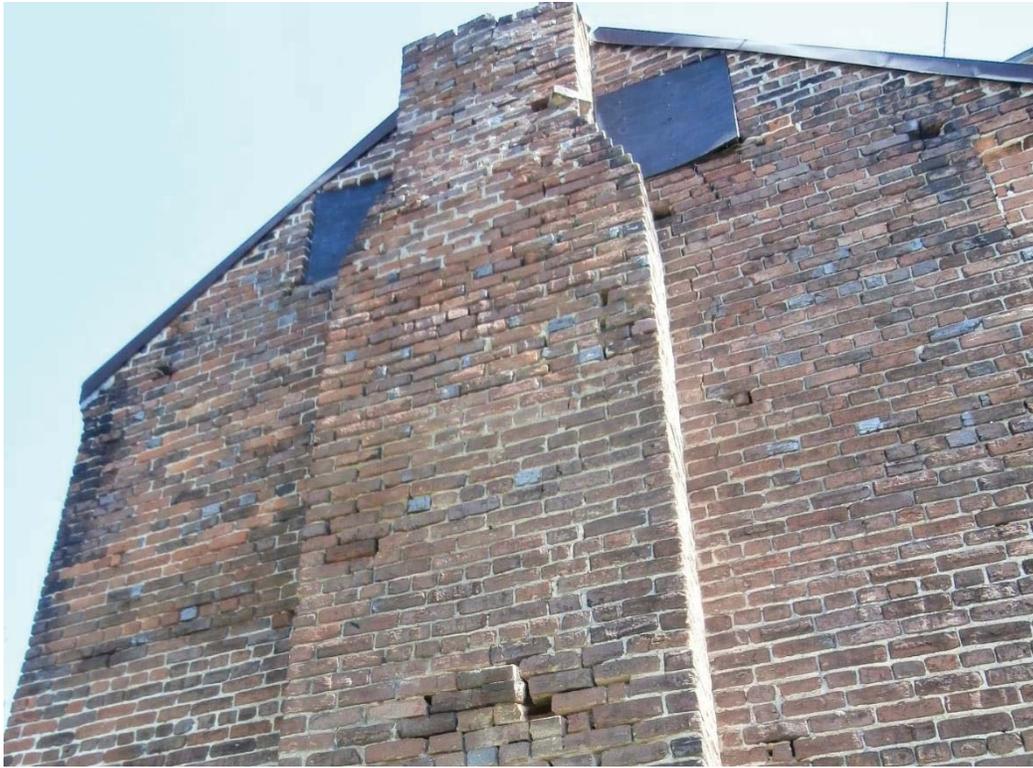
Figure 4-3. Photograph of south wall at roofline, and exterior chimney, 2017.

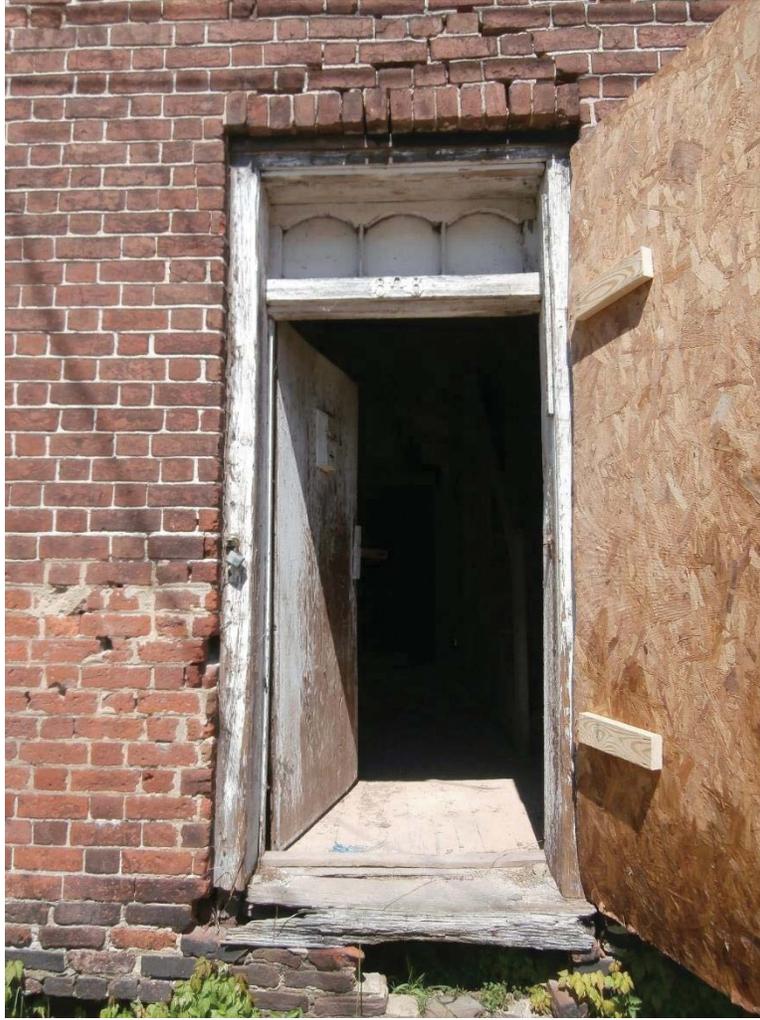
Figure 4-8 Photograph of House 1, main entrance with intact transom on the primary façade, 2017.

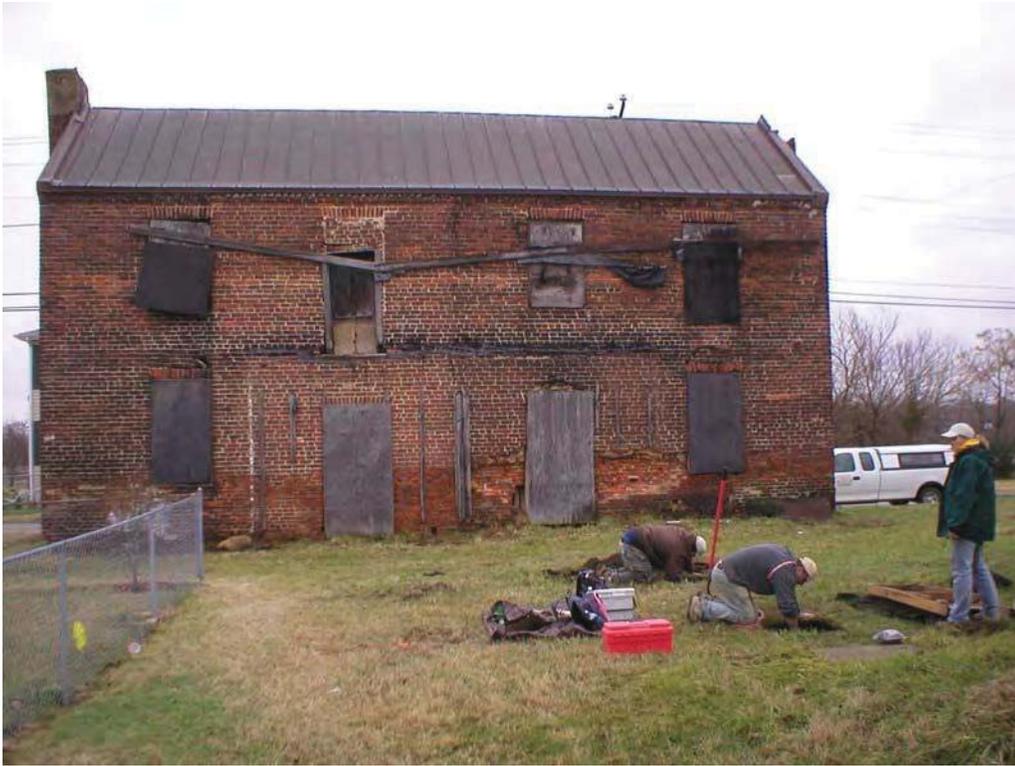
Figure 4-11. Photograph of Jarratt House, rear façade, 2006.

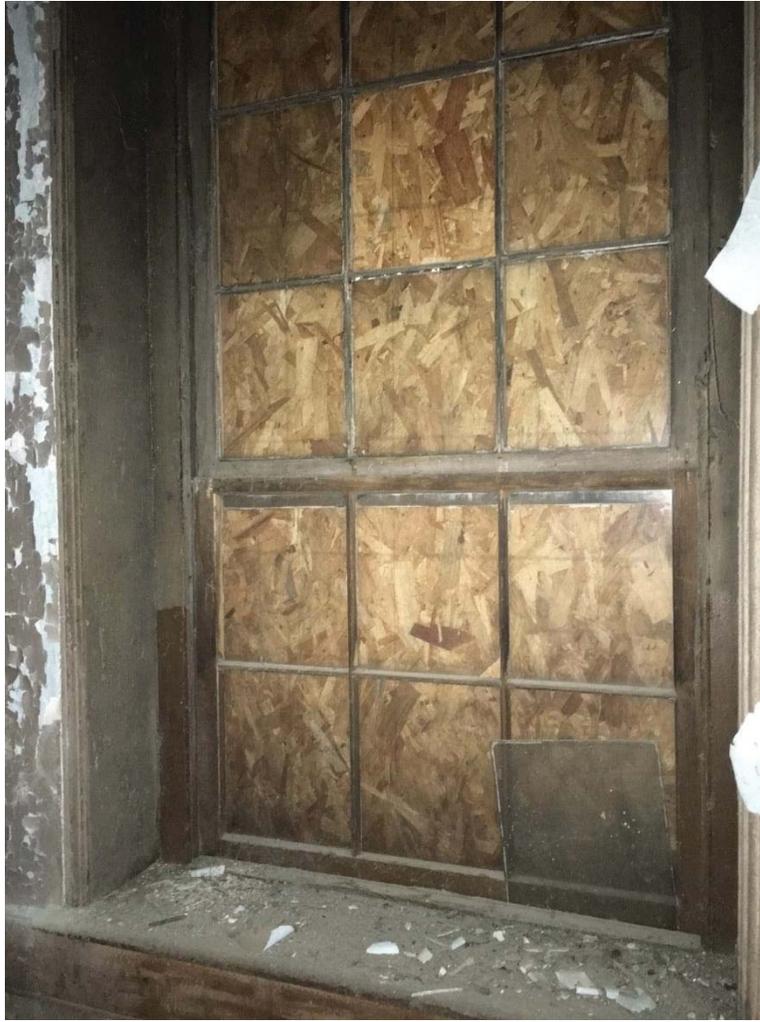
At the time of the survey, very few of the building's windows were intact, however, all the extant window frames within the building appear to be original. Many windows were missing panes or were damaged, but the sills and frames were intact, and are currently protected from the elements by the exterior plywood. The windows on the first floor living rooms of both houses appear to be the original window frames with twentieth century replacement 9-over-6, wooden double-hung sash. Several of the windows were missing a few glass panes, but are otherwise sound. The windows are free of paint but were not operational and are in need of re-glazing and caulking. The windows on the upper floor also appear to be the original frames with twentieth century replacement, 6-over-6 double hung wooden window sills. The northernmost window on the upper story large chamber room is missing and boarded over, while the second window in this room is damaged and boarded over. The northernmost, second-story chamber room has a rear, 6-over-6 window that is also boarded over. The rear window and door on the first floor of House 1 are missing due to the wall collapse. The windows on the primary façade, exhibit severe damage and covered with tarp and/or plastic sheeting. These windows appear to be the original window frames with replacement, twentieth century, 9-over-6, double-hung wooden frames.

Figure 4-13. Interior photograph of historic 9-over-6 window (window 6) in northernmost room on first floor, 2017.

Original window frames are a key character-defining feature of any historic building, while many of the Jarratt House's windows are damaged and/or missing, the original materials are largely intact, and may be restored and/or repaired to their original appearance. It appears the Jarratt House windows on the south façade may be original and should be preserved and used as template for any replacement fenestration.

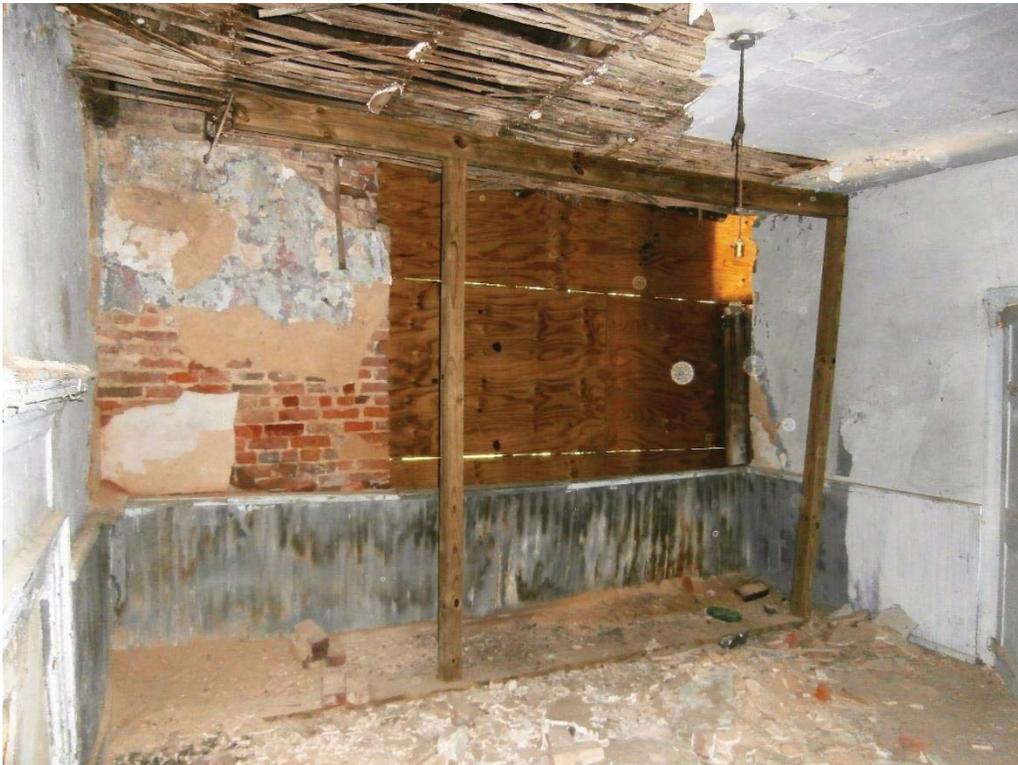
Figure 4-18. Photograph of southernmost room, on first floor, House 1, with collapsed interior wall, supporting beams, and ceiling, 2017.

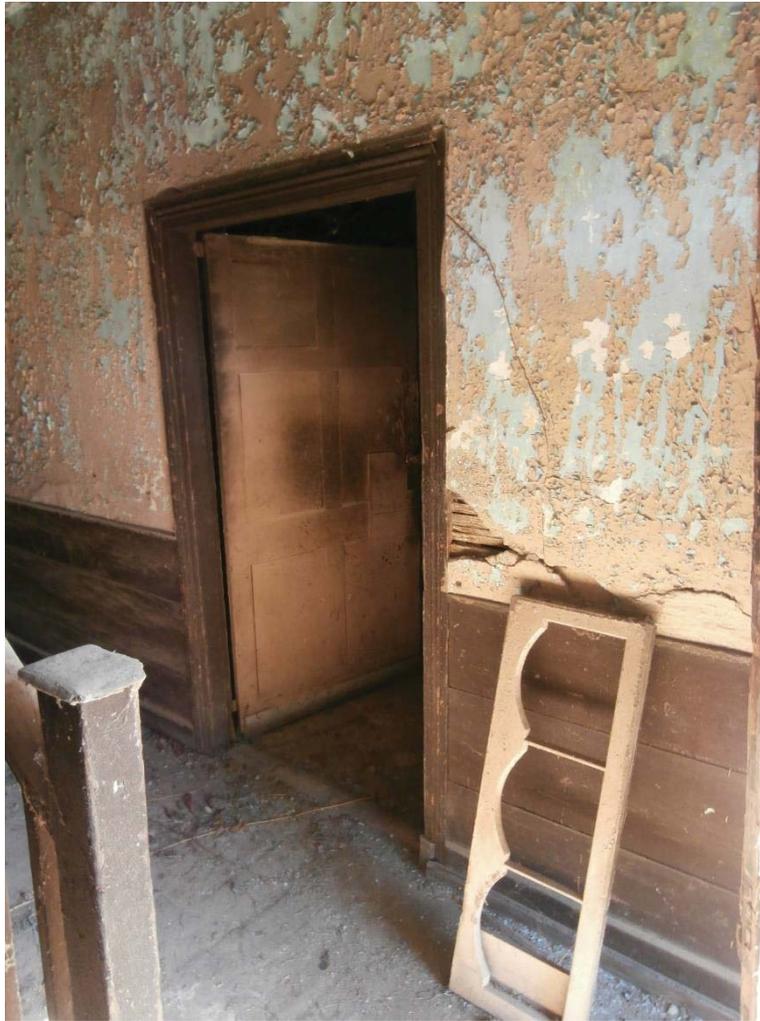
Figure 4-21. Photograph of northernmost room, on first floor, House 2, detailing six-panel door and exposed lath and plaster, 2017.

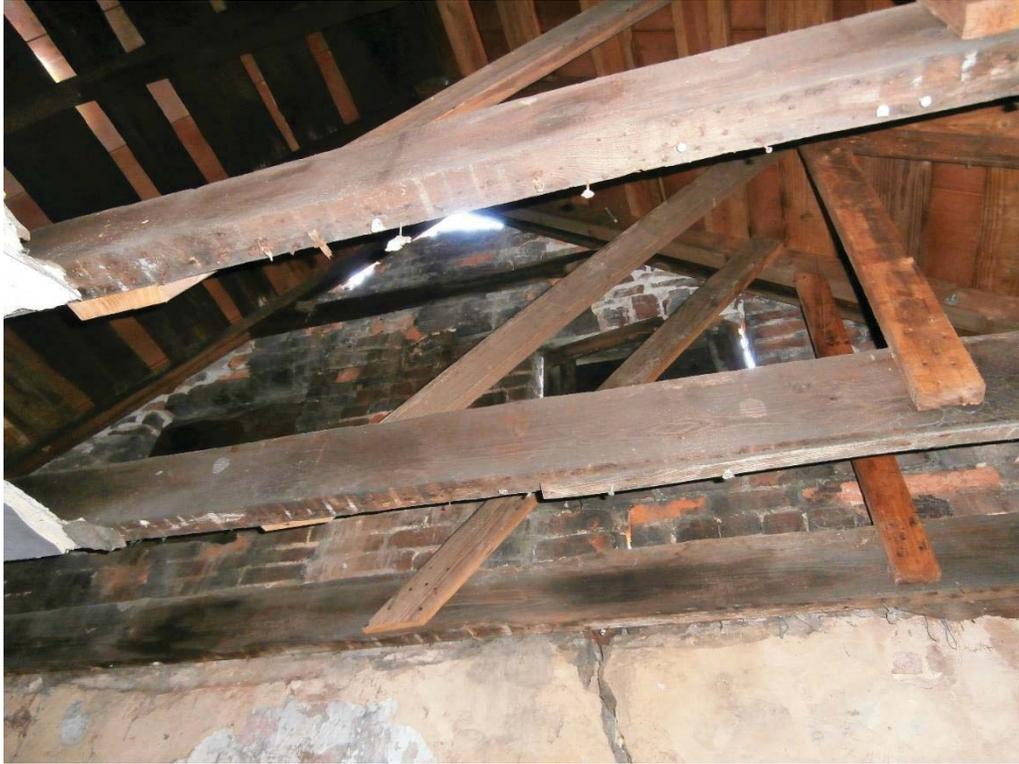
Figure 4-25. Photograph looking at rafters in the southernmost room, on the second floor, House 1, 2017.

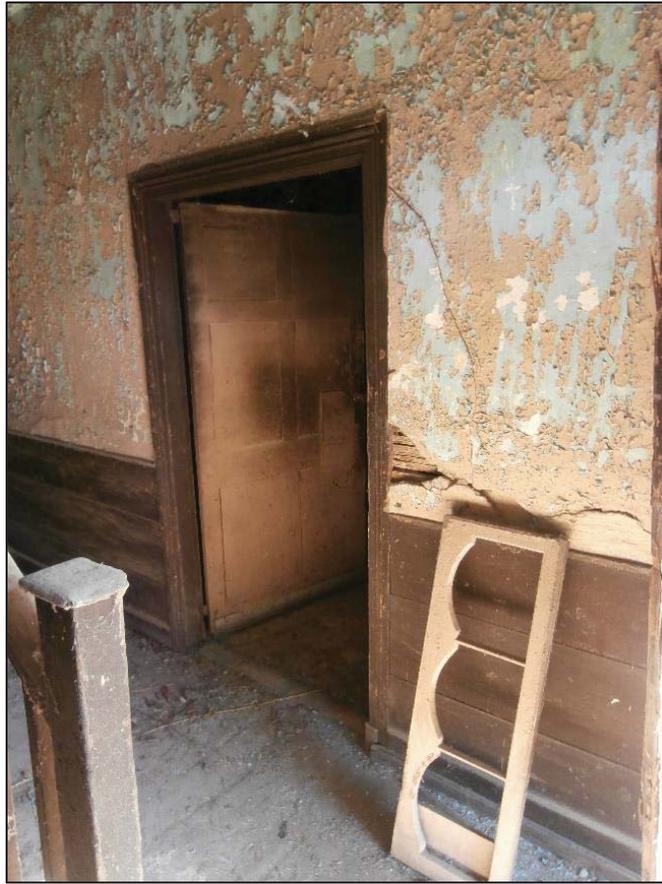
Plate 11: View looking toward north most room showing exposed plaster and lath (House 2), facing northwest.

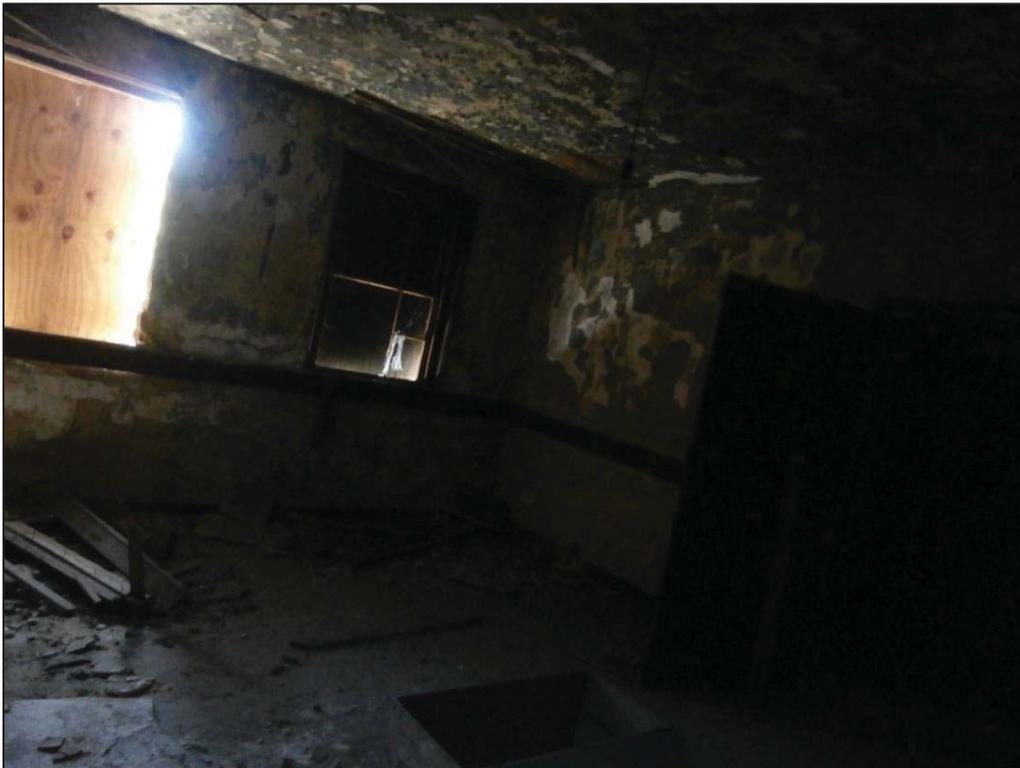
Plate 39: View of northern-most room on the 2nd floor with a missing window covered with plywood on the front façade (House 2), facing northeast.

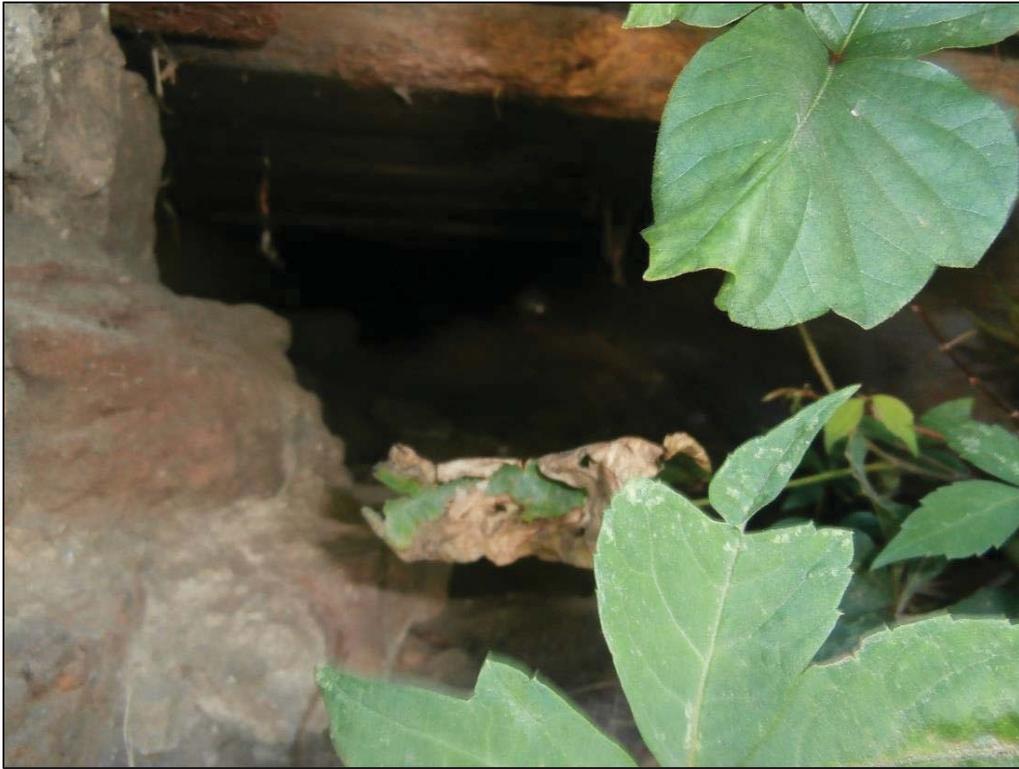
Plate 61: Detail showing under the building showing crawlspace, foundation and subfloor.

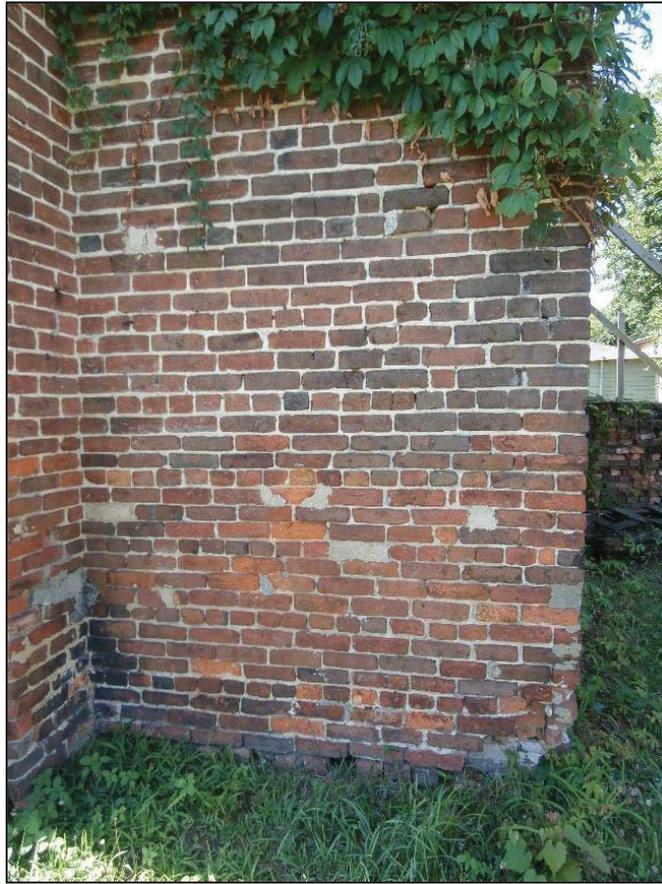
Plate 63: View of the north façade with chimney at left, facing south.

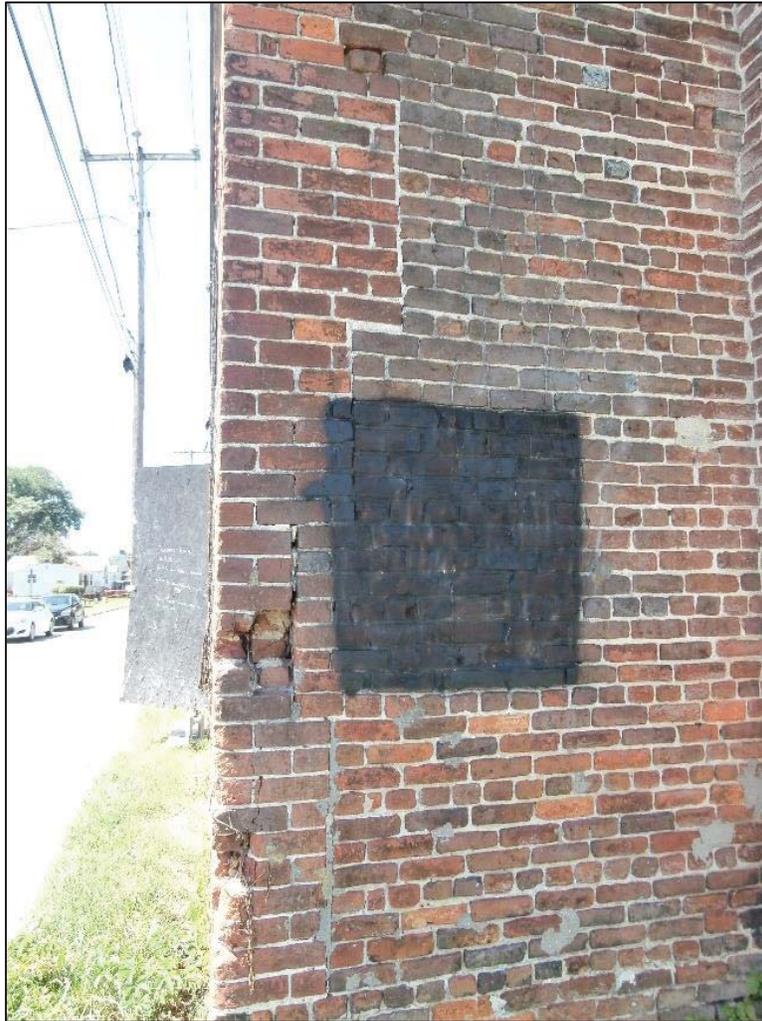
Plate 65: Detail of the northeast corner of the north façade showing a variety of brick courses and area vandalized with spray paint, facing south.

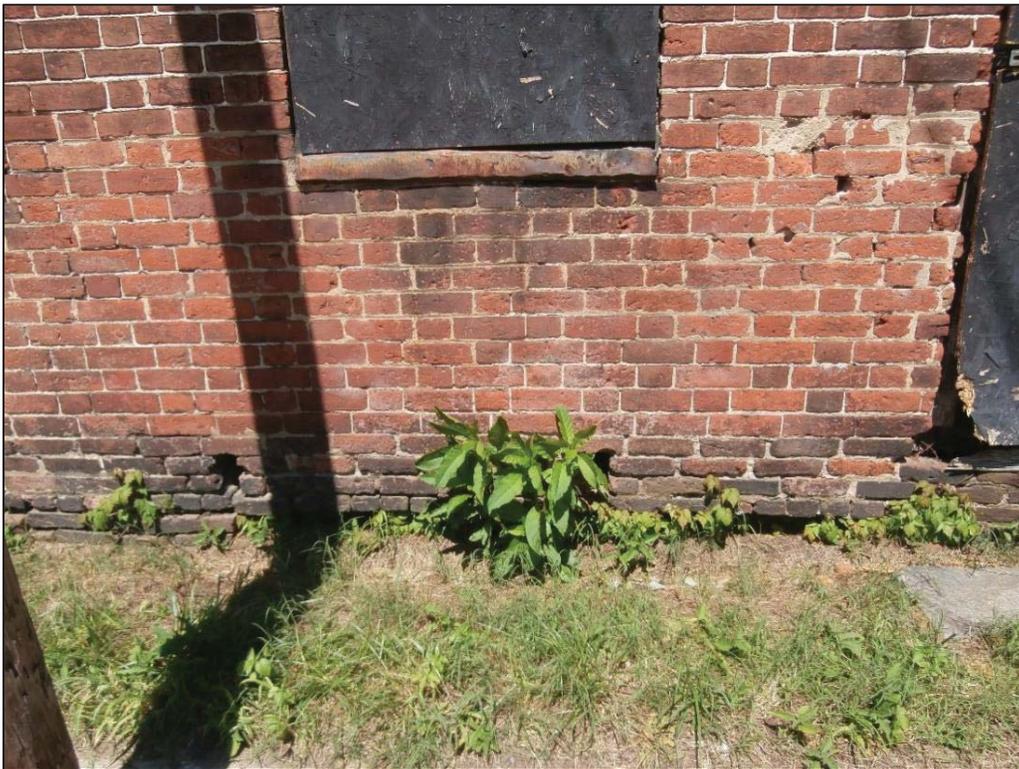
Plate 70: Detail of front façade (east) showing particle board infilled window and part of the entrance to House 1, facing west.

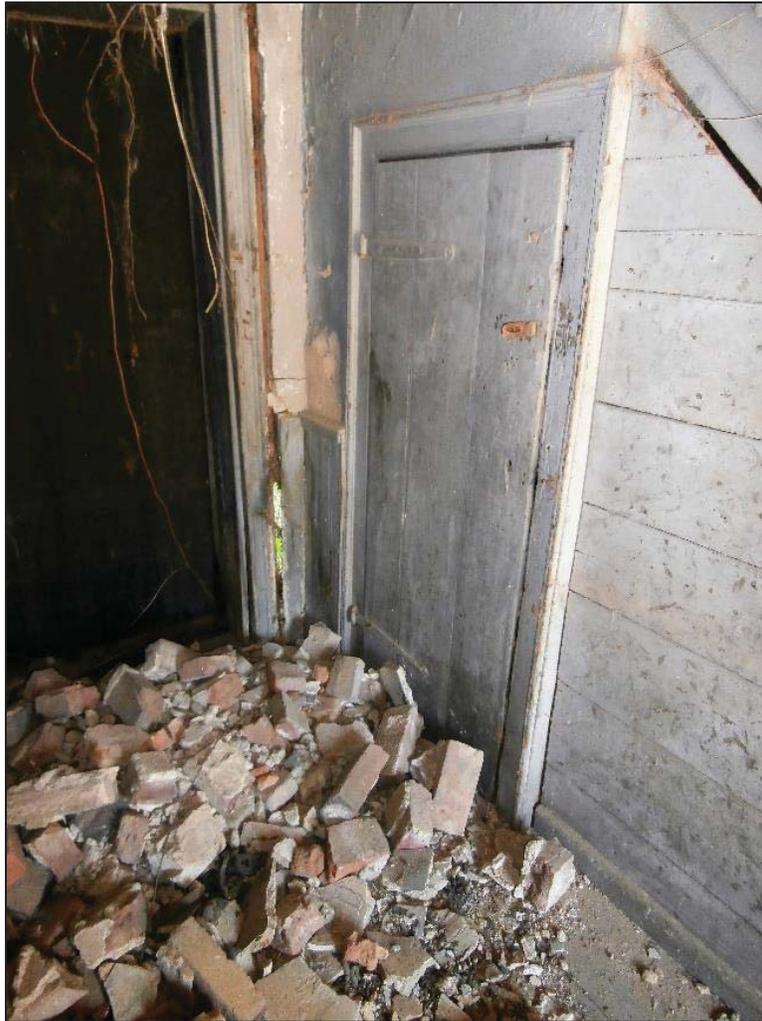
Plate 79: View of closet door beneath staircase in hallway (House 1), facing northwest.

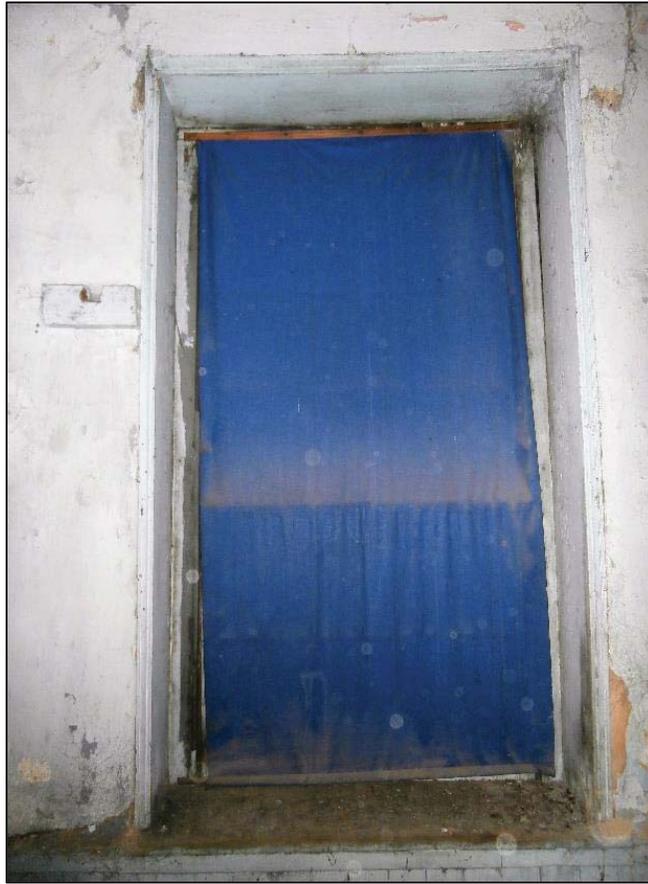
Plate 85: Detail of infilled window on the east wall of the south-most room (House 1).

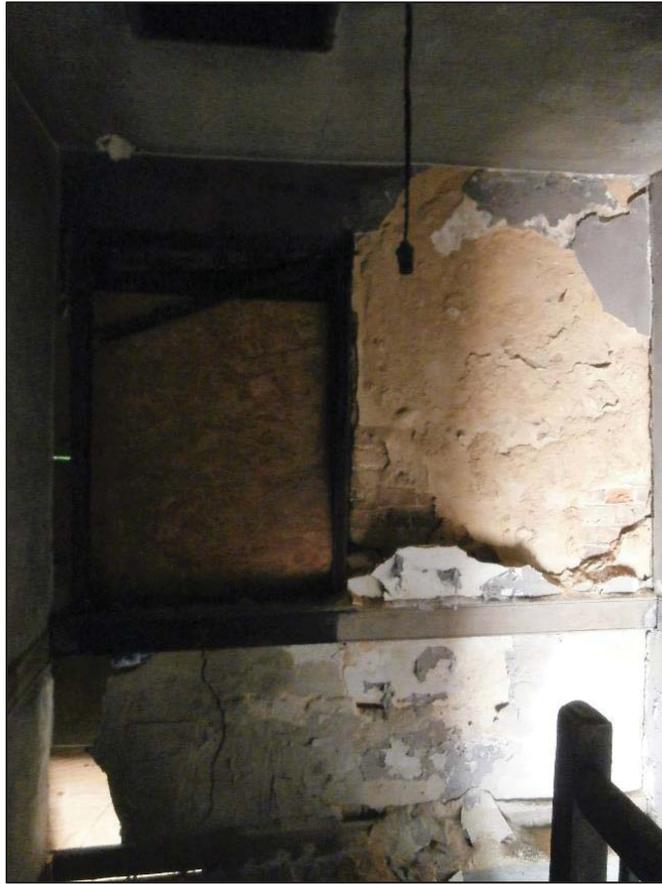
Plate 91: View of 2nd story hallway and infilled window (House 1), facing west.

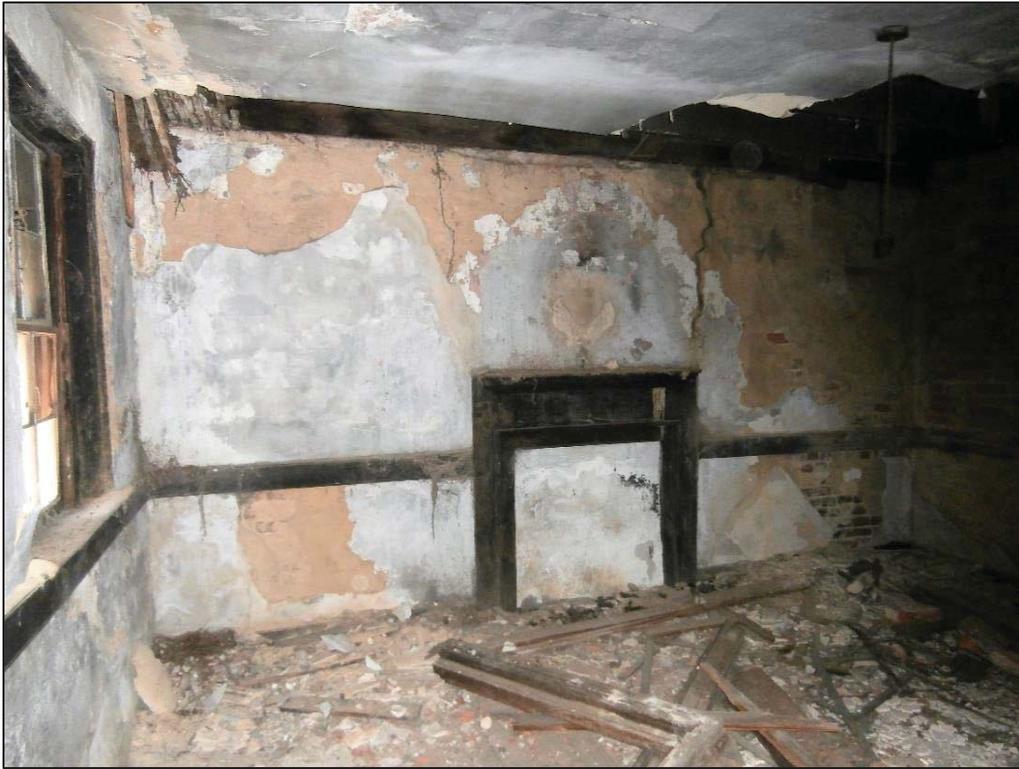
Plate 99: View of historic fireplace and chair rail in southern-most room on the 2nd floor (House 1), facing south.

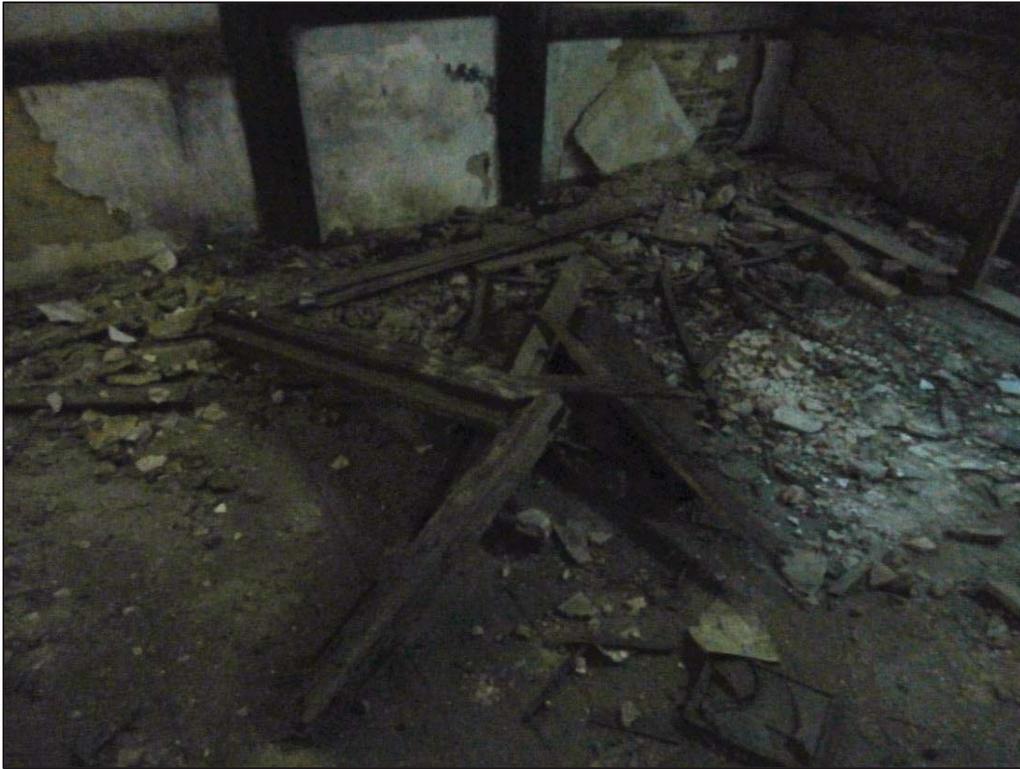
Plate 101: Detail of rubble in the southern-most room on the 2nd floor (House 1).

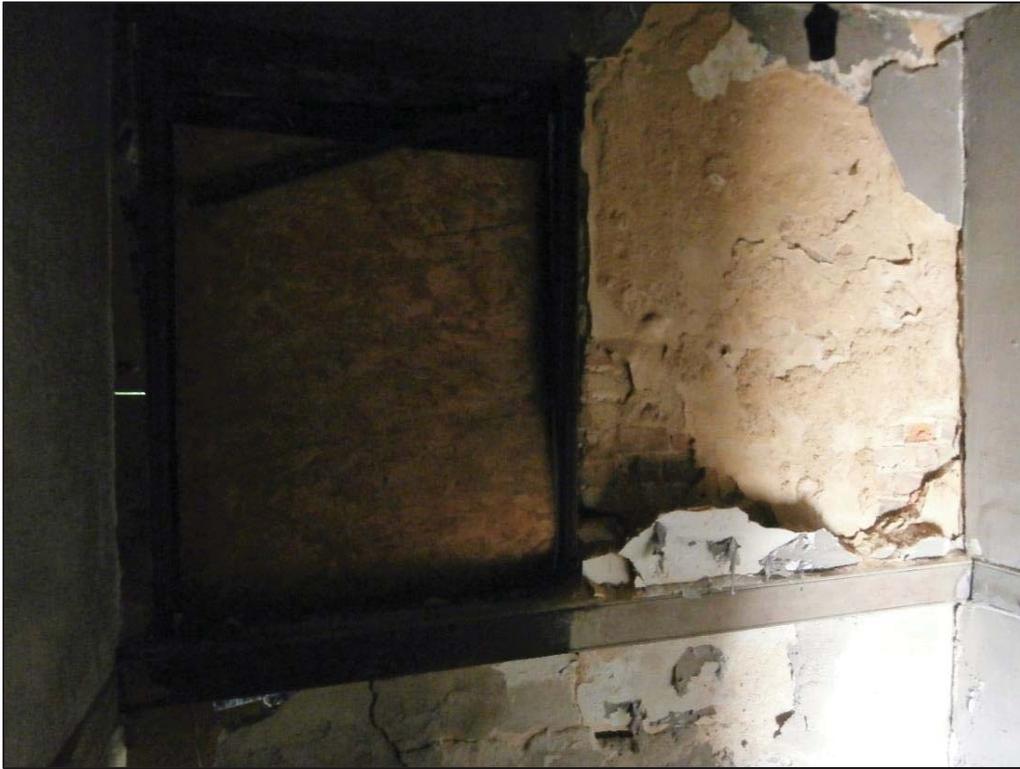
Plate 109: Detail of rear infilled window in the hallway on the 2nd floor (House 1), facing northwest.
